A lime based mortar for thermal insulation of medieval church vaults

Citation (APA):
Hansen, T. K., Larsen, P. K., Hansen, K. K., Bjarløv, S. P., & Peuhkuri, R. H. (2016). *A lime based mortar for thermal insulation of medieval church vaults*. Paper presented at Historic Mortars Conference 2016, Santorini, Greece.

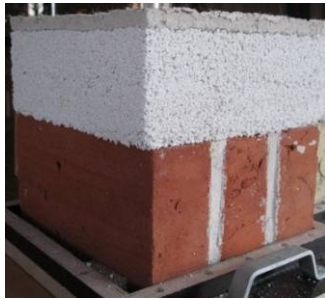
Figure 1: Model of vault construction with insulation mortar; ½ brick thick vault, 100 mm insulation mortar and 10 mm cattle hair reinforced mortar

which was why the lime based perlite mortar was developed and tested for this intended use. Lime is compatible with the existing clay fired bricks and lime mortar joints, and perlite is a naturally occurring volcanic rock type, expanded under heat loads. The insulation mortar is able to lie directly on the existing vault, following the rounded geometry. For increased load bearing capacity, a thin layer of lime mortar reinforced with cattle hair is applied on top of the insulating mortar. A model of the insulated vault is seen in Figure 1.

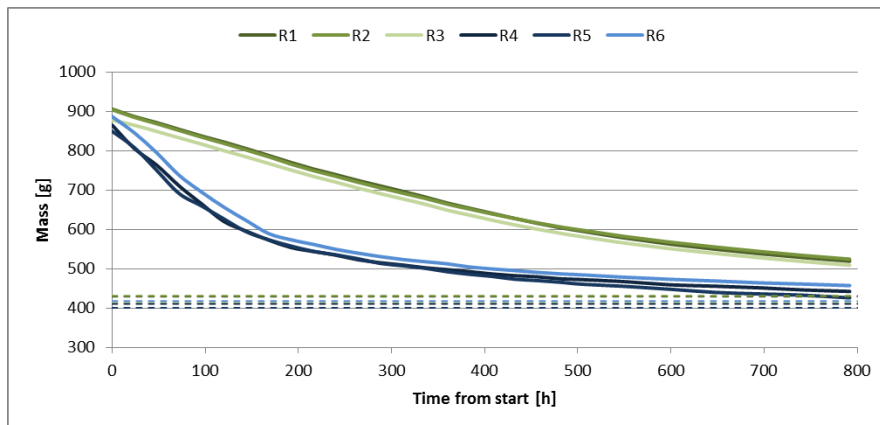
Figure 2: Mass whilst drying of specimens. Specimens numbered 1-3 have been subjected to an air velocity of 0 m/s, specimens numbered 4-6 have been subjected to an air velocity of 3 m/s. The dotted lines represent dry-weight of specimens

For the drying experiment, each specimen was sealed on all sides except one for determined drying area. The specimens were saturated by capillary suction, hereafter they were placed in a climate chamber at approximately 22-25°C and 64-70% relative humidity, for daily monitoring of the drying process by weighing. In the experiment, half of the specimens were subjected to 3 m/s air velocity, and the rest 0 m/s air velocity.

The results of capillary suction showed, that LBM Test Method 1 had more reliable results than the Karsten tube measurements, as more specimens were tested in LBM, and the standard deviation found to be 5 times lower than Karsten tube. On the other hand, the results did not differ outrageously, and it was found that the capillary suction in the insulation mortar is higher than both brick and lime mortar [3]. It is seen in the drying progress depicted in Figure 2 that the air velocity has a big influence on the drying rate, as the mass of these specimens drastically reduced in the first 200 hours. After 200 hours the drying curve levels out. At the end of the experiment, specimens subjected to air movement are closer to initial weight, dry weight, but the difference at this point is not substantial. The value of 3 m/s for air movement is not realistic in the church attic however the air is not still, as there are many leakages in these roofs. The experiment showed that in the course of 1 month, capillary saturated insulation mortar can almost dry completely with air movement from 0-3 m/s. The cup-test revealed a more than 3

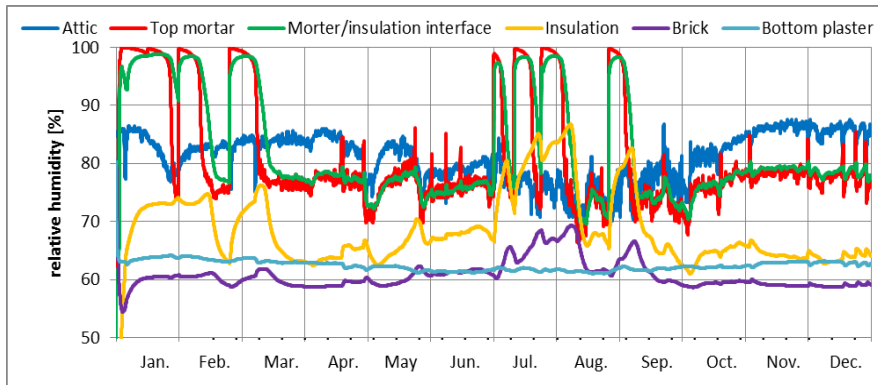
Figure 3: Yearly simulation of church vault with 100mm insulation mortar

Simulation results of relative humidity through the construction are expressed in Figure 3.

The simulation results indicated that only the upper three output points were clearly affected by the exterior water loads. The exterior water loads added in winter and summer, seemed to have a significant influence on humidity conditions in layers down to the middle of the insulation layer, but not further, towards the brick layer. It was seen, that the interface area between brick and insulation, as well as the middle of the brick layer, was influenced during summer periods, but to no severe extent. In the summer period the superficial layers dried out quicker than in winter due to increased temperature, which also made the vapour pressure in the attic increase and cause the deeper penetration of moisture during summer. Neither the bottom part of the brick or the bottom layer of plaster was affected by the external water loads at any time.

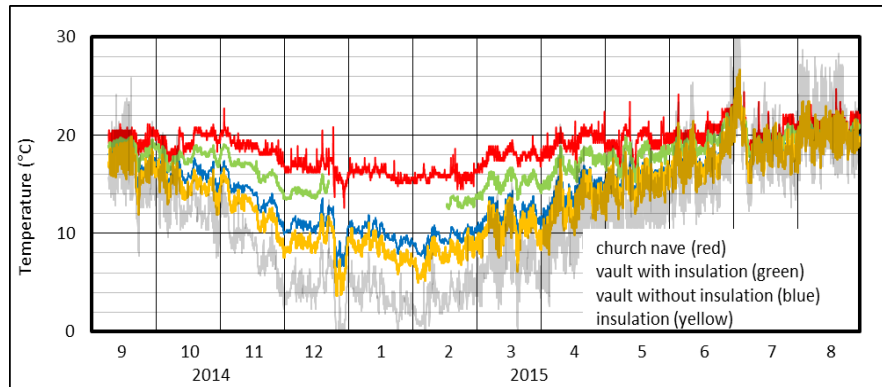
Figure 4: Temperature measurements from Annisse Church

Results from in situ measurements of temperature and relative humidity are shown in Figure 4 and Figure 5.

The temperature measurements, seen in Figure 4, show that the temperature of the insulated vault was 2-3° warmer than the un-insulated vault during winter. The temperature measured in the insulation was slightly colder than the uninsulated vault. In the summer period, the temperature in both vaults and in insulation were very similar. The measured relative humidity is depicted in Figure 5. It is seen that the humidity in the insulated vault is initially a bit higher than the uninsulated vault, but due to drying of building moisture, the insulated vault reaches humidity levels resembling interior conditions within ½ year. The humidity measured in the insulation mortar, is higher for a while, with a peak in October 2014. The peak was likely caused by the carbonization process of lime, which expels water, also explaining the high humidity declining in the insulation layer. In the period where the humidity reaches 100 % in the insulation, it is seen to not affect the underlying brick in any essential way. The relative humidity in the uninsulated vault has less variation.

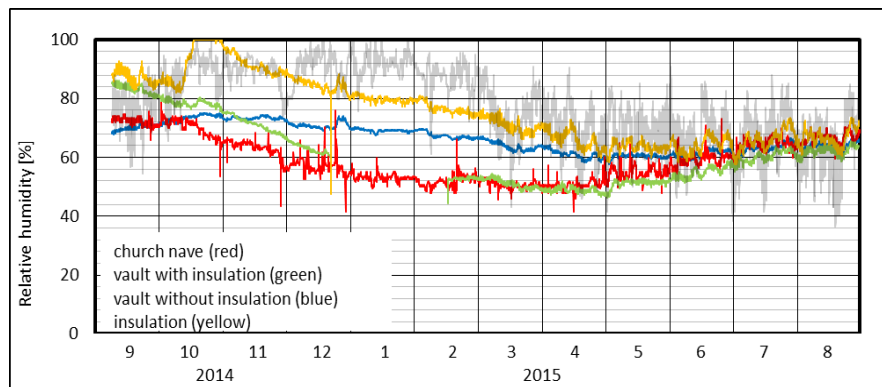
Figure 5: Relative humidity measurements from Annisse Church
