Electrokinetic desalination of protruded areas of stone avoiding the direct contact with electrodes

Published in:
Materials and Structures

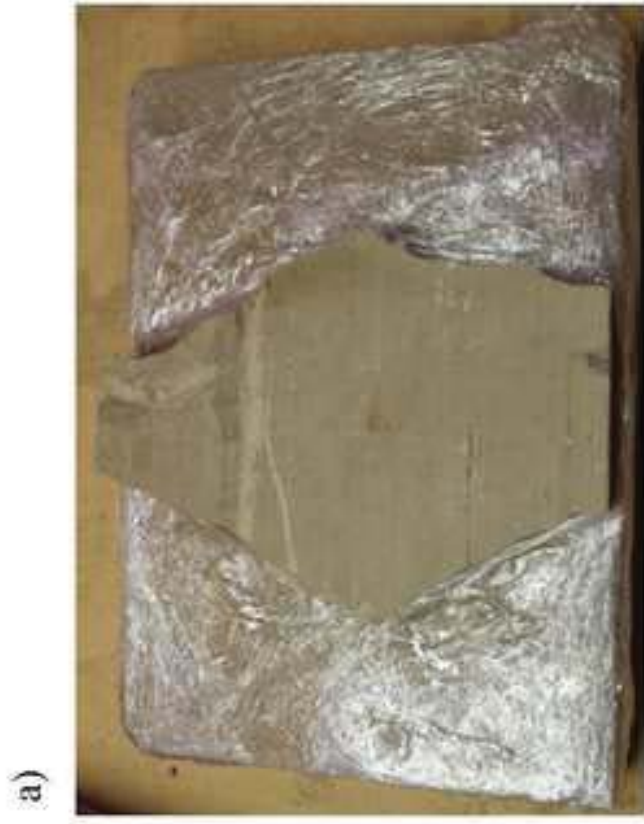
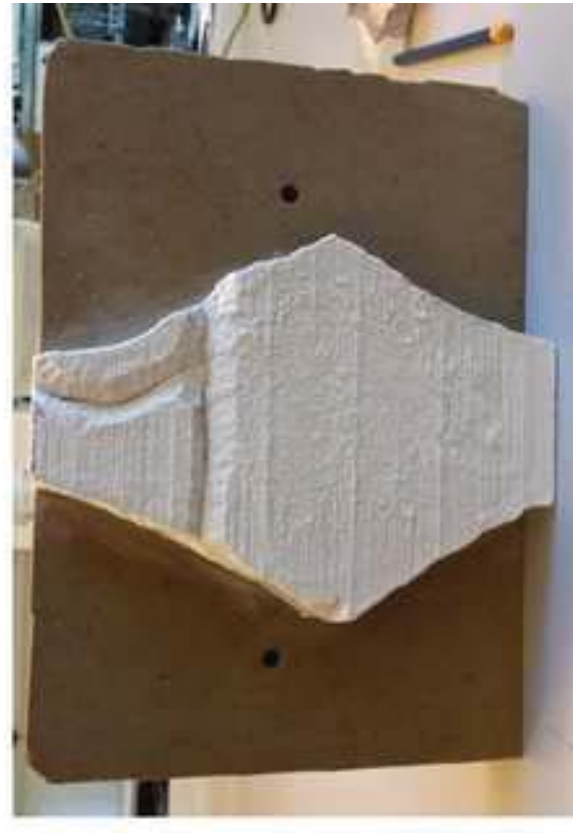
24 INSERT FIGURE 1

9 An ashlar of 28.8 x 20.0 x 28.8 cm of dimension was extracted from one of the outer walls of
10 the castle. A slab of 6.8 cm of thickness which comprises the exposed surface was cut from the
11 ashlar. On this slab, 3.1 cm into depth on each side of the central area was carved, in order to
12 create the protruded area (see Figure 1 a-b). So, two areas have distinguished: the protruded area
13 (called in this research the *central area*) and the both sides of this central area, i.e., the adjacent
14 parts of the central area (called in this research *neighbouring areas*).

15 This recess, which evidently cannot be performed in situ, was carried out in order to increase the
16 salt content only on the central area by capillary absorption. The aim of this contamination
17 (which is explained later) was to achieve an area with a high salt content (central area)
18 surrounded by an area with a lower salt content (neighbouring areas). This situation usually
19 occurs in monuments, where it is common to find areas such as reliefs, capital columns,
20 archivolts or sculpted motifs with a higher salt content (in consequence with a degree of
21 superficial decohesion that would make impossible the contact with the electrodes) and
22 neighbouring areas with lower salt content (less deteriorated, where the desalination equipment
23 could be placed).

20 In order to increase the soluble salt content of the rock only in the central area, a salt
21 contamination process was carried out. For this purpose, the rock was wrapped with plastic film,
22 leaving only the central area uncovered, as shown in Figure 1-a.

3 A total of five cycles of contamination were conducted. Once the cycles of contamination were
4 ended, the block (still covered with plastic in the neighbouring areas) was left to dry at room
5 temperature during a week in order to promote the migration of the salts towards the central
6 area, and their accumulation in this area. Then, the plastic was removed and during another
7 week, the rock was left to dry at room temperature in order to favour the loss of the residual
8 moisture and to promote the crystallization of the salts, especially in areas where there is a
9 greater concentration of them. After this period of time, the central area of sandstone showed a
10 different aspect regarding to the initial appearance (see Fig. 1-d) due to the presence of the salts.

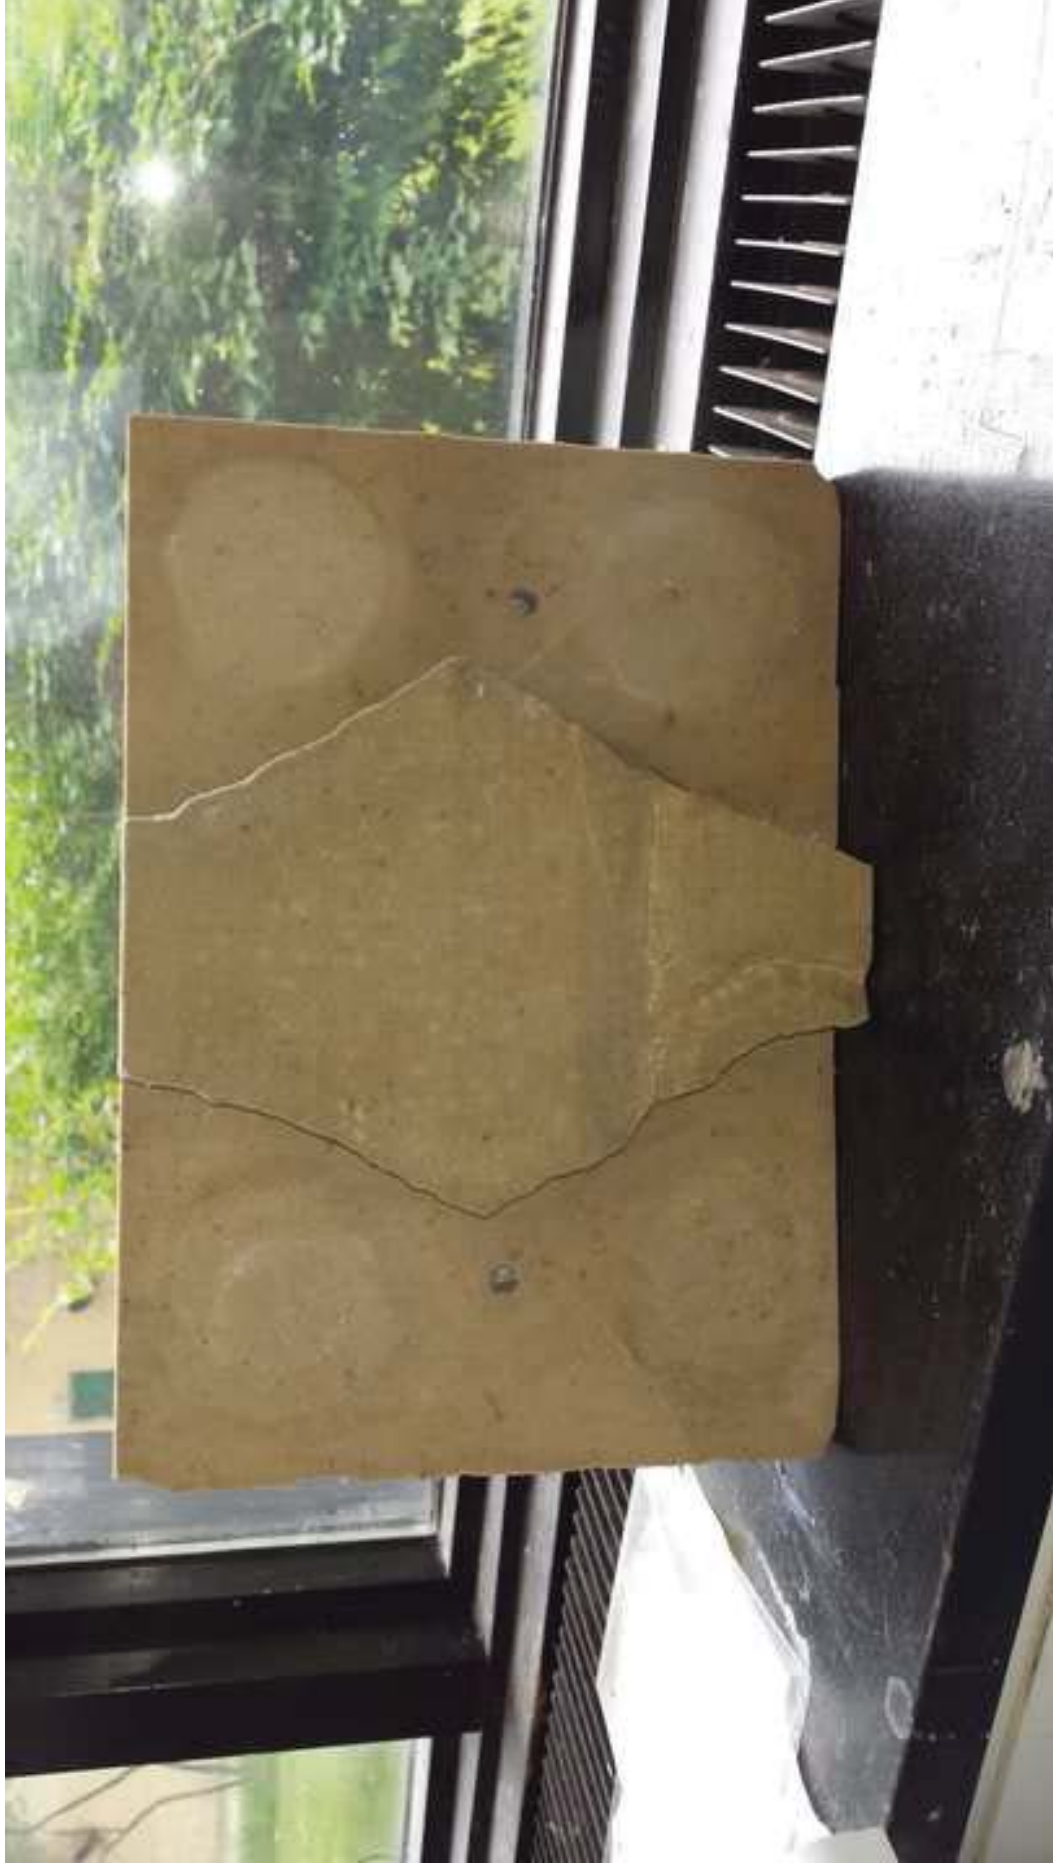
figure 6

23 Figure 6. Appearance of the rock after the desalination treatment.
