Published in:
COLD CLIMATE HVAC 2009

Performance of the Low-energy House in Sisimiut

Carsten Rode^{1,*}, Jesper Kragh², Egil Borchersen¹, Petra Vladykova¹, Simon Furbo¹ and Janne Dragsted¹

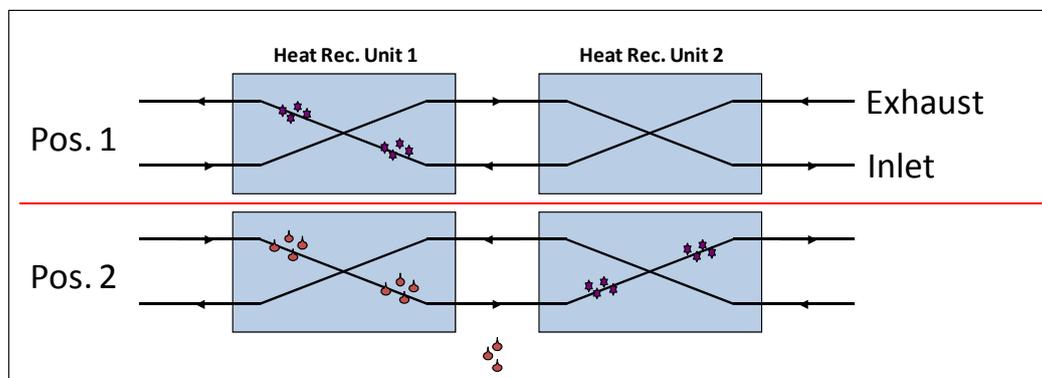
A new heat recovery unit was developed for the low-energy house in Sisimiut in cooperation between EXHAUSTO A/S and the Technical University of Denmark. The dimensions of the unit are: Length 1,760 mm, width 930 mm and height 660 mm. The unit consists of two highly efficient aluminium counter flow heat exchangers coupled in a serial connection. A valve is able to switch the air flow direction through the units. When ice formation starts to reduce the airflow in the coldest exchanger the air flow direction is switched. The exchangers, valve and filters are mounted in a cabinet with 50 mm insulation, although the unit is recommended to be placed in a heated place to minimize risks of frost damages from the condensing water. The theoretical temperature efficiency of the heat recovery unit is approximately 90 %. A diagram of the system is shown in Figure 2.

Figure 2. Diagram of the heat recovery unit with two heat exchangers.

The heat recovery system has in some periods been blocked by ice. Beginning ice formation in the system has had the effect to impair the cyclic change of the order of the two parts of the heat recovery system, so the defrosting function has not been fully functional, and the frosting situation has gotten worse. In October 2006, an insulated box was built around the heat exchanger unit, and an electric heater ensured heating of the air around the box to a temperature that approaches normal indoor air temperature. However this initiative has not eliminated the problem, and the temperature efficiency of the heat exchanger remains around 50% (in some periods only 30%), while the system was expected to have an efficiency of 80% (Rode et al., 2007 and 2008). Wasted energy by insufficient heat recovery (estimate): 30% of ventilation heat loss = approximately 25 kWh/m².

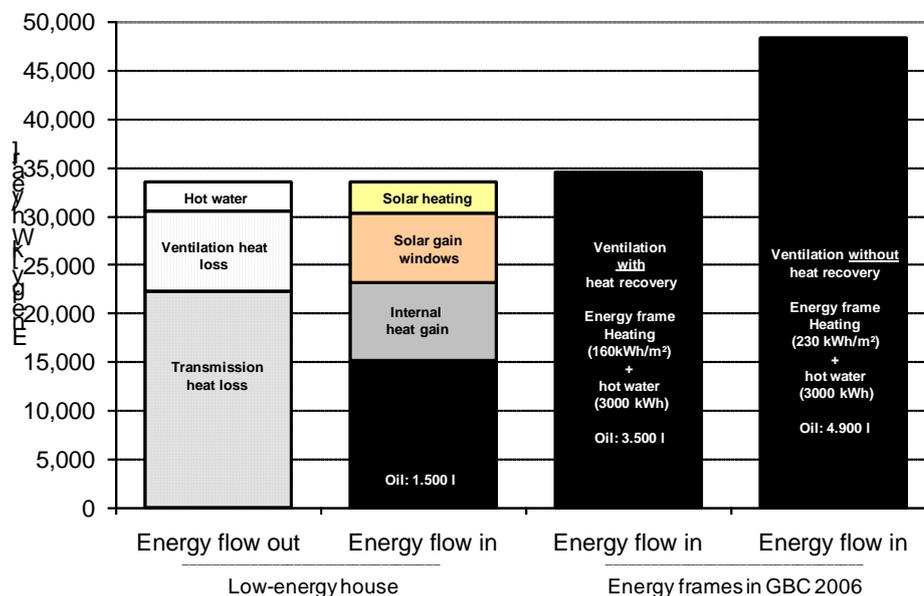
A calculation model has been set up in the thermal building analysis tool *BSim* (BSim 2009) to analyse the energy performance of the house. As the low-energy house is a double house made of two equal houses with common scullery/boiler room and entrance hall, the calculation model is simplified to only one of the two halves. Figure 3 shows the calculated contributions to the energy balance of the low-energy house. In the calculations, the heating set point temperature was 21 °C in all rooms except the two bathrooms where 23 °C were used. The assumed internal heat gain was 5 W/m² and the infiltration was 0.1 h⁻¹. The total ventilation rate was 45 l/s as required by the building code.

Figure 3. Energy balance of the 197 m² low-energy house compared with the demands of the Greenlandic building code.

The results are compared with the expected energy frame demands in the building code of Greenland. For a house with a mechanical ventilation system with or without heat recovery the energy frame demands are set to 160 and 230 kWh/m² respectively. It is seen that the energy consumption is simulated to be approximately 1,500 litres of oil per year. Compared with the energy frames of the building code it is seen that more than 3,000 litres of oil are saved every year. The simulation results show that the annual energy consumption of the low-energy house is below the target of 80 kWh/m² (Kragh et al., 2005).

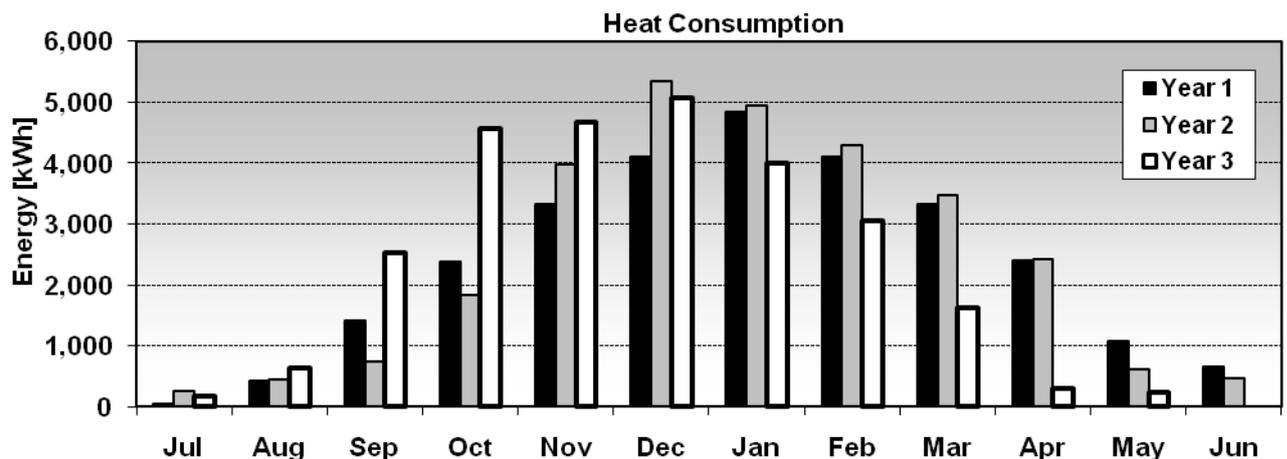
Figure 4 shows the monthly energy consumption for heating (exclusive of domestic hot water), where year 1 is for the period July 2005 – June 2006. The house has not been inhabited during the period July 2007 – April 2008 during which period the house underwent some renovation activities: A separation wall was erected in the boiler room, and the wooden floor of the living rooms was changed because of a failure with the first delivered floor. The house was heated during the construction period, although in a somewhat unusual pattern.

Figure 4. Heat consumption during the months of the first three full years of operation.

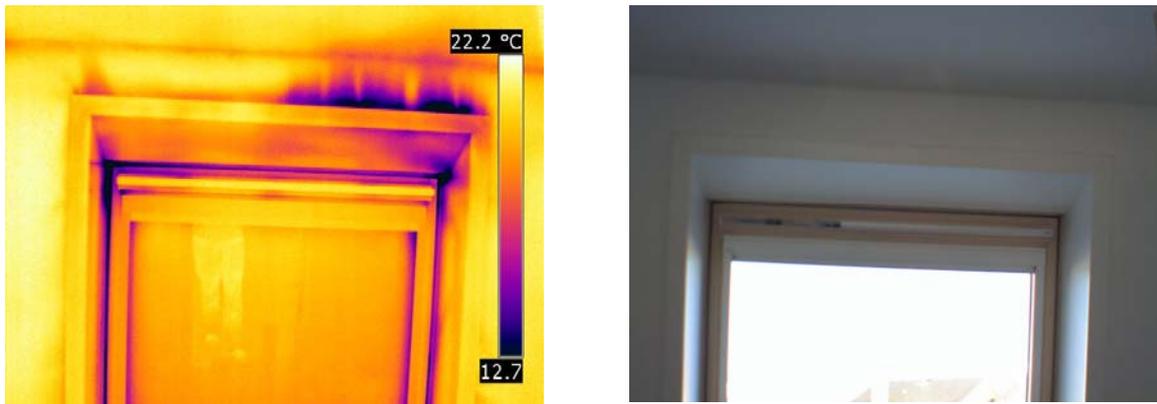
A so-called blower door test has been carried out on February 7, 2009. The test showed an average leakage of 3.2 h^{-1} measured at 50 Pa over- and under-pressure. While this air leakage is not too high compared to the Greenlandic Building Code, since there are no requirements, it is significantly above the requirement imposed since 2006 in the Danish Building Code, that the air change must not exceed 1.5 h^{-1} when measured at 50 Pa pressure difference. Problem areas were identified around windows, at floor joints, at electrical outlets, and possibly under the floor (see Figure 5).

Figure 5. Infrared and normal picture of north-west facing window taken during blower door test.

For a building which is not in a sheltered environment, it can be expected that the free air change due to infiltration/exfiltration, n_{inf} is around 10% of n_{50} (DIN, 2003) and thus infiltration/exfiltration in the house can be expected to be around 0.32 h^{-1} . The volume of air in the building is 530 m^3 , and thus the annual ventilation heat loss associated with this air change can be estimated to be 68 kWh/m^2 (based on the average outdoor temperature: -3.9°C). The assumption when designing the house was that the infiltration/exfiltration air flow would be only 0.1 h^{-1} , and thus the annual extra energy consumption due to poor air tightness of the building envelope, amounts to approximately 45 kWh/m^2 .
