*Published in:*  
COLD CLIMATE HVAC 2009

# Performance of the Low-energy House in Sisimiut

## SUMMARY

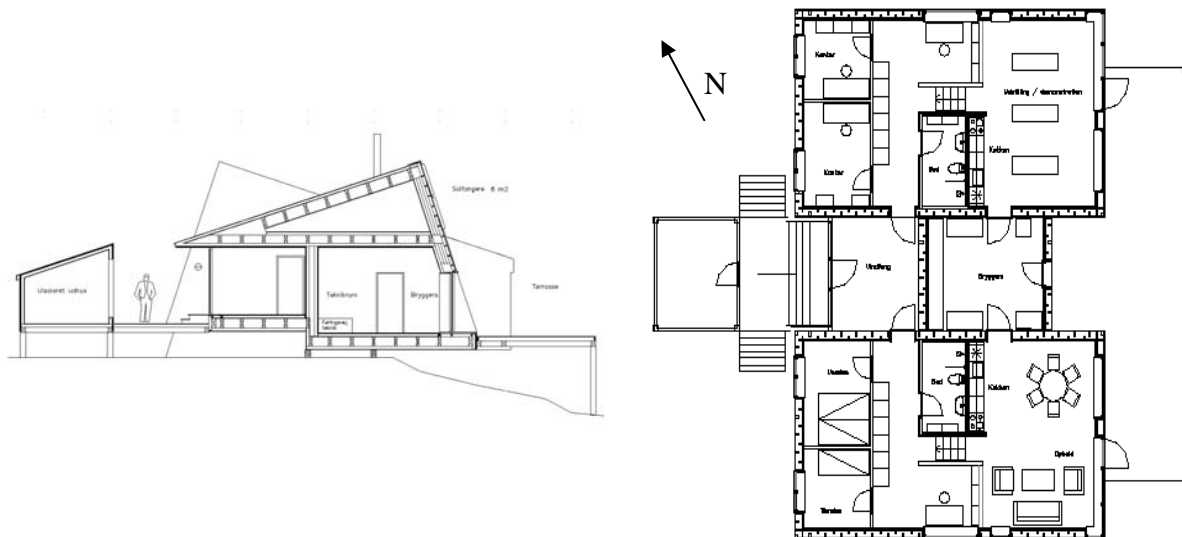
Figure 1. Cross section and floor plan of the low-energy house. The house is built as a double house with common scullery/boiler room and entrance hall.

The low-energy house is made as a double-house with a floor area of 197 m<sup>2</sup>, where the two living areas are built on each side of the boiler room and an entrance hall. Figure 1 shows a cross section and floor plan of the house. One of the two apartments serves as home for a family, while the other is used as an exhibition, and also occasionally functions as a guest house for visitors. Some descriptions of the building are given below, but more can be found in the proceedings of the inauguration symposium (Artek, 2005).

The building is generally made as a wood frame construction. The inhabited part is all in one floor, which is distributed over two slightly displaced levels, and there is a cold attic above the whole building, and an open crawl space below. The heat loss due to thermal transmittance of the building envelope constructions is kept at a minimum by using large insulation thicknesses and wooden posts and girders which come in two separate layers that don't touch each other, so thermal bridges are practically eliminated, see Table 1.

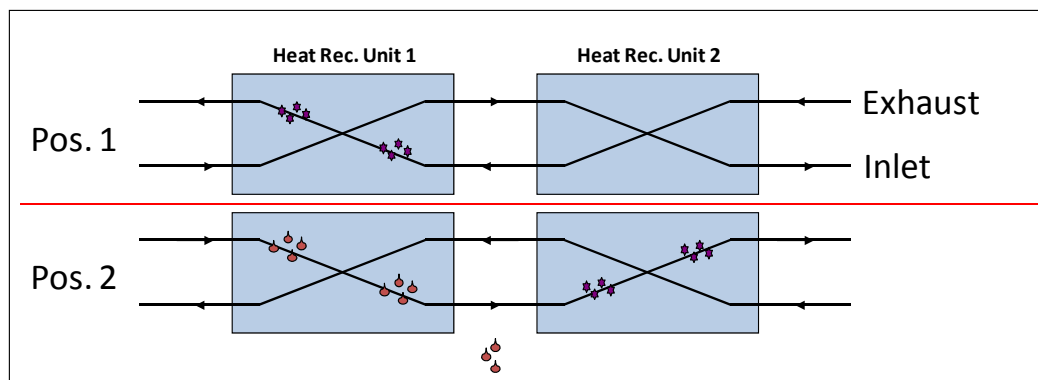
Figure 2. Diagram of the heat recovery unit with two heat exchangers.

A new heat recovery unit was developed for the low-energy house in Sisimiut in cooperation between EXHAUSTO A/S and the Technical University of Denmark. The dimensions of the unit are: Length 1,760 mm, width 930 mm and height 660 mm. The unit consists of two highly efficient aluminium counter flow heat exchangers coupled in a serial connection. A valve is able to switch the air flow direction through the units. When ice formation starts to reduce the airflow in the coldest exchanger the air flow direction is switched. The exchangers, valve and filters are mounted in a cabinet with 50 mm insulation, although the unit is recommended to be placed in a heated place to minimize risks of frost damages from the condensing water. The theoretical temperature efficiency of the heat recovery unit is approximately 90 %. A diagram of the system is shown in Figure 2.

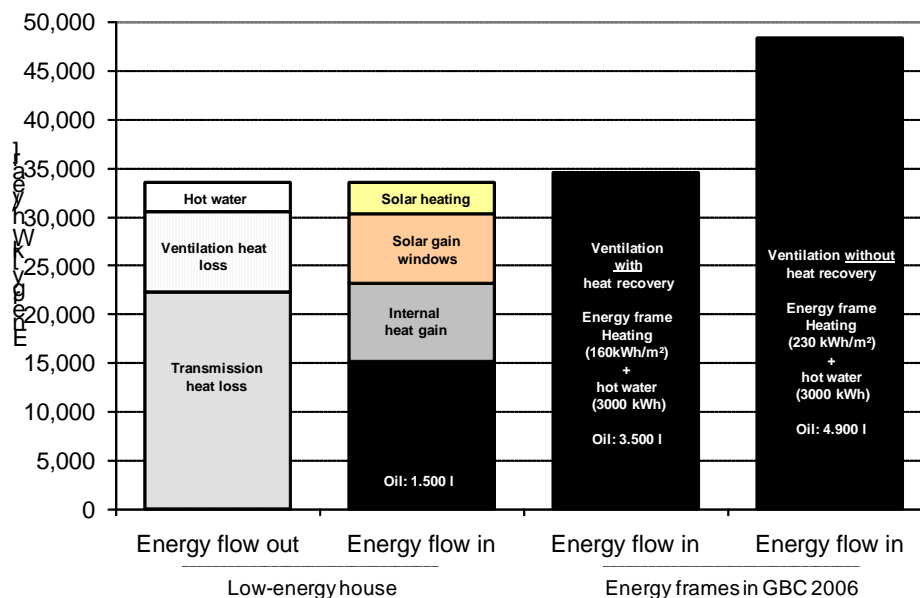
Figure 3. Energy balance of the 197 m<sup>2</sup> low-energy house compared with the demands of the Greenlandic building code.

A calculation model has been set up in the thermal building analysis tool *B<sub>Sim</sub>* (B<sub>Sim</sub> 2009) to analyse the energy performance of the house. As the low-energy house is a double house made of two equal houses with common scullery/boiler room and entrance hall, the calculation model is simplified to only one of the two halves. Figure 3 shows the calculated contributions to the energy balance of the low-energy house. In the calculations, the heating set point temperature was 21 °C in all rooms except the two bathrooms where 23 °C were used. The assumed internal heat gain was 5 W/m<sup>2</sup> and the infiltration was 0.1 h<sup>-1</sup>. The total ventilation rate was 45 l/s as required by the building code.

The results are compared with the expected energy frame demands in the building code of Greenland. For a house with a mechanical ventilation system with or without heat recovery the energy frame demands are set to 160 and 230 kWh/m<sup>2</sup> respectively. It is seen that the energy consumption is simulated to be approximately 1,500 litres of oil per year. Compared with the energy frames of the building code it is seen that more than 3,000 litres of oil are saved every year. The simulation results show that the annual energy consumption of the low-energy house is below the target of 80 kWh/m<sup>2</sup> (Kragh et al., 2005).

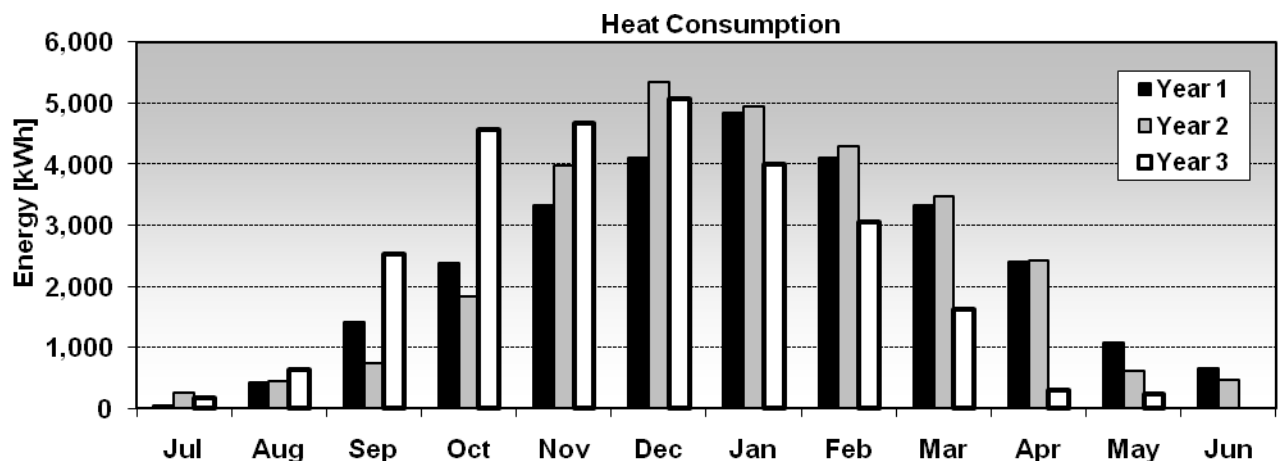
Figure 4. Heat consumption during the months of the first three full years of operation.

Figure 4 shows the monthly energy consumption for heating (exclusive of domestic hot water), where year 1 is for the period July 2005 – June 2006. The house has not been inhabited during the period July 2007 – April 2008 during which period the house underwent some renovation activities: A separation wall was erected in the boiler room, and the wooden floor of the living rooms was changed because of a failure with the first delivered floor. The house was heated during the construction period, although in a somewhat unusual pattern.

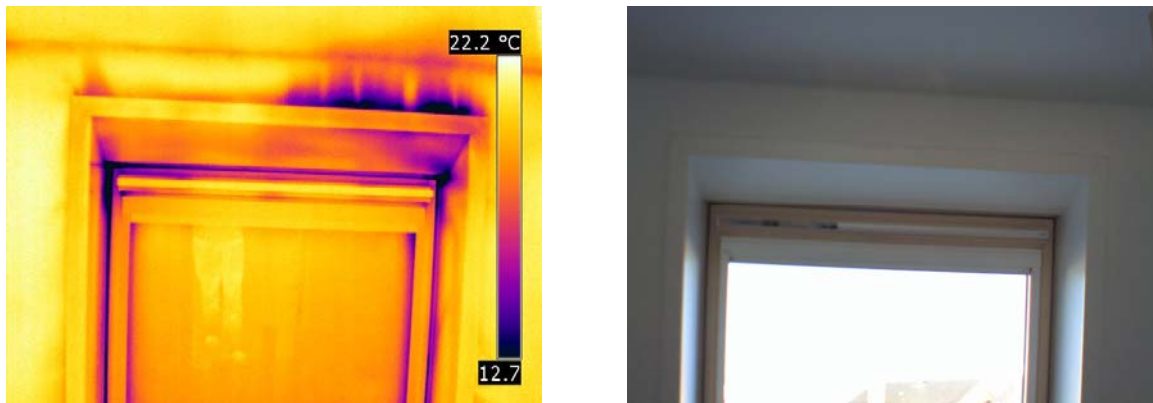
Figure 5. Infrared and normal picture of north-west facing window taken during blower door test.

A so-called blower door test has been carried out on February 7, 2009. The test showed an average leakage of  $3.2 \text{ h}^{-1}$  measured at 50 Pa over- and under-pressure. While this air leakage is not too high compared to the Greenlandic Building Code, since there are no requirements, it is significantly above the requirement imposed since 2006 in the Danish Building Code, that the air change must not exceed  $1.5 \text{ h}^{-1}$  when measured at 50 Pa pressure difference. Problem areas were identified around windows, at floor joints, at electrical outlets, and possibly under the floor (see Figure 5).
