Valuation of the 12 year old Concrete in the Ulkebugt Bridge, Sisimiut, Greenland

Published in:
Nordic Concrete Research

Publication date:
2011

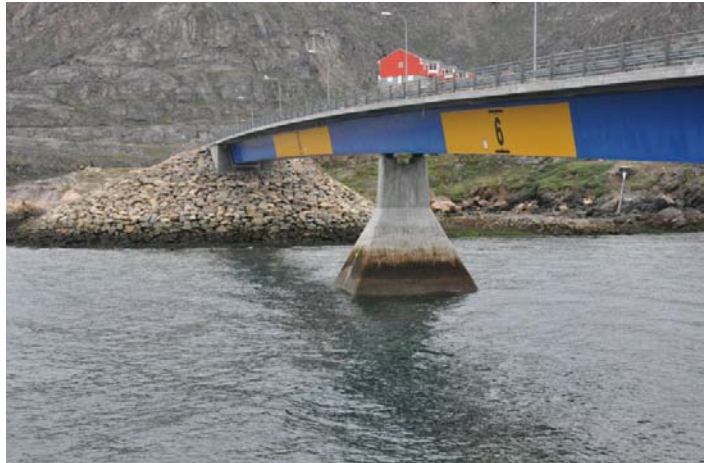
The concrete pillar is exposed directly to seawater, as it is shown in Figure 1. The pillar is founded on the seabed, so a major part of the concrete surface is constantly under water and thereby exposed to chloride ingress by capillary suction and diffusion. The ingress is relatively slow under water in this dense concrete and due to lack of oxygen there is no real concern for chloride driven corrosion. The most critical part on the surface is in the splash-zone with tide and wave action. In the Ulkebugt the tide has a variation of around 4 meters. The chloride ingress in the splash-zone gives the best opportunity to estimate the lifetime on the concrete pillar.

Figure 1 - The pillar on the Ulkebugt Bridge.

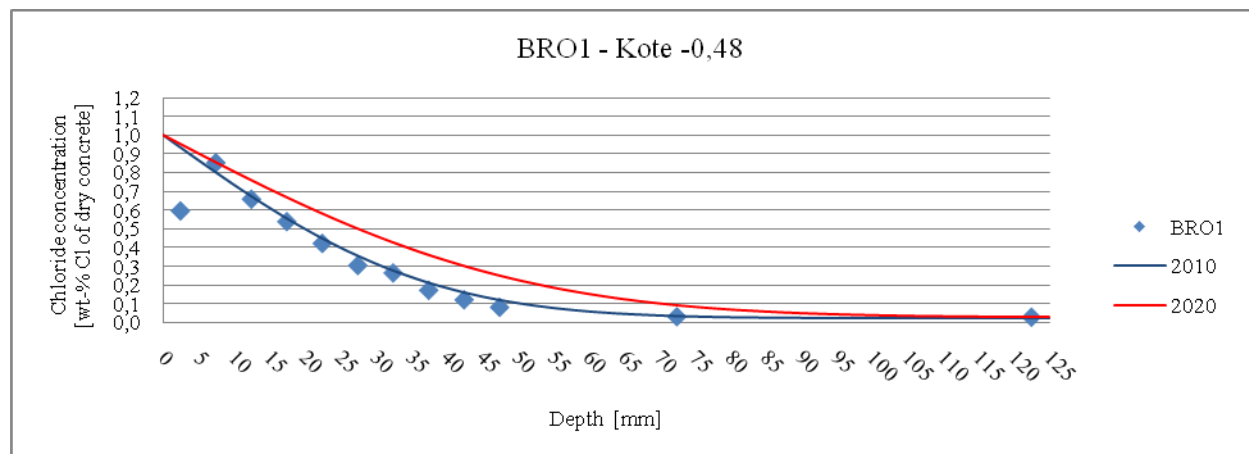
A projection of the chloride ingress has been conducted by use of Fick's 2. Law of Diffusion and the results are presented in Figure 2.

Figure 2 – Chloride profile of the concrete in the splash-zone. Year 2010 (blue) and 2020 (red). Measurement results are marked.

The lifetime of the concrete is limited by the chloride ingress. Corrosion of the reinforcement will initiate once the chloride level reaches 0.1 wt-% of the dry concrete. To make an estimated lifetime, it is important to know the thickness of the cover over the reinforcement. The requirement for the cover in the pillar in the splash-zone is 70 mm. Figure 2 shows that the critical chloride level at the depth of 70 mm will be reached in approximately 10 years.

The concrete pillar is exposed directly to seawater. The most critical part on the surface is in the splash-zone with tide and wave action. Here the critical chloride level at the depth of the reinforcement bars will be reached in approximately 10 years.

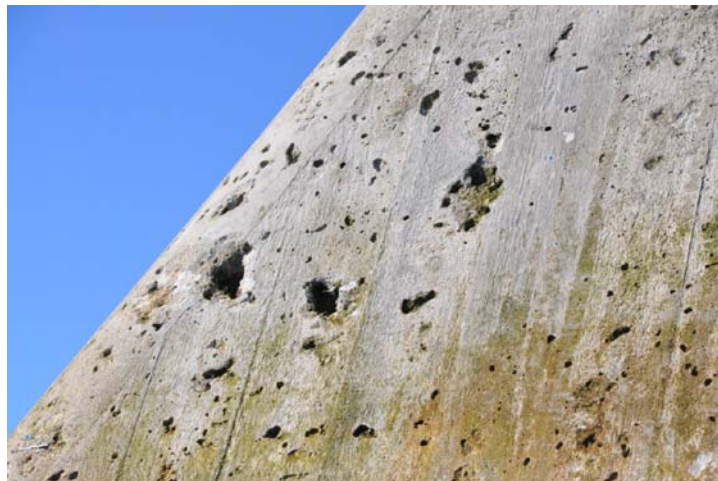
However the concrete surface of the pillar shows in some areas signs (smaller and larger holes in the surface) which could indicate freeze-thaw damages. These holes are probably smaller and larger agglomerates of air voids, probably caused by an improper compaction of the fresh concrete in relation with a "closed" design of the formwork, which leads to a high amount of entrapped air voids (equal to agglomerates of air voids) along the form side. In places with larger holes, the seawater is allowed to enter far into the holes from start, making the concrete and reinforcement more vulnerable to chloride initiated corrosion. The result of insufficient compaction of the concrete is many deep holes in the concrete, which is contributing to the overall state of the concrete pillar.

Figure 3 – Deep holes into the concrete surface.

The concrete surface of the pillar shows in some areas signs in form of smaller and larger holes in the surface which could indicate freeze-thaw damages. These holes are probably smaller and larger agglomerates of air voids, probably caused by an improper compaction of the fresh concrete in relation with a “closed” design of the formwork, which leads to a high amount of entrapped air voids along the form side. The seawater is allowed to enter far into the holes from start, making the concrete and reinforcement more vulnerable to chloride initiated corrosion.
