Thermal inspection of water pit heat storages using drones

Sifnaios, Ioannis; Dragsted, Janne; Jensen, Adam R.

Published in:
Proceedings of SWC 2021: ISES Solar World Congress

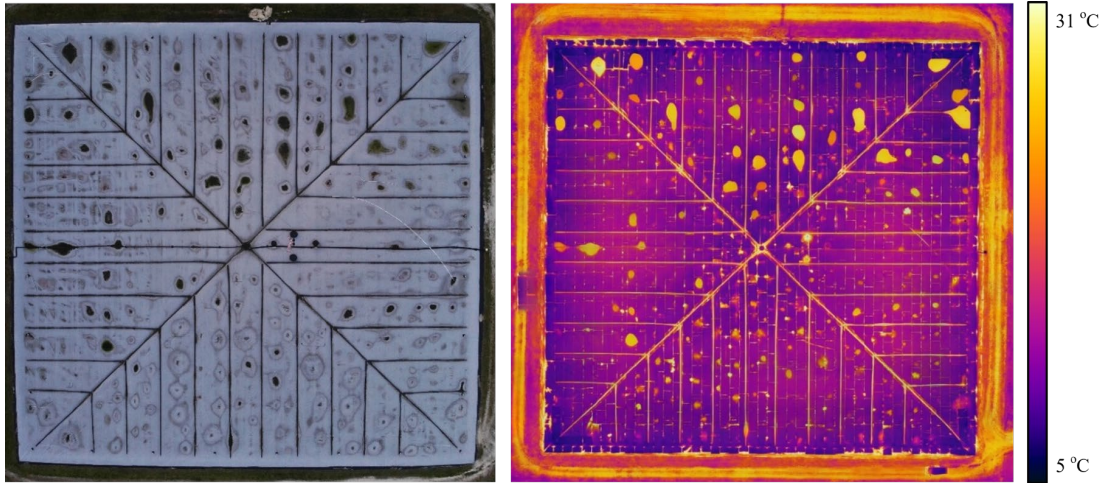
Nomalén is used as insulation material for the lid in the PTESs in Dronninglund and Marstal. Fig. 2 shows a thermal image and daylight photo of the Dronninglund PTES lid. One of the most noticeable observations in the thermal image is the many warm (yellow color) oval shapes on the lid. When comparing the locations and shapes of these to the RGB image on the left, it can be seen that they are water puddles. They are detected as warmer than the adjacent areas because the emissivity of water is higher than that of the lid surface. The water puddles can therefore not be compared with the surrounding areas; however, the puddles' temperatures can be compared with each other. By comparing the detected temperature of the different water puddles, it was identified that the puddle in the top left corner was warmer than the rest. The puddle temperature in the top left corner was 30.6 °C, while the average temperature of the rest of the puddles was 20 °C. The plant manager was informed about this finding, and the warmer pond was manually inspected. The inspection showed that

the liner under the lid was torn in this area, and warm water from the storage was entering the lid. Afterward, the leak was fixed, resulting in a positive impact on the storage performance and lifetime of the insulation. By inspecting the thermal image in Fig. 2, a rectangular grid of thermal bridges can be noticed, corresponding to the gaps between the insulation mats underneath the top liner. The average temperature of the thermal bridges was 18 °C.

Fig. 2: RGB (left) and thermal (right) image of the PTES in Dronninglund.

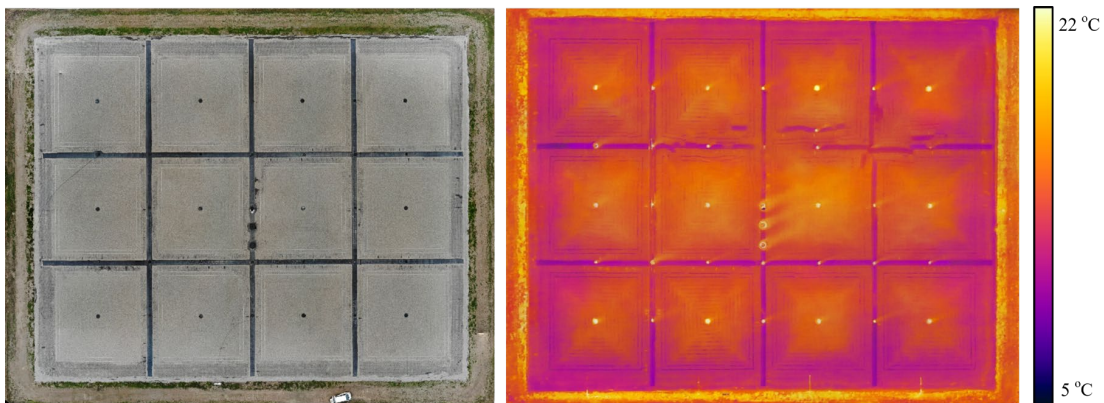
In Fig. 3, the thermal and RGB images of the Marstal PTES are presented. As of April 2020, a new lid was installed consisting of twelve square sub-sections. Each sub-section is covered with gravel to ensure a slope towards the center, where a rainwater drainage system is located. Consequently, it is the only inspected PTES with no water ponds on its surface, and thus an easier assessment of the thermal image can be made. The bright yellow dots indicate the pump wells at the center of each sub-section. Additionally, several air vents and the three maintenance holes can be identified in the thermal image. The average temperature of the pump wells, vents, and maintenance holes was 20 °C. No issues were identified during the inspection that took place in October 2020. It can be observed that there was a small problem with the thermal image stitching at the top of the thermal image, though this did not significantly alter the thermal inspection.

Fig. 3: RGB (left) and thermal (right) image of the PTES in Marstal (October 2020).

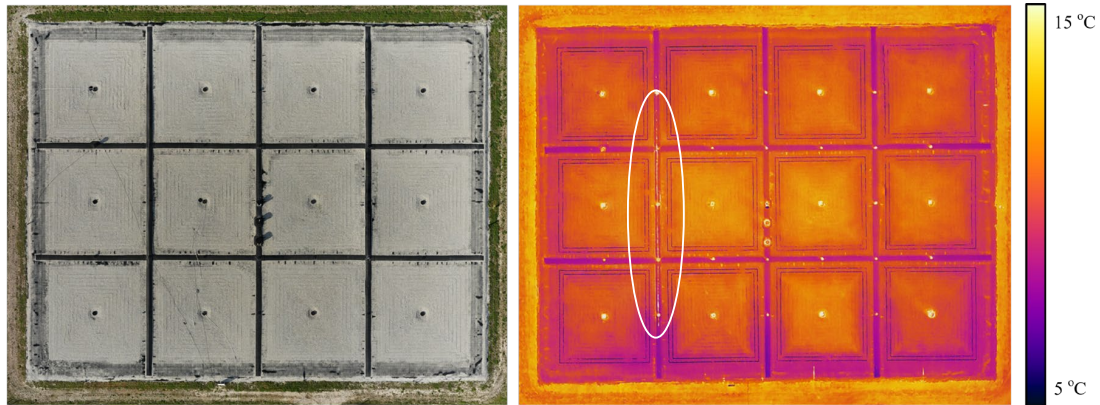
A second inspection of the Marstal PTES was done in October 2021, a year after the first one, to verify the performance of the new lid technology. The results can be seen in Fig. 4. Overall, no significant differences were spotted between the two inspections, indicating that the performance of the lid has not degraded significantly during this period. However, a warmer area was detected at the connections of the left-most modules (marked with a white oval in Fig. 4). This is due to the separation of insulation covering the joint between the modules, which is thought to be caused by lid expansion. In general, the temperature of the hot spots where the insulation was separating was between 10 – 12 °C, whereas the temperature of the rest connections was around 8 °C. The separation of the insulation creates a thermal bridge and increases the heat

loss of the lid.

Fig. 4: RGB (left) and thermal (right) image of the PTES in Marstal (October 2021).

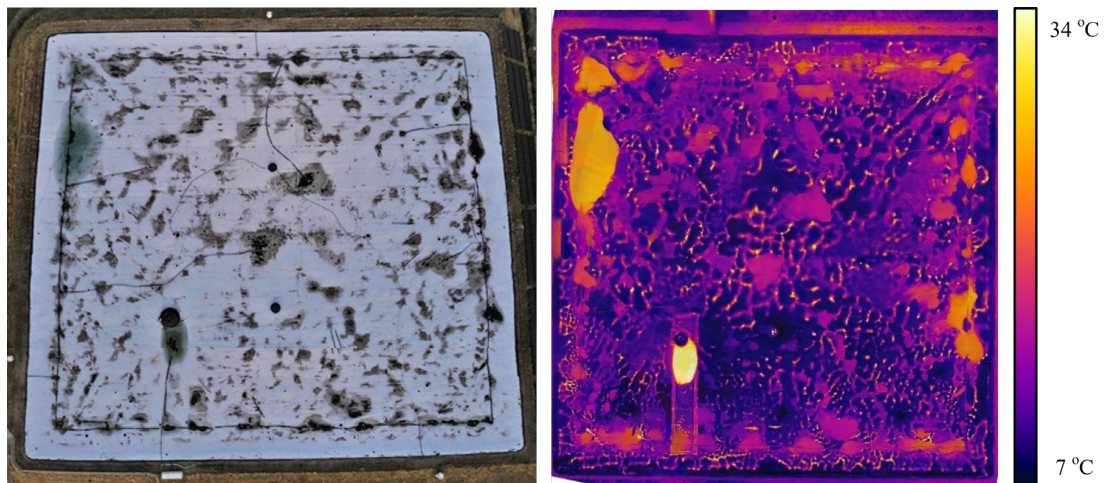
LECA is used as insulation material in the lid for the PTESs in Gram, Toftlund, and Vojens. Fig. 5 illustrates the orthomosaic for the PTES in Gram. This image looks vastly different from the PTESs in Dronninglund and Marstal. The reason for this is the different insulation materials used within the PTES lids. The brain-like pattern visible in Fig. 5 is thought to be due to heat convection within the lid. This phenomenon should be minimized as much as possible, as it enhances the thermal losses from the storage. The image clearly illustrates the presence of thermal bridges, which are most likely due to convection. The average temperature of the thermal bridges was 22 °C. It is suggested that smaller clay pebbles should be used in the future, or a convection membrane should be installed. Lastly, in Fig. 5, it was possible to identify a significantly warmer puddle (33 °C) on the lid near the top diffuser, indicating a potential leak.

Fig. 5: RGB (left) and thermal (right) image of the PTES in Gram.

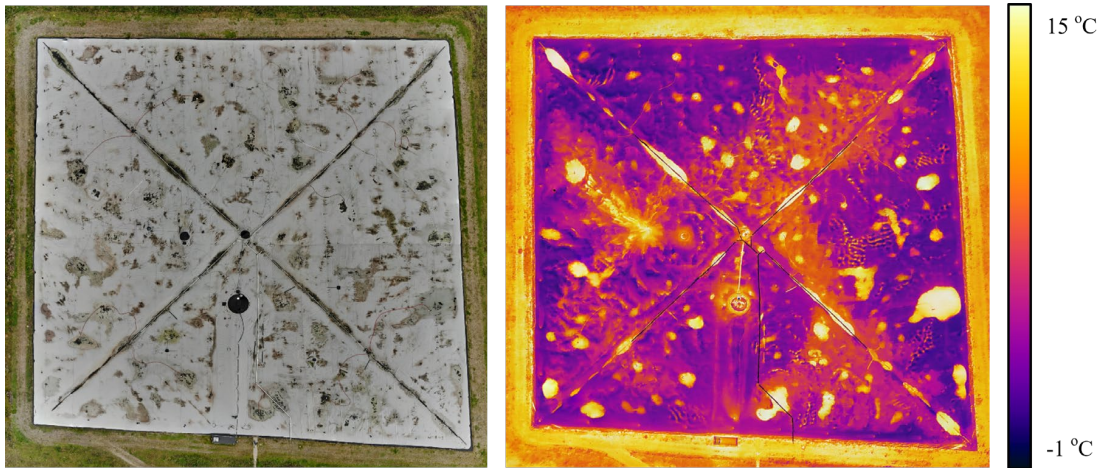
In Fig. 6 and Fig. 7, the RGB and thermal images of the PTESs in Toftlund and Vojens are shown, respectively. Similar to Gram, these PTESs use LECA as lid insulation, and thus brain-like patterns due to convection can be observed in the thermal image. However, contrary to Gram, in both PTES, there seem to be areas of the lid where this phenomenon is more intense, indicating that either a thinner layer of LECA exists in these areas or that LECA is wet, resulting in higher heat losses.

**Fig. 6: RGB (left) and thermal (right) image of the PTES in Toftlund.**

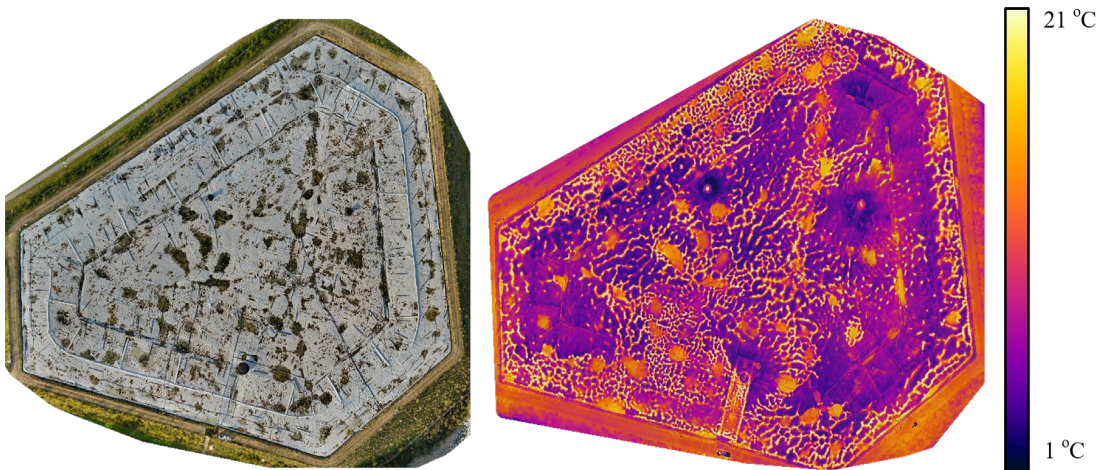
Fig. 7: RGB (left) and thermal (right) image of the PTES in Vojens.
