Thermal inspection of water pit heat storages using drones

Sifnaios, Ioannis; Dragsted, Janne; Jensen, Adam R.

Published in:
Proceedings of SWC 2021: ISES Solar World Congress

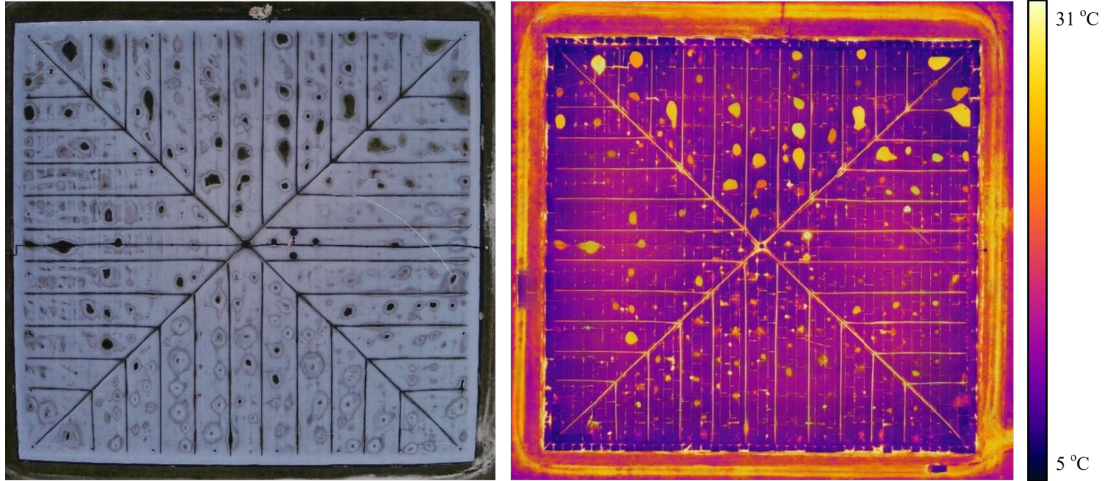
Nomalén is used as insulation material for the lid in the PTESs in Dronninglund and Marstal. Fig. 2 shows a thermal image and daylight photo of the Dronninglund PTES lid. One of the most noticeable observations in the thermal image is the many warm (yellow color) oval shapes on the lid. When comparing the locations and shapes of these to the RGB image on the left, it can be seen that they are water puddles. They are detected as warmer than the adjacent areas because the emissivity of water is higher than that of the lid surface. The water puddles can therefore not be compared with the surrounding areas; however, the puddles' temperatures can be compared with each other. By comparing the detected temperature of the different water puddles, it was identified that the puddle in the top left corner was warmer than the rest. The puddle temperature in the top left corner was 30.6 °C, while the average temperature of the rest of the puddles was 20 °C. The plant manager was informed about this finding, and the warmer pond was manually inspected. The inspection showed that

the liner under the lid was torn in this area, and warm water from the storage was entering the lid. Afterward, the leak was fixed, resulting in a positive impact on the storage performance and lifetime of the insulation. By inspecting the thermal image in Fig. 2, a rectangular grid of thermal bridges can be noticed, corresponding to the gaps between the insulation mats underneath the top liner. The average temperature of the thermal bridges was 18 °C.

Fig. 2: RGB (left) and thermal (right) image of the PTES in Dronninglund.

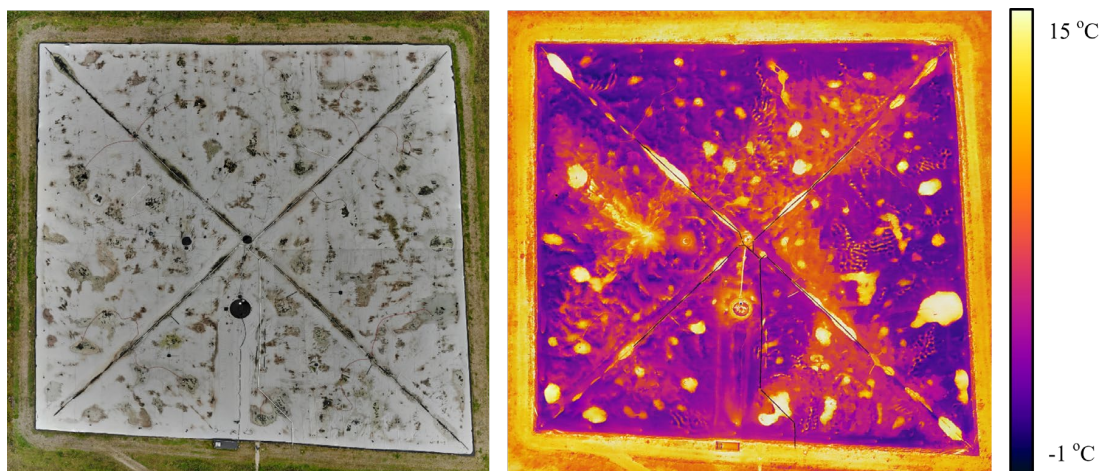
In Fig. 6 and Fig. 7, the RGB and thermal images of the PTESs in Toftlund and Vojens are shown, respectively. Similar to Gram, these PTESs use LECA as lid insulation, and thus brain-like patterns due to convection can be observed in the thermal image. However, contrary to Gram, in both PTES, there seem to be areas of the lid where this phenomenon is more intense, indicating that either a thinner layer of LECA exists in these areas or that LECA is wet, resulting in higher heat losses.

**Fig. 6: RGB (left) and thermal (right) image of the PTES in Toftlund.**

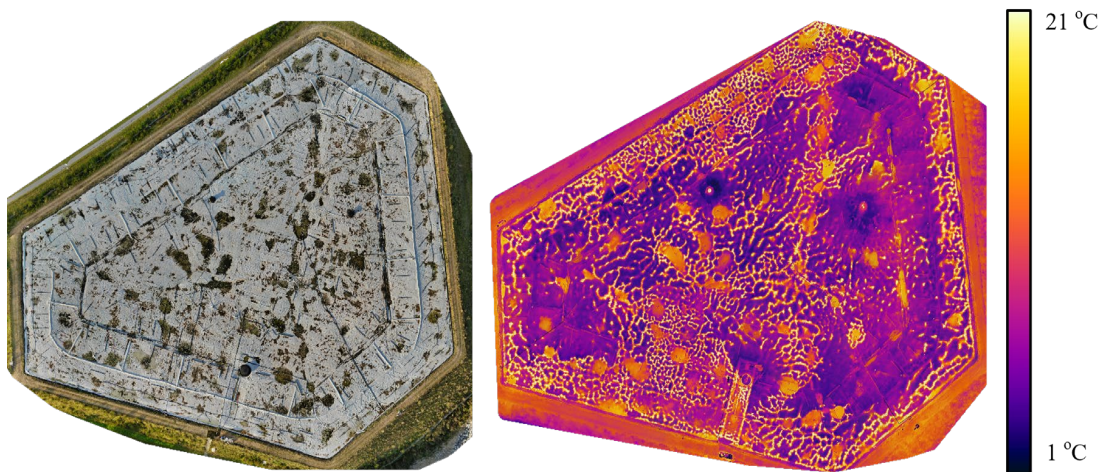
Fig. 7: RGB (left) and thermal (right) image of the PTES in Vojens.
