Synergetic effect of temperature and humidity on the leakage of KOH electrolyte and related reliability of zinc-air batteries

Rao, Jyothsna Murli; Yadav, Abhijeet; Conseil-Gudla, Helene; Ambat, Rajan

[1]Department of Civil and Mechanical Engineering, Technical University of Denmark, Lyngby, Denmark,
[2]R&D Department, WS Audiology, Lynge, Denmark

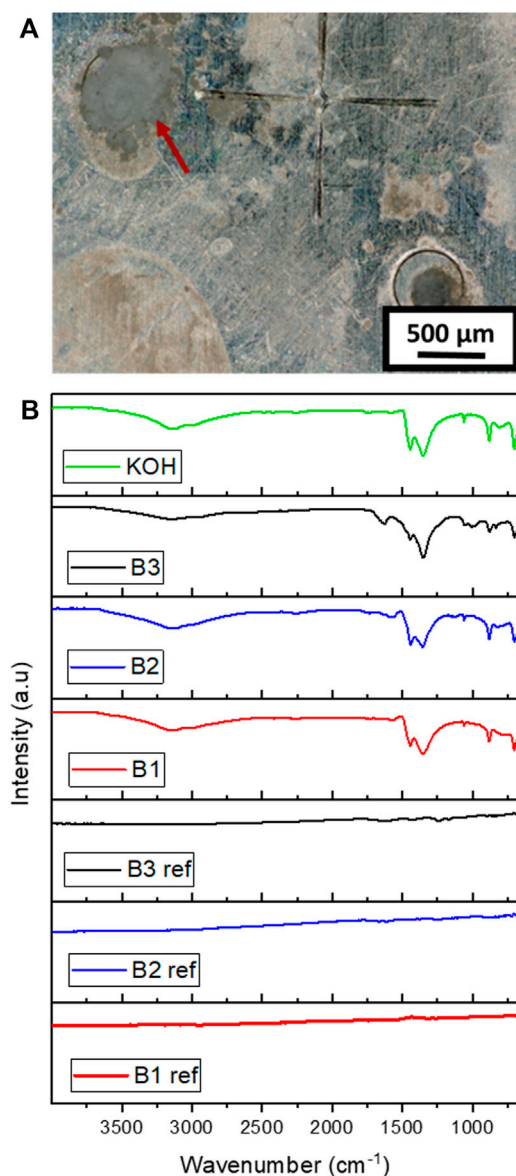
FIGURE 4
(A) Picture showing residues on ZAB surface after humidity exposure and **(B)**. FTIR spectra obtained on the surface on as-received batteries (ref) and on residues found on the three ZAB variants surfaces after humidity exposure.

FTIR analysis was performed to characterize the chemical nature of the residues that were found near the ventilation air holes (Figure 4A) in all the three types of ZAB variants (B1, B2, and B3) after their exposure to conditions mentioned in Section 2.1.3. FTIR spectroscopy analysis of these residues was carried out and was compared to the reference spectrum obtained from the surface of fresh battery variants and laboratory-grade KOH crystals. The obtained spectrum from the FTIR analysis is shown in Figure 4B. The spectrum for KOH crystals matches with the spectrum obtained from the residues found on three battery variants, while the spectrum obtained from the fresh batteries did not shown any sign of KOH residues. Thus confirming that the residues found on the battery surface is KOH, which is released from the battery upon their exposure to humid climatic conditions.

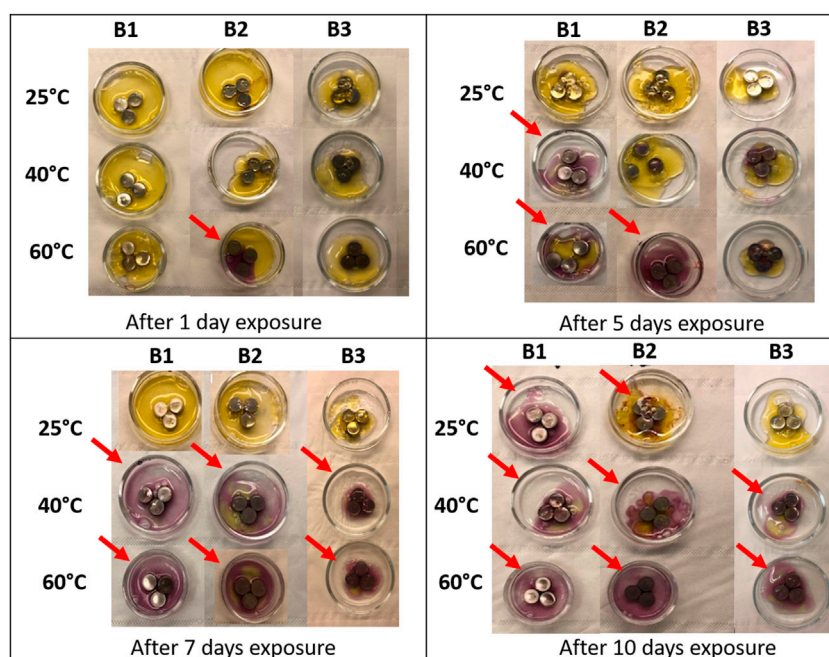
Figure 6 shows the application of gel with pH indicator applied on different ZAB variants after their exposure to saturated humidity at different temperatures and varying exposure times. Some batteries showed an immediate color change to purple, indicating the release of KOH. Nevertheless, none of the battery variants showed any sign of KOH leakage from the battery on exposure after 1 day at 25°C and 40°C. The first sign of KOH release from the batteries was observed after 1 day of exposure at 60°C for the B2 variant. Stronger purple color was then observed after 5 days of exposure at 40°C and 60°C for the B1 variant and at 60°C for the B2 variant. Significantly low KOH leakage was observed for the B3 variant at any exposed temperature levels after 5 days. However, all the three battery variants showed significant release of KOH on their exposure to 40°C and 60°C after 7 and 10 days. B1 variant was the only type that showed KOH leakage from the batteries at 25°C after 10 days of exposure time. The tendency of KOH electrolyte leakage from ZAB increases with an increase in temperature and exposure

duration, and B1 battery variant is found to be more susceptible to KOH leakage at low temperature conditions.

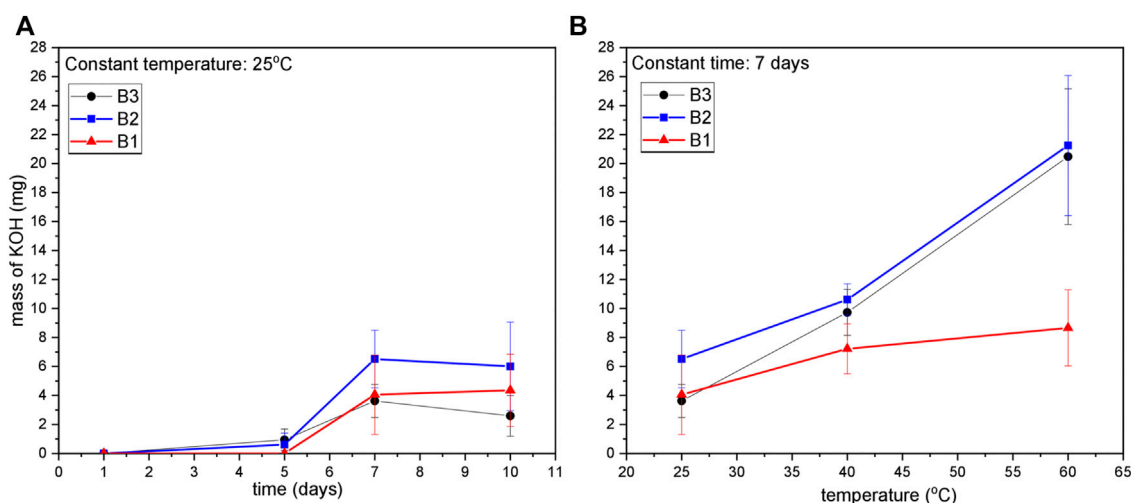
Figure 7B shows the titration result for KOH release after immersion in water at 25°C, 40°C, and 60°C for 7 days. A gradual increase in the amount of KOH released was observed for B2 and B3 with increasing temperature, while a significantly low amount of KOH leakage was observed for B1 variant when compared to the other two variant types. When comparing the two curves (a), and (b) from Figure 7, it is quite evident that temperature has a

FIGURE 7
Titration result for KOH residue released from three different ZAB variants after their exposure to: **(A)** Constant temperature of 25°C and varying exposure time, **(B)** Constant exposure duration of 7 days with varying temperature level.

greater impact on the amount of KOH released from ZAB's compared to the duration of their exposure to climatic conditions. The variation in the amount of KOH released from ZAB's was found to increase with increasing exposure time and temperature level, with the highest variation was observed after 7 days at 60°.

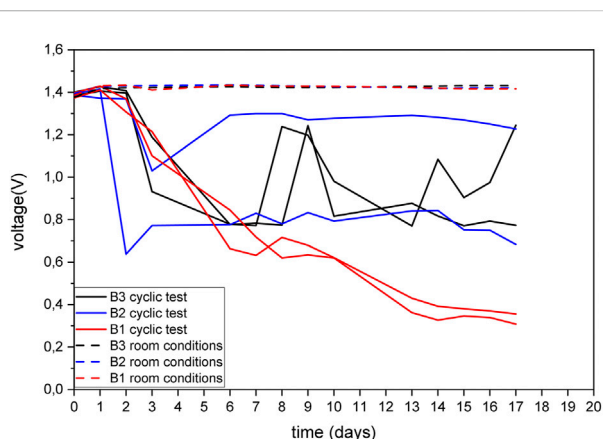
FIGURE 8
Voltage discharge of the battery variants after exposure to wet and dry and room conditions.

in Figure 8. Upon exposure to humidity, the voltage discharge readings show a significant amount of fluctuation for the B2 and B3 battery variants. As observed before during the titration analysis, the high variance in KOH electrolyte leakage was found for B2 and B3 variants, which can provide a possible reason for the instability and fluctuation in voltage discharge for the two battery variants. These two battery variants showed a large drop in voltage (up to 0.7 V) just after 3 days of exposure, while there seems to be a gradual decrease in voltage for the B1 variant. Over the duration of the test (about 17 days), the three variants of the batteries showed a decrease in voltage, however they were not fully discharged. B2 and B3 variants showed a lower voltage discharge than B1 (continuous decrease drops up to 0.3 V after 17 days). These results can be correlated to the Gel test, where B1 variant showed higher susceptibility to KOH leakage even at lower temperature conditions.

The voltage discharge test showed high fluctuation in voltage readings of B2 and B3 battery variants, whereas a gradual decrease of voltages was observed for B1. This fluctuation in the voltage during discharge can be attributed to the lowering of KOH electrolyte molarity due to the ingress of water vapor inside the cell and diluting the electrolyte, thus affecting its performance (Schröder, 2016). Furthermore, the release of KOH and the production of carbonate products during humidity and temperature exposure can clog the ventilation holes of the battery, which can decrease the availability of oxygen at the air electrode, thus causing performance degradation of the batteries.

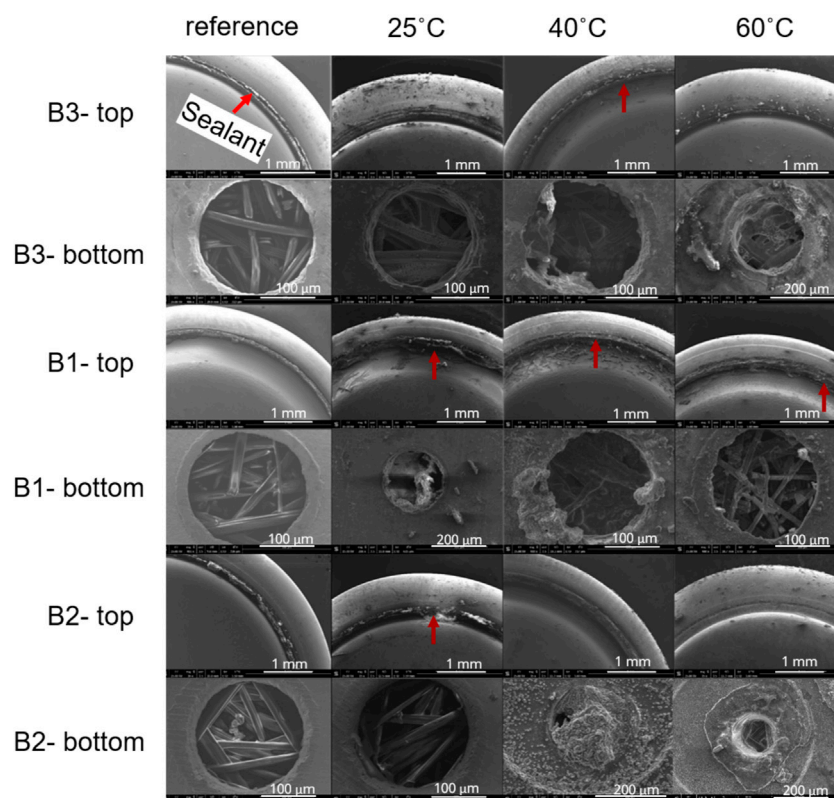
FIGURE 9
Secondary electron SEM images of the sealant gasket and the ventilation holes on the ZAB's exposed to different temperatures and constant exposure time of 7 days.

Figure 9 shows SEM images of the sealant gasket and ventilation air holes for the three ZAB variants when subjected to saturated humidity level at 25°C, 40°C, and 60°C for 7 days. The red arrows shows the structural and morphology changes on the gasket sealant, which might have occurred during the exposure. However, the effect of temperature on the damage of gasket sealant is not very clear since B2 variant showed some kind of structural change or damage to its sealant at 25°C, while no such damage was observed at 40°C, and 60°C. Similarly, battery type B3 showed some structural change or damage on its sealant at 40°C and nothing at 60°C. Notice that the surface of the sealant gasket for all three battery variants were thoroughly investigated under SEM, and only the relevant images are included in this study.

The ventilation air holes shows the presence of residues in and around it for all the three battery variants (Figure 9). The amount of residues seems to be greater in amount for batteries exposed to higher temperatures namely 40℃, and 60℃. The residues also seem to have clogged the entire ventilation hole for B2 variant exposed to 40℃ and 60℃, while a similar observation was made for B3 variant when exposed to 60℃. High amount of KOH residue are observed at the air holes for B2 variant compared to the other two variant type. EDS elemental mapping was done in order to get a better overview of the elemental composition of these residues at air holes. The EDS elemental maps (Figure 10B) shows that it consists of K, Zn, and O. The distribution of Zn and K follows the distribution of O,

2) SEM-EDS analysis of the battery surface after their exposure to different temperatures under saturated humidity showed Zn-O-based corrosion products along with KOH residues. Outgassing caused by the release of hydrogen gas during the corrosion of Zn electrode was linked to the damage found on the battery sealant gasket.

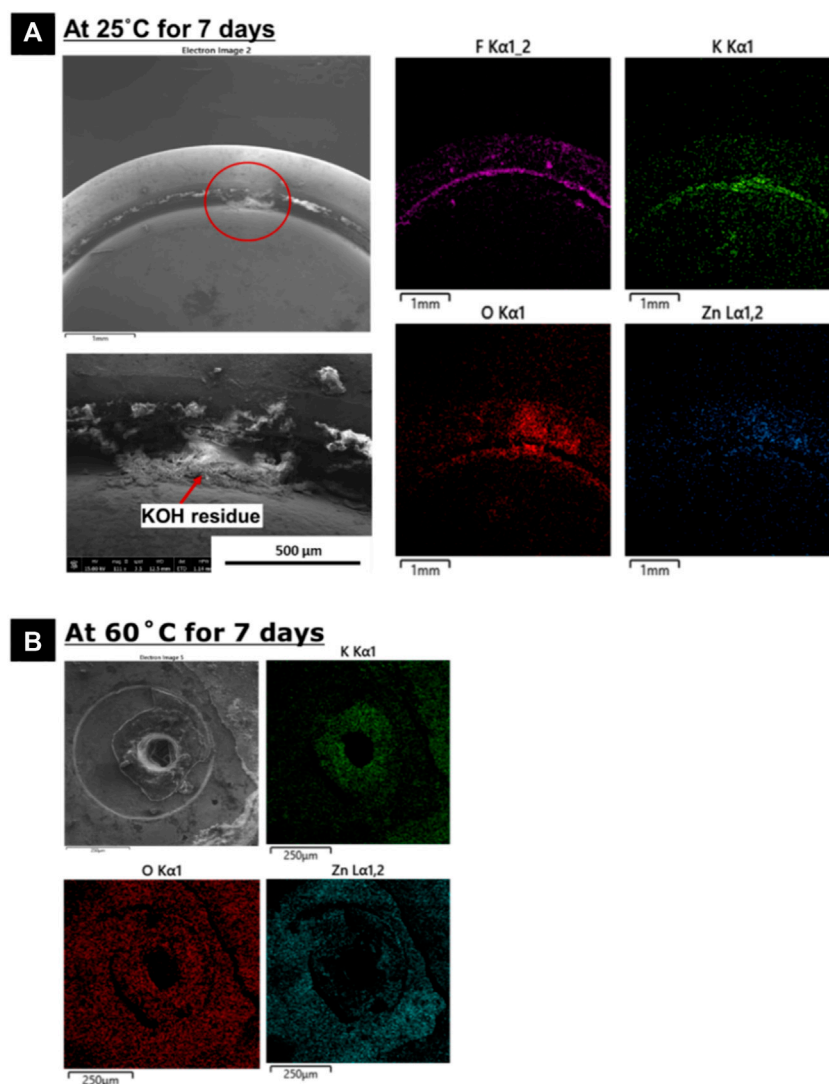
The EDS elemental maps of the gasket sealant shows the presence of F, K, O, and Zn elements. The other elements from the battery material are not shown in the analysis. The distribution of K map follows the distribution of O, suggesting the possibility of KOH presence. The presence of KOH residues in the vicinity of the sealant was identified and thus confirming the damage that occurred to the sealant gasket. The presence of Zn could possibly be because of the corrosion of Zn electrode in the presence of water and subsequent generation of hydrogen gas. The corrosion products of Zn are pushed outside the battery along with KOH electrolyte due to cell volume expansion. Some part of O map follows the distribution of Zn, thereby possibly indicating the presence of Zn-O based corrosion products. F element comes from the material composition of gasket sealant. It is possible that the KOH residues are moved to the sealant gasket area upon its release from the ventilation holes present at the backside. However, the EDS mapping showed that the characteristics X-rays of K, O and Zn elements are more pronounced at the damaged sealant gasket surface, than other areas near the gasket.

FIGURE 10
Secondary electron images and EDS elemental maps for B2 variant after exposure: **(A)** Sealant gasket, **(B)** Residues found on ventilation holes.

suggesting the presence of possible KOH residue along with Zn-O based corrosion products.
