# **Inherent hazards, poor reporting and limited learning in the solid biomass energy sector: a case study of a wheel loader igniting wood dust, leading to fatal explosion at wood pellet manufacturer**

Project No.  
Document no. Aars 2010  
Version 20  
Date of issue April 4, 2014

Frank Huess HEDLUND,  
Technical University of Denmark, (DTU) DK-2800 Kongens Lyngby, Denmark. Tel: +45 45252525 E-mail [fhue@dtu.dk](mailto:fhue@dtu.dk)\*  
COWI, Parallelsvej 2, DK-2800 Kongens Lyngby, Denmark. E-mail [fhue@cowi.dk](mailto:fhue@cowi.dk)

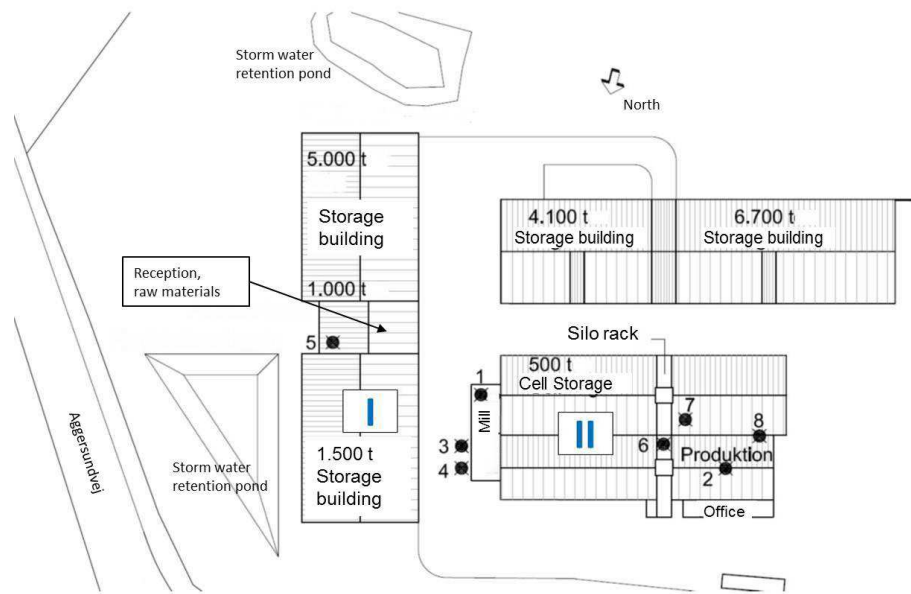
**Figure 1** Layout of facility with Building I (raw materials) and II (intermediate dust storage and production) marked, other buildings are for storage of final product. Numbers refer to 1) mill, 2) three pelletizer lines and pellet cooler, 6) silos/hoppers for final product, 7) chimney. North is down. Source: Company application for environmental permit, dated Jan 28, 2010
