Published in: Wear

3D characterization of rolling contact fatigue crack networks

Casey Jessop^a, Johan Ahlström^a, Lars Hammar^a, Søren Fæster^b, Hilmar K. Danielsen^b

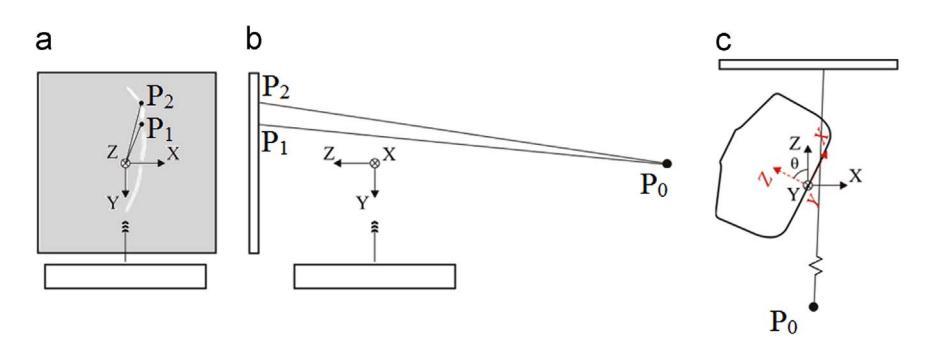
Fig. 2. Radiographic set-up and system for geometrical reconstruction: (a) front view (as seen from the X-ray tube) and (b) view from left side, showing rotation table and symbolic detector, and (c) top view, showing rail sample and symbolic detector. The rail standing on the rotation table is excluded in a and b, and the rotation table itself is excluded in c for improved visibility.

The parts of the crack which provide the highest contrast in each image (as projected on the detector) are mapped manually on the images. An illustration is shown in Fig. 2a, where two such points called P₁ and P₂ are selected. The path between the points, $\overline{P_1P_2}$ is assumed to be a straight line and identifies a part of the crack where the radiation is parallel to the crack plane. The larger the curvature as projected on each image, the closer the points are recorded. The plane, S_n , is obtained from the vector $\overrightarrow{P_1P_{2_n}}$ and the point P₀ positioned in the X-ray source (Fig. 2b). When the object has been rotated by an angle $\Delta \theta$, new points P₁ and P₂ are selected. A new vector $\overrightarrow{P_1P_{2_n}}$ is obtained, and the next plane, S_{n+1} , is calculated. The lines of intersection between the individual planes and the vectors $\overrightarrow{P_0P_1}$ and $\overrightarrow{P_0P_2}$ give the endpoints of each plane. The midpoint between intersection line endpoints is equal to the tangent to the crack plane, which gives the z coordinate of the crack (Fig. 2c). The result was plotted in MATLAB [20].
