Microstructural investigations of Ni and Ni₂Al₃ coatings exposed in biomass power plants

Wu, D. L.; Dahl, K. V. ; Christiansen, T. L.; Montgomery, M.; Hald, J.

Published in:
Materials at High Temperatures

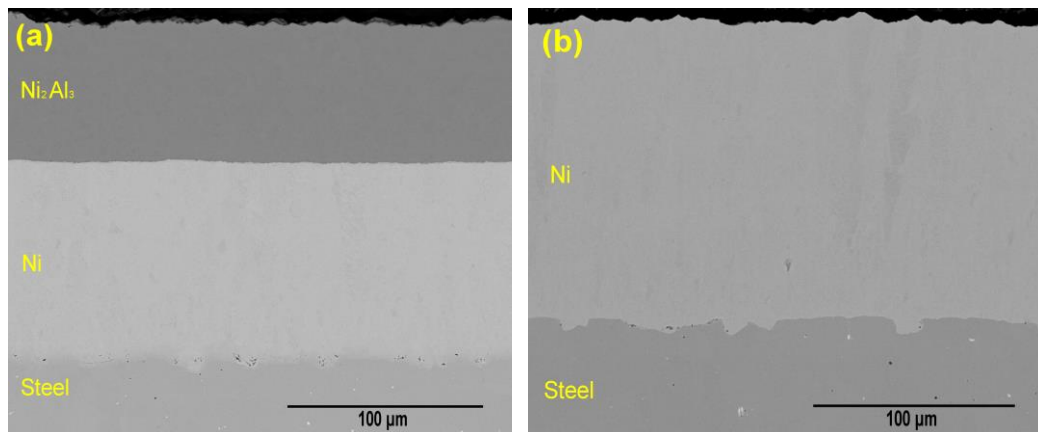
The Ni and Ni₂Al₃ coatings were uniform with smooth interfaces and surfaces (Figure 3). The Ni-Al coating consisted of an outer Ni₂Al₃ layer (thickness variation between 50 and 70 μm) and an inner Ni layer (100 μm) and was adherent to the steel. The Ni₂Al₃ layer was identified by XRD (not shown). A very thin (<5 μm) layer of intermediate phases could be seen at the interface between Ni and Ni₂Al₃. Porosities could be observed at the Ni/steel interface. The Ni coating consisted of a single Ni layer with a thickness of about 125 μm .

Figure 3. BSE-SEM micrograph of cross-section of (a) Ni₂Al₃ coated and (b) Ni coated tube sections
