Published in:
Wear

2D AND 3D CHARACTERIZATION OF ROLLING CONTACT FATIGUE CRACKS IN A MANGANESE STEEL WING RAILS FROM A CROSSING

Abstract: Rail wheel contact at switches and crossings (S&Cs) induces impact stresses along with normal and shear contact stresses, resulting in plastic deformation and eventually crack formation. Damaged and deformed wing rails of a manganese steel crossing are studied and the microstructure, hardness and 3D crack network within the steel are characterized. The surface of the rail receives the maximum deformation resulting in a hardened top layer. The deformation is manifested in a high density of twins and dislocation boundaries in the microstructure. A complex crack network is revealed in high resolution by X-ray tomography.

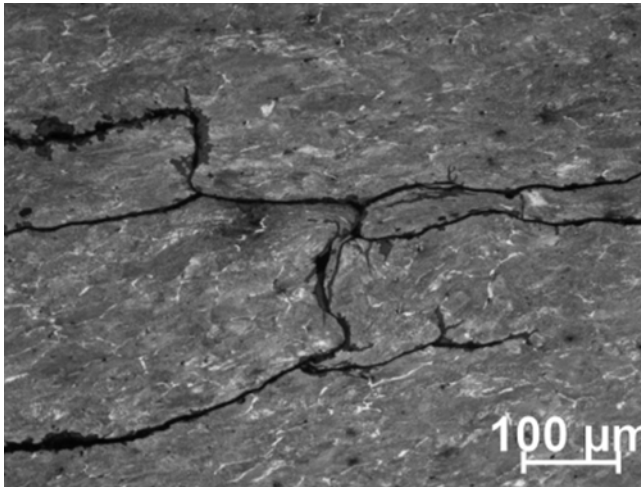
The two-phase microstructure in a pearlite grade material, consisting of ferrite and cementite, affects the deformation mechanism and eventually the crack initiation and propagation [14], where cracks tend to propagate through the softer ferrite phase, resulting in a wavy appearance. Figure 6 shows a rolling contact fatigue crack in pearlite grade steel from a straight track with a wavy crack propagation that passes through several grains. Figure 7 shows an optical micrograph of a subsurface crack in the wing rail of the manganese steel crossing investigated in this work having the same wavy appearance intersecting several grains with several crack branches and a seemingly random crack propagation. This is in correspondence to the cracks found in a manganese steel crossing nose studied previously in [9], where a more detailed study showed the cracks avoided the twinned regions (harder areas of the matrix) and were mostly transgranular giving the wavy appearance by following the weakest link in the microstructure. Therefore, although the plastic deformation is caused by slip in pearlitic grade without twinning, and for manganese steel deformation is from both dislocation motion as well as twinning, the crack networks have a similar appearance for pearlitic steel straight tracks and manganese steel crossings irrespective of the very different loading conditions in the two cases.

Figure 6: Optical micrograph of a rolling contact fatigue crack in a rail from straight track of pearlitic steel [15].
