# 2D and 3D characterization of rolling contact fatigue cracks in manganese steel wing rails from a crossing

*Published in:* Wear

Publication date: 2019

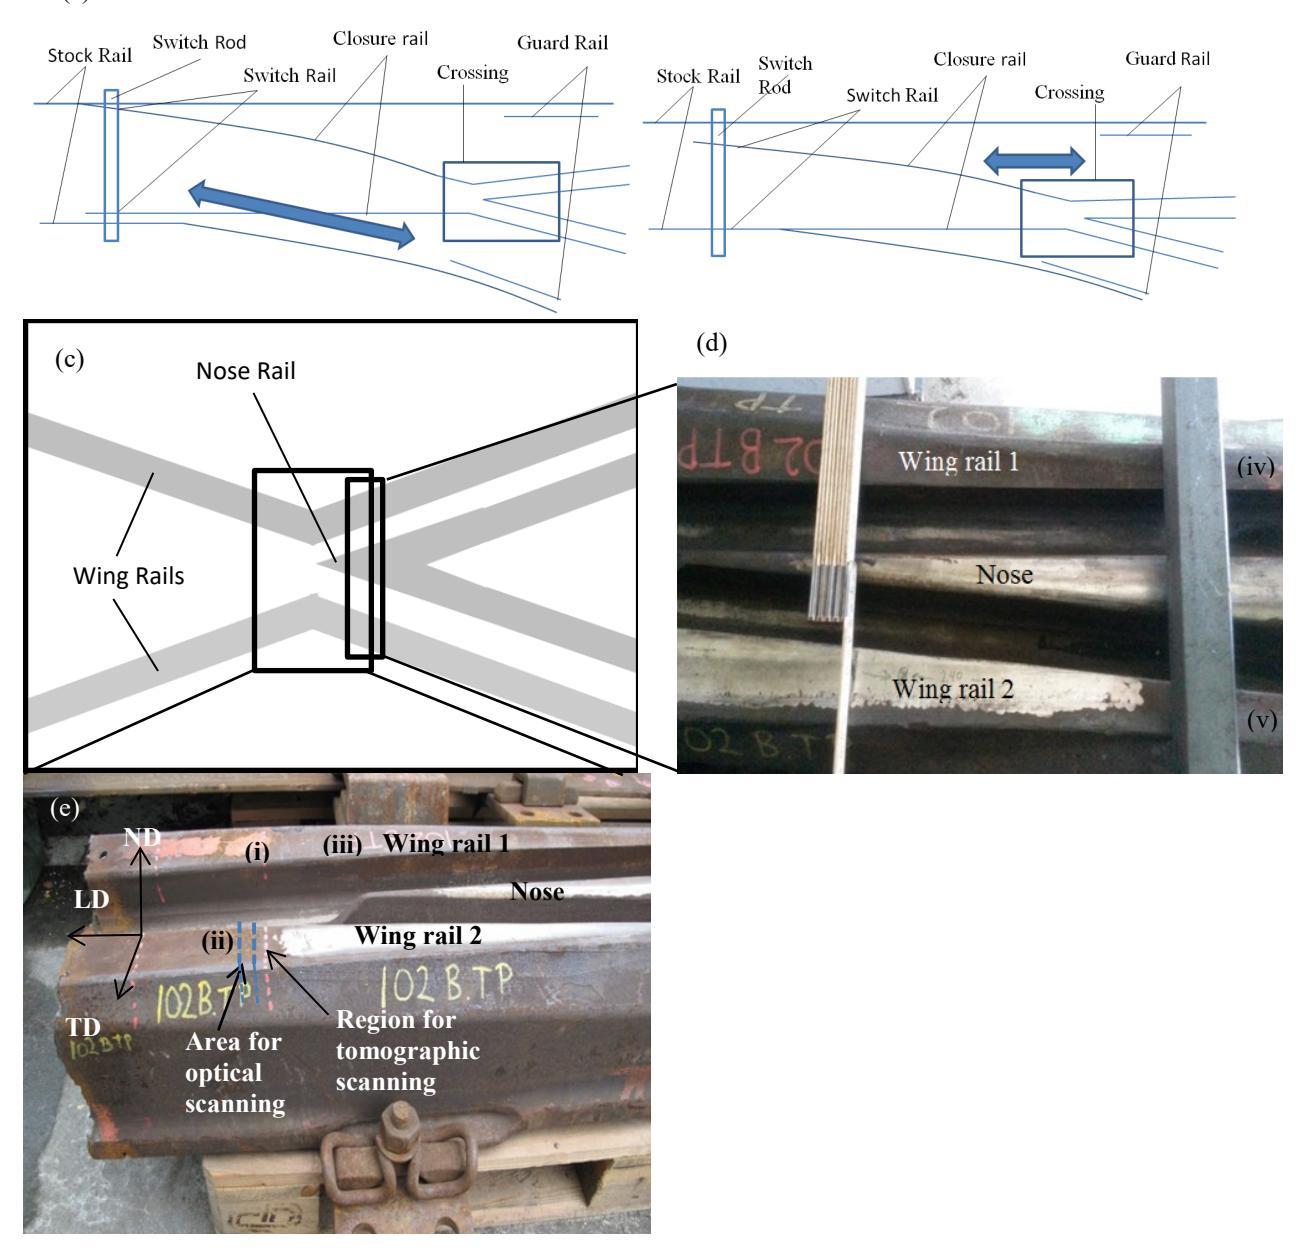
**Figure 1**: Schematic diagram of a railway switch and crossing showing the position of switch rails when the train moves on to the (a) diverging track and (b) straight track. (c) Schematic diagram of only the crossing panel showing the different components, with (d) and (e) showing the parts of the manganese steel crossing cut out for investigations. The roman numbers within the figure (in black) indicate the locations of hardness measurements. ND, TD, LD represents normal direction, transverse direction and longitudinal direction respectively.

Two samples with size 10 mm by 10 mm by 40 mm from wing rail 2 (see Figure 1e) were characterized by X-ray tomography. Figure 4(a-d) shows 2D slices from one of the 3D tomographic reconstructions. Tomographical reconstructions are 3D density maps, which allow detection of even small cracks due to differences in density, thereby identifying cracks in 3D giving a detailed overview of the entire crack surface. Figure 4 shows a very long subsurface crack parallel to the running surface across the entire cross section of the specimen. However, the full 3D reconstruction also reveals the presence of cracks in contact with the surface. While most of the cracks run parallel to the running
