Fatigue testing of a 14.3 m composite blade embedded with artificial defects – damage growth and structural health monitoring

Published in: Composites Part A: Applied Science and Manufacturing

Publication date: 2021

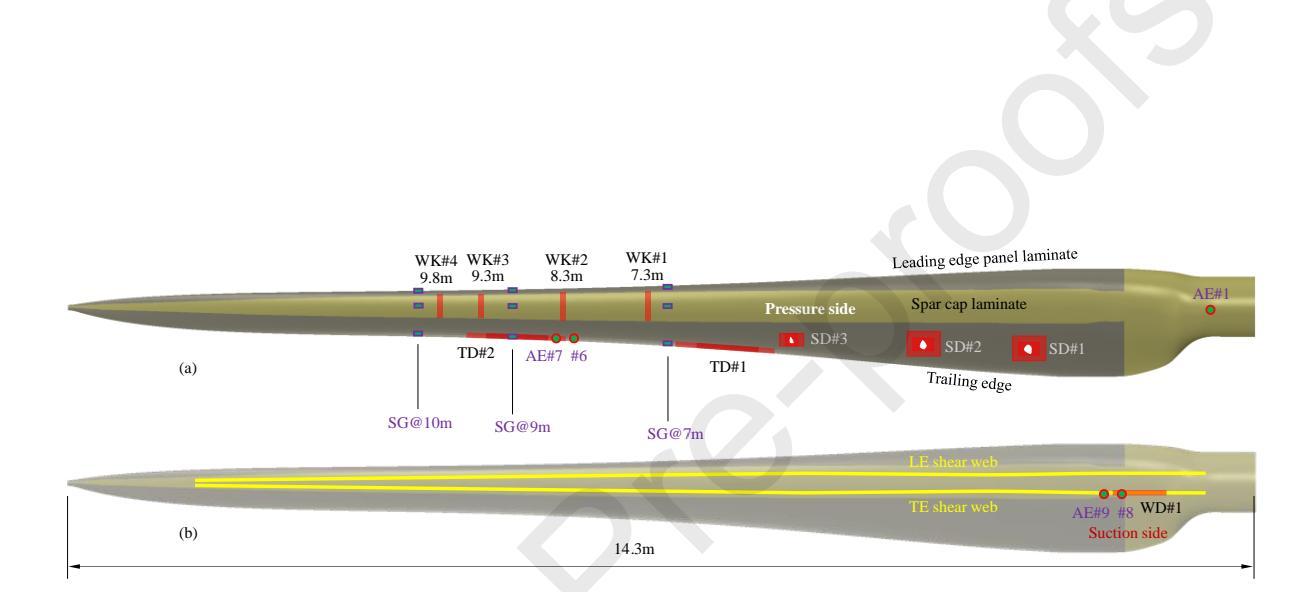
Figure 1

In total, four types of defects are designed to be included in the blade. They are laminate wrinkles in spar caps, core materials/skin laminates debond in sandwich panels, adhesive joint debonds in trailing edge, and adhesive joint debond between the shear web and the spar cap. These defects are among the most typical types of defects found in wind turbine blades [9][18][19]. The overview of the defect distribution over the blade is schematically presented in Fig. 1. The detailed descriptions of the defects are shown in Table 1.

Fig. 1. Distribution of artificial defects and sensors over the blade. Defect types: wrinkle insert – WK; sandwich skin/core debonding – SD; trailing edge adhesive joint debond – TD; shear web/spar cap debond – WD. Sensor types: strain gauge – SG; Acoustic emission sensor – AE. (a) The distribution of defects and sensors over the pressure side shell and trailing edge of the blade. (b) The adhesive joint debonds between the rear shear web and the spar cap at the suction side of the blade.

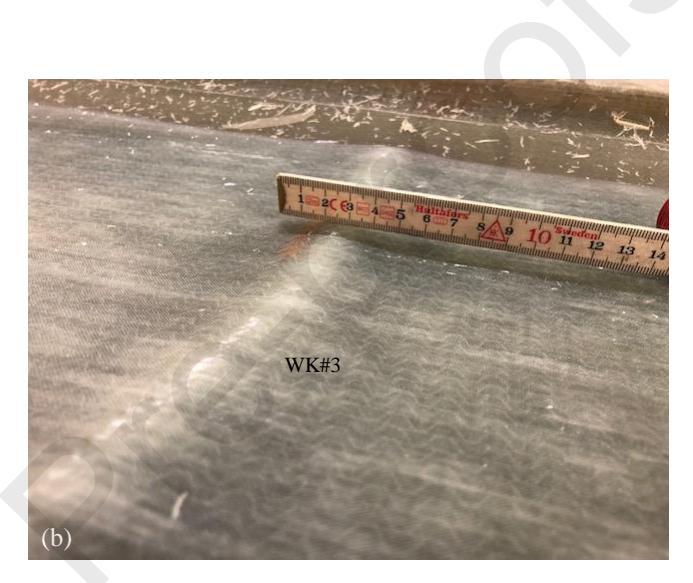
Figure 3

Fig. 3. Manufactured pressure side spar cap embedded with four resin inserts to create wrinkles in the laminate. (a) The overview of four wrinkles with embedded resin inserts in the entire spar cap. (b) A close up of WK#3. The resin inserts are embedded in such a way that the flat side of the inserts is placed towards the mold side, i.e., the outside surface of the blade, and the bump side is facing the inside surface of the spar cap. The outside surface of the blade after demolding is therefore smooth.
