# Fatigue testing of a 14.3 m composite blade embedded with artificial defects – damage growth and structural health monitoring

Xiao Chen\*, Sergei Semenov, Malcolm McGugan, Steen Hjelm Madsen, Süleyman Cem Yeniceli, Peter Berring, Kim Branner

Department of Wind Energy, Technical University of Denmark, Frederiksborgvej 399, 4000 Roskilde, Denmark

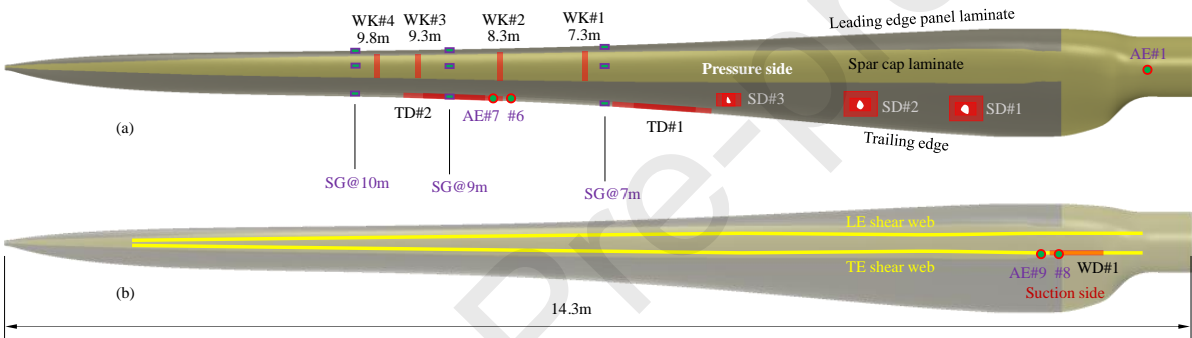
Figure 1

In total, four types of defects are designed to be included in the blade. They are laminate wrinkles in spar caps, core materials/skin laminates debond in sandwich panels, adhesive joint debonds in trailing edge, and adhesive joint debond between the shear web and the spar cap. These defects are among the most typical types of defects found in wind turbine blades [9][18][19]. The overview of the defect distribution over the blade is schematically presented in Fig. 1. The detailed descriptions of the defects are shown in Table 1.

Fig. 1. Distribution of artificial defects and sensors over the blade. Defect types: wrinkle insert – WK; sandwich skin/core debonding – SD; trailing edge adhesive joint debond – TD; shear web/spar cap debond – WD. Sensor types: strain gauge – SG; Acoustic emission sensor – AE. (a) The distribution of defects and sensors over the pressure side shell and trailing edge of the blade. (b) The adhesive joint debonds between the rear shear web and the spar cap at the suction side of the blade.

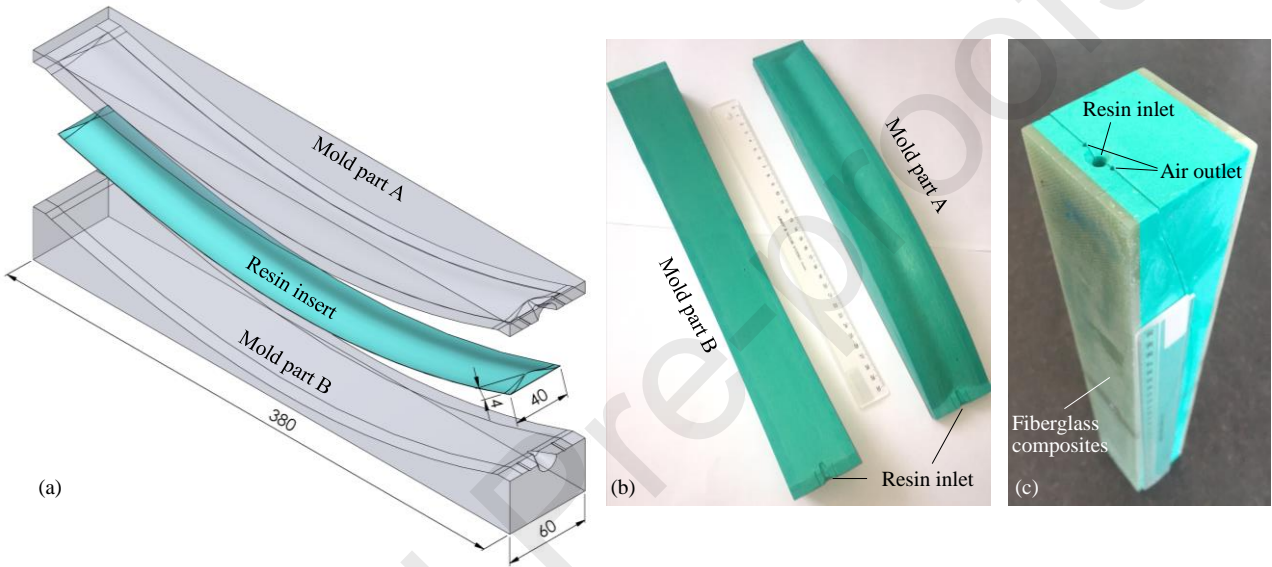
Figure 2

*Fig. 2. A mold used to cast resin inserts to be embedded in the spar cap laminates to create out-of-plane waviness, i.e., wrinkles. (a) The design of the mold and the resin insert, dimension in mm. (b) The actual mold parts fabricated by milling an EB700 high-temperature epoxy tooling board. (c) Casting the resin insert by injecting resin into the resin inlet. Two air outlets are also made in the mold to facilitate casting. Fiberglass composite plates are glued on two mold parts to provide stiffness to the mold.*

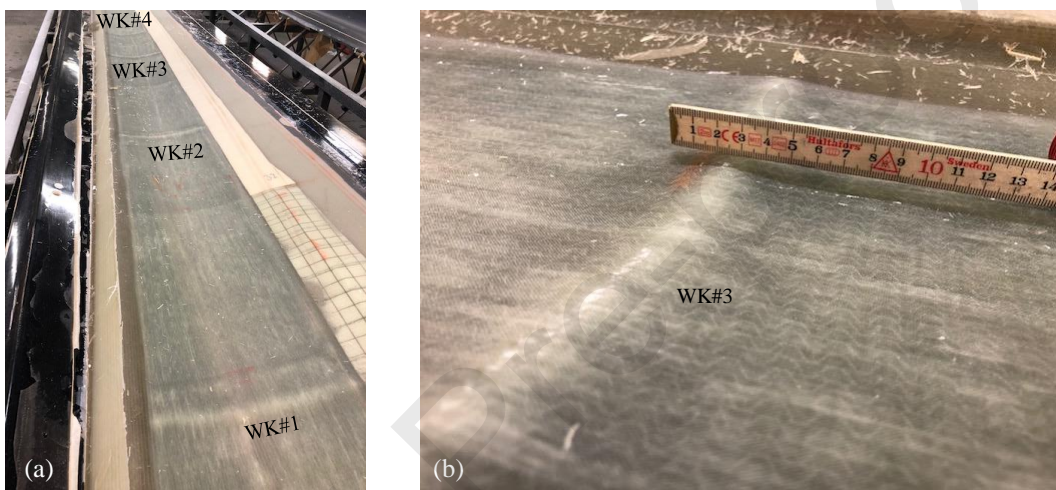
Figure 3

*Fig. 3. Manufactured pressure side spar cap embedded with four resin inserts to create wrinkles in the laminate. (a) The overview of four wrinkles with embedded resin inserts in the entire spar cap. (b) A close up of WK#3. The resin inserts are embedded in such a way that the flat side of the inserts is placed towards the mold side, i.e., the outside surface of the blade, and the bump side is facing the inside surface of the spar cap. The outside surface of the blade after demolding is therefore smooth.*

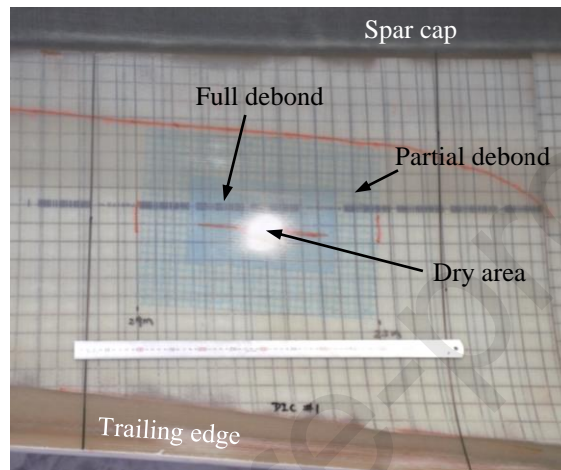
Figure 4

To create debond regions between core materials and skin laminates in sandwich panels, slip foils, or perforated release films R120-P3, with a thickness of 28  $\mu\text{m}$  are inserted at the interface of interest. The slip foils are divided into two parts: the center part is made by the original slip foils to create a fully debonded region while the outskirt part is made by perforating the slip foils with holes with a diameter of 10 mm to create a partially bonded region, see Fig. 4. The purpose of including this partially bonded region is to facilitate the progress of debonding during the fatigue test. Preliminary FE simulations indicate the debond is unlikely to grow under pure flapwise or edgewise fatigue loading of the blade. Note that an area of dry fiber fabrics arises in the center of the debond region due to the lack of resin flow in this area.

*Fig. 4. The debonding SD#1 was introduced by inserting a slip foil between cores and skin laminates. The slip foil is made in such a way that the center region creates a full debond while the outskirts create a partial debond due to perforations (holes with  $D=10\text{mm}$ ) made in the slip foil. An area of dry fiber fabrics arises in the center of the debond region due to the lack of resin during the blade manufacturing.*
