## Decisive parameters for moisture safe internal insulation of masonry – Long time monitoring in inhabited dwellings

*Published in:*  
Energy and Buildings

*Publication date:*  
2024

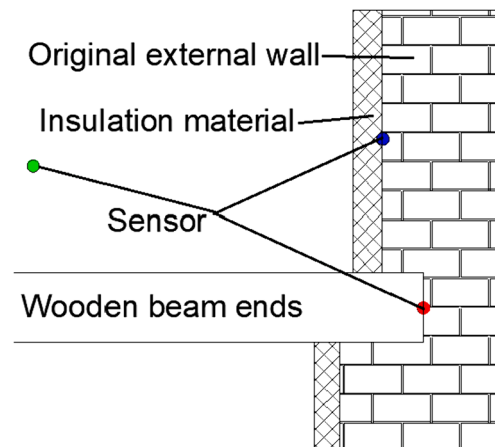
**Fig. 1.** Wall construction and sensor placement. Blue: wall interface, Green: internal, Red: wooden beam ends (only in case M). (For interpretation of the references to colour in this figure legend, the reader is referred to the web version of this article.)

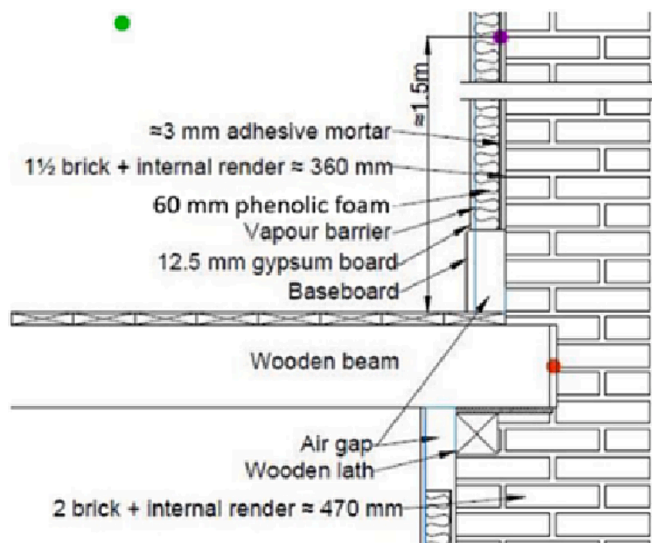
Fig. 2. Construction detail with sensor placement. Red (B3, B5 and B7): wooden beam ends. Purple (W2, W4 and W6): intersection. Green (I1): internal climate [16]. (For interpretation of the references to colour in this figure legend, the reader is referred to the web version of this article.)

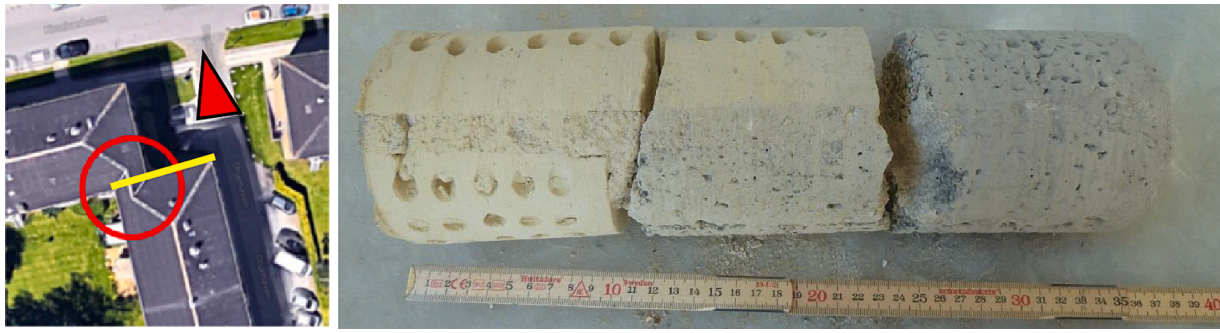
Fig. 3. Left: Top view of the building showing the covering of the neighboring property and the refurbished wall (yellow) [34] (Copyright Google Maps). Right: Drill core from original wall of case D. The outer part of the wall (on the left) is made of yellow brick and the inner part of lightweight clinker concrete (on the right). (For interpretation of the references to colour in this figure legend, the reader is referred to the web version of this article.)

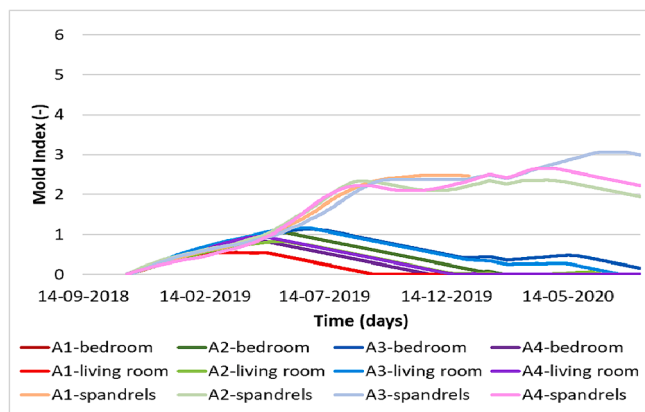
Fig. 14 depicts the mold growth risk for case B. Except for the sensors at the spandrels, all sensors had a Mold Index of less than 1. All spandrels had a Mold Index higher than 2. Sensor A3\_spandrels had the highest value of  $M = 3$  between all spandrel sensors.

Fig. 14. Mold index of case B of all sensors as a function of time. Apartments: A1-N + H, A2-S + H, A3-N, A4-S.
