APISSEQ Sisimiut – Greenland

-1st winter survey 2011-

Report nr. SR 11-01 DTU BYG March 2011

This report summarizes the very first survey of the engineering dormitory Apisseq in Sisimiut, Greenland. The dormitory was inaugurated in August 2010 and the survey was performed in March 2011. The experienced problems and their possible causes are explained in the report. Furthermore possible solutions are suggested.

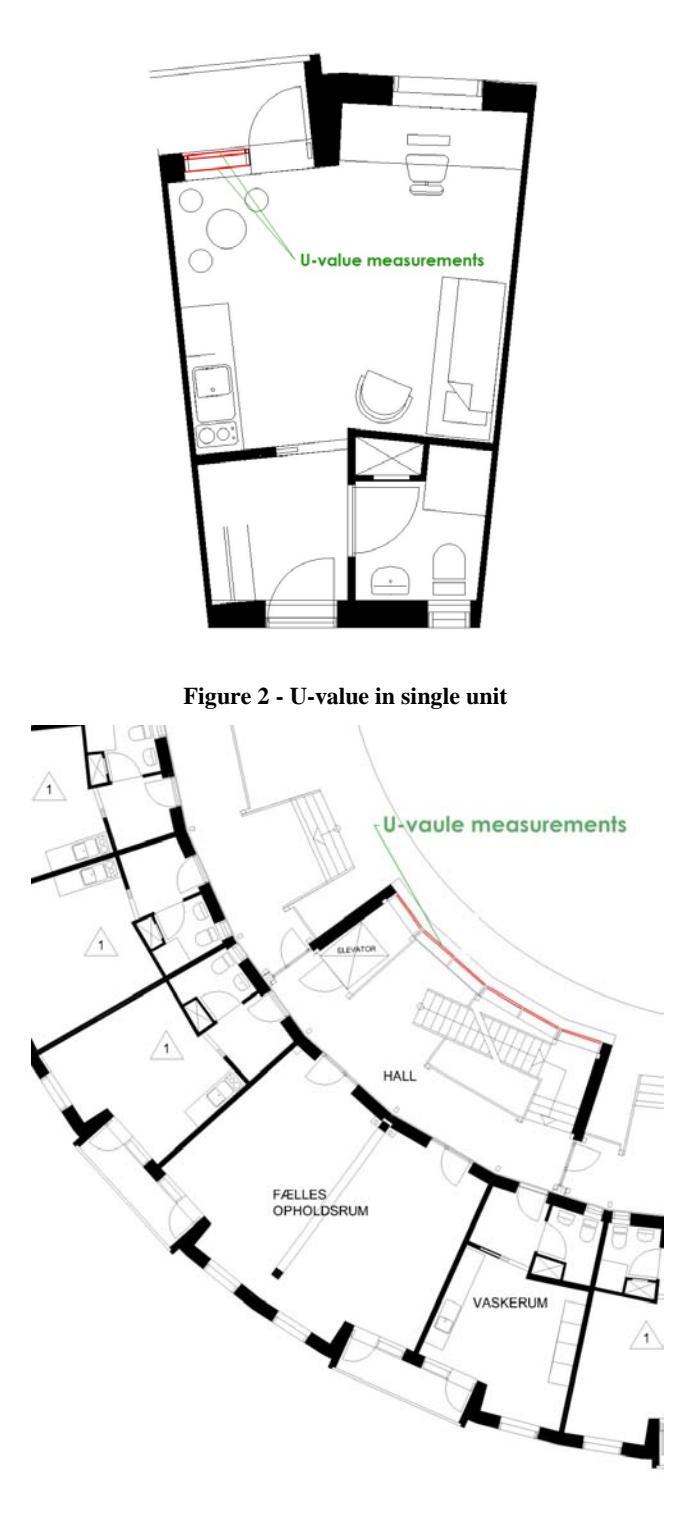
Figure 3 - Glazed atrium, U-value measurements

The U-value of the glazing in the atrium (double glazed panels) is reasonably low. But considering the large area of the glazing, it results in fairly large heat loss. It is therefore recommended to decrease the heating set point or skip the heating of the atrium at all. Since there aren't any moisture sources in the atrium, there shouldn't be a risk of any condensation problems. To investigate the actual heat consumption of the entire atrium, some calorimeters could be installed on the two radiators in the ground floor.

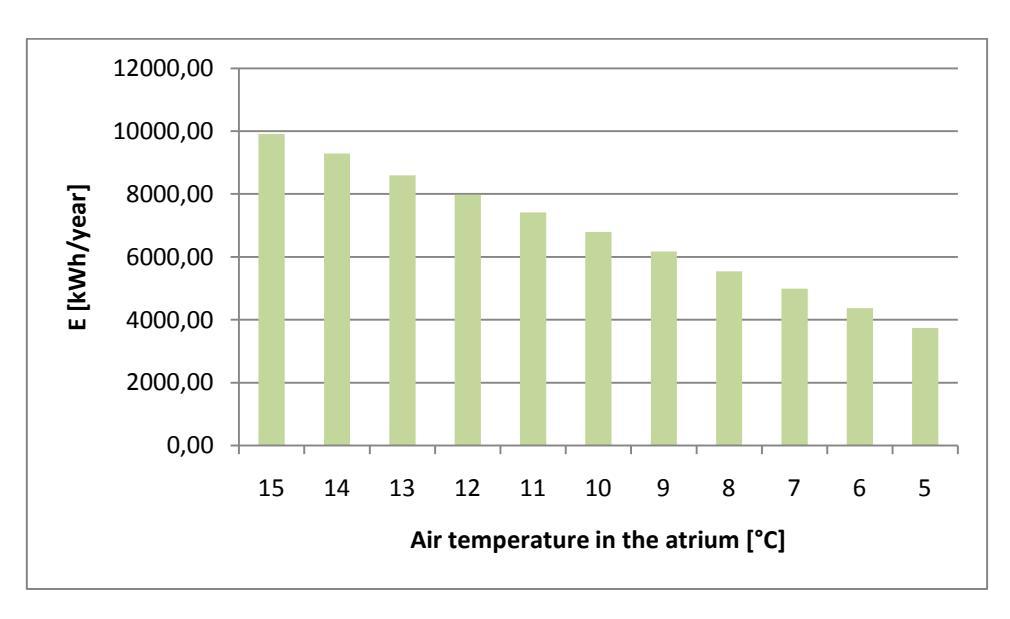
Figure 4 - Heat loss from the glazed facade (different indoor temperatures)

The average temperature measured inside the atrium was 15°C which results in 5958,33 HDD (based on the average outdoor temperatures within last 4 years). Heat losses as a result of different temperatures in the atrium are presented in Figure 4.
