## Large Steel Tank Fails and Rockets to Height of 30 meters - Rupture Disc Installed Incorrectly

**Vertical cylindrical 90 m<sup>3</sup>  
steel tank operated at  
"slight overpressure"  
rockets to height of 30 m –  
rupture disc overpressure  
relief device inoperative,  
installed upside down**

At a brewery, the base plate-to-shell weld seam of a 90 m<sup>3</sup> vertical cylindrical steel tank failed catastrophically. Leaving the contents behind, the 4 ton tank “took off” like a rocket and landed on a van, crushing it. The top of the tank reached a height of 30 m. The internal overpressure responsible for the failure is estimated at 60 kPa. A rupture disc rated at less than 50 kPa provided overpressure protection and thus prevented the tank from being covered by the European Pressure Equipment Directive. This safeguard failed and it was later found that the rupture disc had been installed upside down. The organizational root cause of this incident may be a fundamental lack of appreciation of the hazards of large volumes of low-pressure compressed air/gas. A contributing factor may be that the standard P&ID symbol for a rupture disc may confuse and lead to incorrect installat

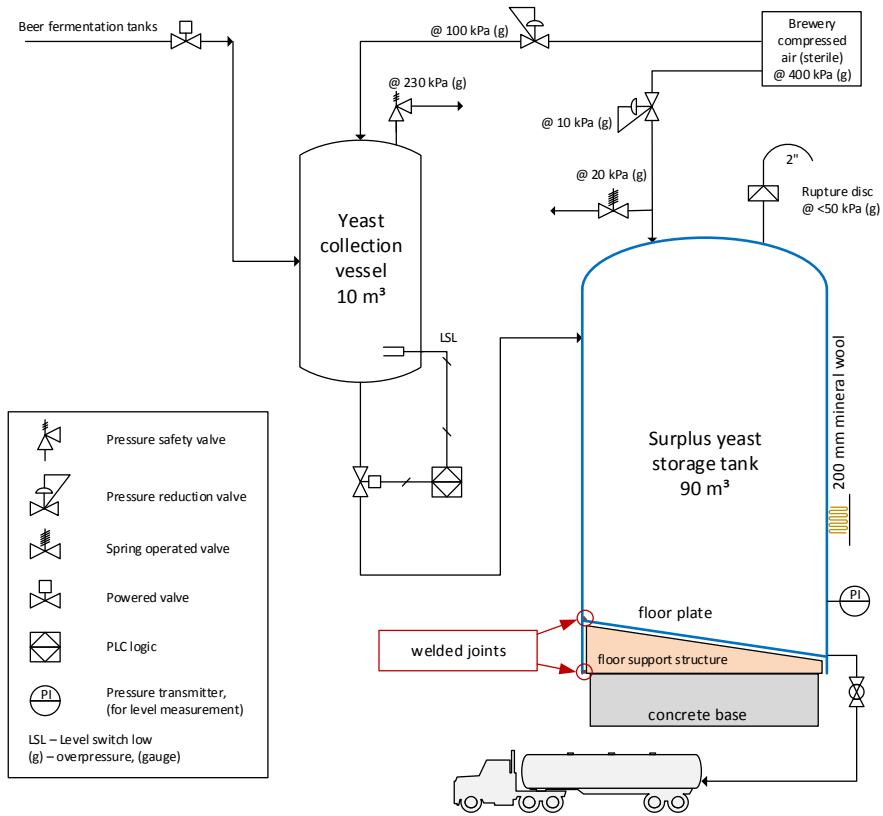
Surplus yeast is a biologically active material and an excellent medium for the growth of unwanted microbes. Occasional nuisance foaming is a concern and the storage tank was therefore modified to operate at a pressure of 10 kPa to suppress foaming. A spring operated pressure valve was set at 20 kPa (g) to allow for tank breathing during loading, when the incoming liquid reduces the headspace vapor volume in the tank. An overpressure relief device, a rupture disc (bursting disc), was installed in the tank's two-inch vent line. The vendor specification sheet gives the burst pressure range of 43-49 kPa @22 °C.

Figure 1 Schematic representation of surplus yeast system
