**Hedlund, Frank Huess; Astad, John; Nichols, Jeffrey**

# **Inherent hazards, poor reporting and limited learning in the solid biomass energy sector: a case study of a wheel loader igniting wood dust, leading to fatal explosion at wood pellet manufacturer**

Project No.  
Document no. Aars 2010  
Version 20  
Date of issue April 4, 2014

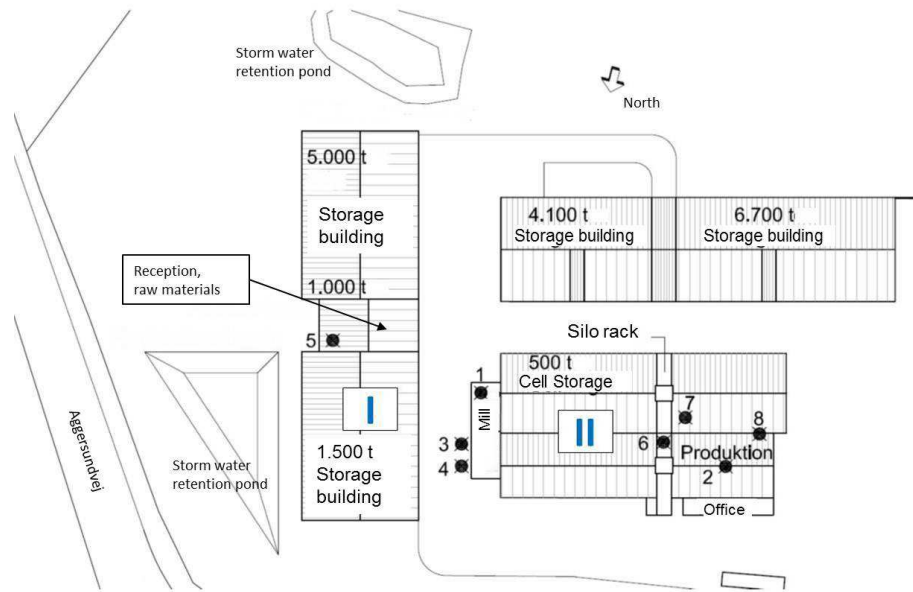
Figure 1 Layout of facility with Building I (raw materials) and II (intermediate dust storage and production) marked, other buildings are for storage of final product. Numbers refer to 1) mill, 2) three pelletizer lines and pellet cooler, 6) silos/hoppers for final product, 7) chimney. North is down. Source: Company application for environmental permit, dated Jan 28, 2010
