## Post-mortem study on structural failure of a wind farm impacted by super typhoon Usagi

*Citation (APA):*  
Chen, X., Li, C. F., & Xu, J. Z. (2015). *Post-mortem study on structural failure of a wind farm impacted by super typhoon Usagi*. Paper presented at EWEA Annual Conference and Exhibition 2015 , Paris, France.

Xiao Chen<sup>\*1</sup>, Chuan Feng Li, Jian Zhong Xu

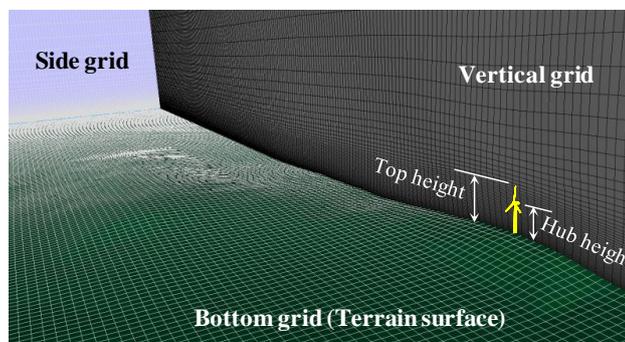
Figure 4 The local grids of CFD model of the wind farm terrain

Using GPS data, the three dimensional topographic model of the wind farm terrain was constructed and it was further used in CFD simulation to study wind characteristics at local site of each turbine. The local grids of CFD model of the terrain are shown in Figure 4. Wind speed and turbulence intensity distribution along the turbine height were calculated for different wind directions with the maximum wind speeds recorded during Usagi.
