Application of aluminum diffusion coatings to mitigate the KCl-induced high-temperature corrosion

Kiamehr, Saeed; Lomholt, T. N.; Dahl, Kristian Vinter; Christiansen, Thomas Lundin; Somers, Marcel A. J.

Published in:
Materials and Corrosion

Pack cementation was used to produce Fe_{1-x}Al and Fe_2Al_5 diffusion coatings on ferritic-martensitic steel P91 and a Ni_2Al_3 diffusion coating on pure nickel. The performance of diffusion coatings against high-temperature corrosion induced by potassium chloride (KCl) was evaluated by exposing the samples at 600 °C for 168 h in static lab air under KCl deposit. In addition, a salt-free experiment was performed for comparison. Microstructure, chemical and phase composition of the samples were analyzed with scanning electron microscopy (SEM), energy dispersive X-ray spectroscopy (EDS) and X-ray diffractometry (XRD) before and after the exposures. It was found that all the diffusion coatings formed protective oxides under salt-free exposure in air. Under the salt deposit, Fe_{1-x}Al showed local failure while on large parts of the sample a protective layer had formed. Fe_2Al_5 was attacked over the entire surface and the dominant mode of atta

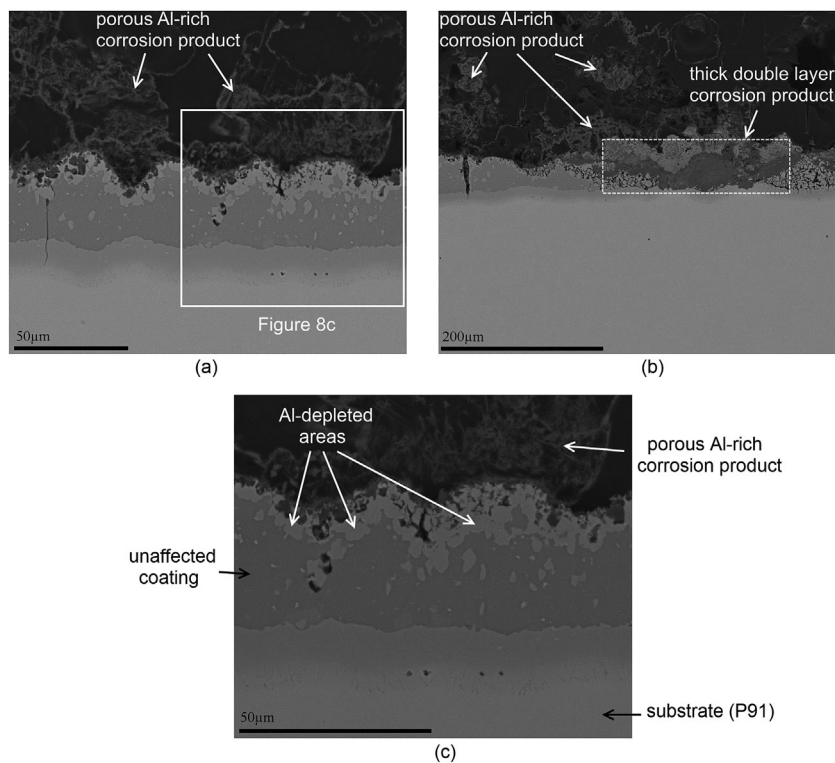
Figure 8. (a and b) Corrosion product morphologies observed for Fe_2Al_5 coating on P91 exposed under air + KCl(s) at 600 °C for 168 h. (c) Magnification of the boxed area in a showing the aluminum-depleted areas and unaffected coating

In contrast with the passive behavior observed for the salt-free exposure, the presence of KCl caused severe attack on Fe_2Al_5 , even on the salt-free part. Generally, selective removal of aluminum and formation of a voluminous and porous aluminum-rich corrosion product on top of the coating was observed (Fig. 8a). EDS spot analysis on the aluminum-diluted areas close to the surface gave an average value of 51 at% aluminum and 6 at% chromium. Dilution of aluminum in

these areas was coupled to enrichment in iron and chromium. An example of this mode of attack is shown in Fig. 8a with further details shown in Fig. 8c. In a few cases, Fe_2Al_5 was completely consumed and a thick double layer oxide, in addition to the outermost highly porous oxide, had formed (Fig. 8b). In both cases potassium was found throughout the corrosion product. EDS spot analysis on the porous aluminum-rich outer oxide gave potassium contents up to 10 at%. Distribution of the main metallic elements as well as potassium and oxygen over the above-mentioned corrosion

The presence of KCl during the exposure has a remarkable impact on Fe_2Al_5 . Unlike Fe_{1-x}Al which only showed local failure, the surface of Fe_2Al_5 was severely attacked. Figure 8a and the mapping in Fig. 9 show that, similar to the results by Vokal et al. [9], aluminum was selectively removed and iron/chromium were enriched. In addition, it turns out that the removed aluminum is present outside the original coating's surface matching the maps of oxygen and potassium. Absence of AlN just underneath the corrosion product (within the aluminum-diluted region in the coating) shows that the corrosion product is outward-growing.

The microstructure in Fig. 8c shows that aluminum removal is not limited to the coating surface; aluminum-diluted areas are also found in the middle of the Fe_2Al_5 layer (in a two-dimensional image these regions appear as light-contrast “islands” in the middle of the coating in Fig. 8c). The depth of aluminum removal as well as the morphology of the corrosion product strongly suggests that the mechanism of dilution is the formation of volatile aluminum chloride (similar to Fig. 2c). It appears that if the aluminum-diluted area maintains a sufficient aluminum content (after an initial removal) it has the possibility to re-passivate. EDS spot analysis on several aluminum-diluted areas similar to Fig. 8a gave values around 51 at% for the residual aluminum content. This is consistent

with the detection of Fe_{1-x}Al when the GI-XRD was performed at 5° and describes why the corrosion does not continue on some parts of the Fe_2Al_5 . Description of the corrosion morphology shown in Fig. 8b is not as straight-forward as that in the Fig. 8a. However, one can speculate a case where the de-aluminization of Fe_2Al_5 is locally so severe that the residual aluminum content is insufficient to support formation of a protective oxide at a later stage. In such a case, the alloy cannot re-passivate after the initial stages of the attack (i.e., de-aluminization by volatilization) and eventually a double layer oxide rich in iron on top and aluminum at the bottom will form underneath the earlier corrosion products.

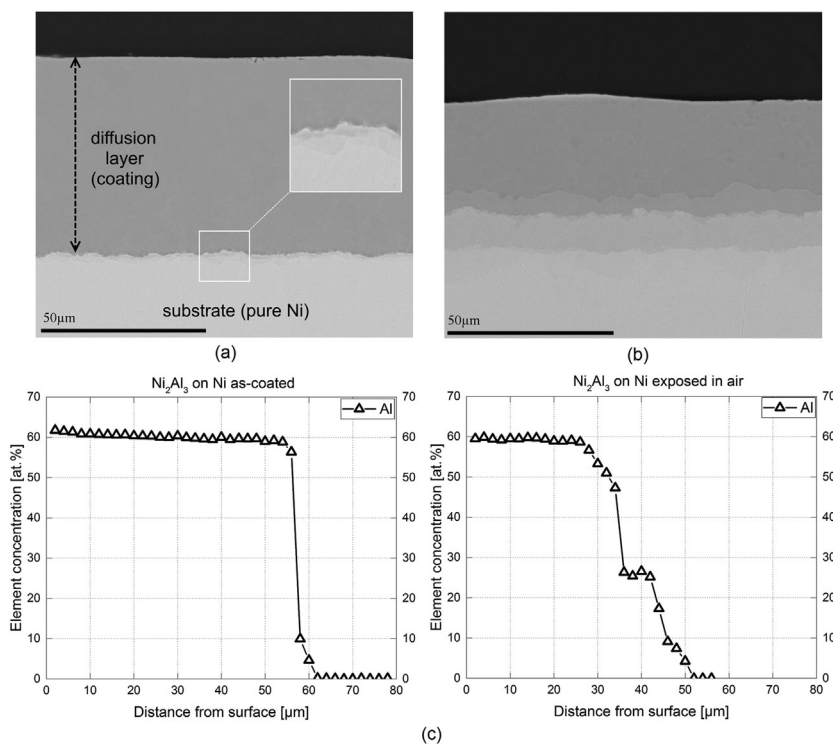
Figure 12. Microstructure of Ni₂Al₃ coating on Ni in (a) as-coated and (b) oxidized in salt-free condition (c) aluminum profile before and after the salt-free exposure

Figure 12a and b show the microstructure of the diffusion coating on a Ni substrate before and after the salt-free exposure.

The as-coated layer showed non-uniform thickness varying between 50 and 70 μm . No deep penetrating vertical cracks, as observed for Fe_2Al_5 , were found. However, occasionally shallow-penetrating transgranular cracks could be observed close to the surface. The contrast differences in the BSE image (Fig. 12) shows the presence of a thin (<5 μm) layer of intermediate phases at the coating/substrate interface. The amount of such intermediate phases constitutes only a very small fraction of the entire coating. No evidence for high-temperature corrosion attack was found after the salt-free exposure. Continued interdiffusion between the diffusion coating and the nickel substrate led to the growth of intermediate phases (Fig. 12b). EDS line scans over the thickness of the coating are given in Fig. 12c. For the as-coated sample, the drop in aluminum content is abrupt while the aluminum concentration profile on the exposed sample is more diffuse. Again, similar to the case for Fe_2Al_5 , the shift of the transition from diffusion coating to the substrate (Fig. 12c) is at least partly caused by the non-uniform

The salt-free exposure of Ni_2Al_3 on Ni did not lead to a visible degradation of the surface. Again, lack of detection of oxide by GI-XRD indicates that it is very thin or amorphous. This is consistent with the micrograph shown in Fig. 12b that demonstrates oxidation resistant behavior. The only visible effect with SEM was the continued interdiffusion of aluminum from the coating and nickel from the substrate. This was evidenced by the thickening of the layer consisting of intermediate phases. The observation that Ni_{1-x}Al had formed close to the surface of Ni_2Al_3 after the salt-free exposure requires further study as this was not observed for the KCl-affected sample.
