## 3D X-ray CT of fatigue damage in fibre composites

*Citation (APA):*  
Jespersen, K. M., Zangenberg Hansen, J., Lowe, T., Withers, P. J., & Mikkelsen, L. P. (2016). *3D X-ray CT of fatigue damage in fibre composites*. Poster session presented at 24th International Congress of Theoretical and Applied Mechanics, Montreal, Canada.

# 3D X-ray CT of fatigue damage in fibre composites

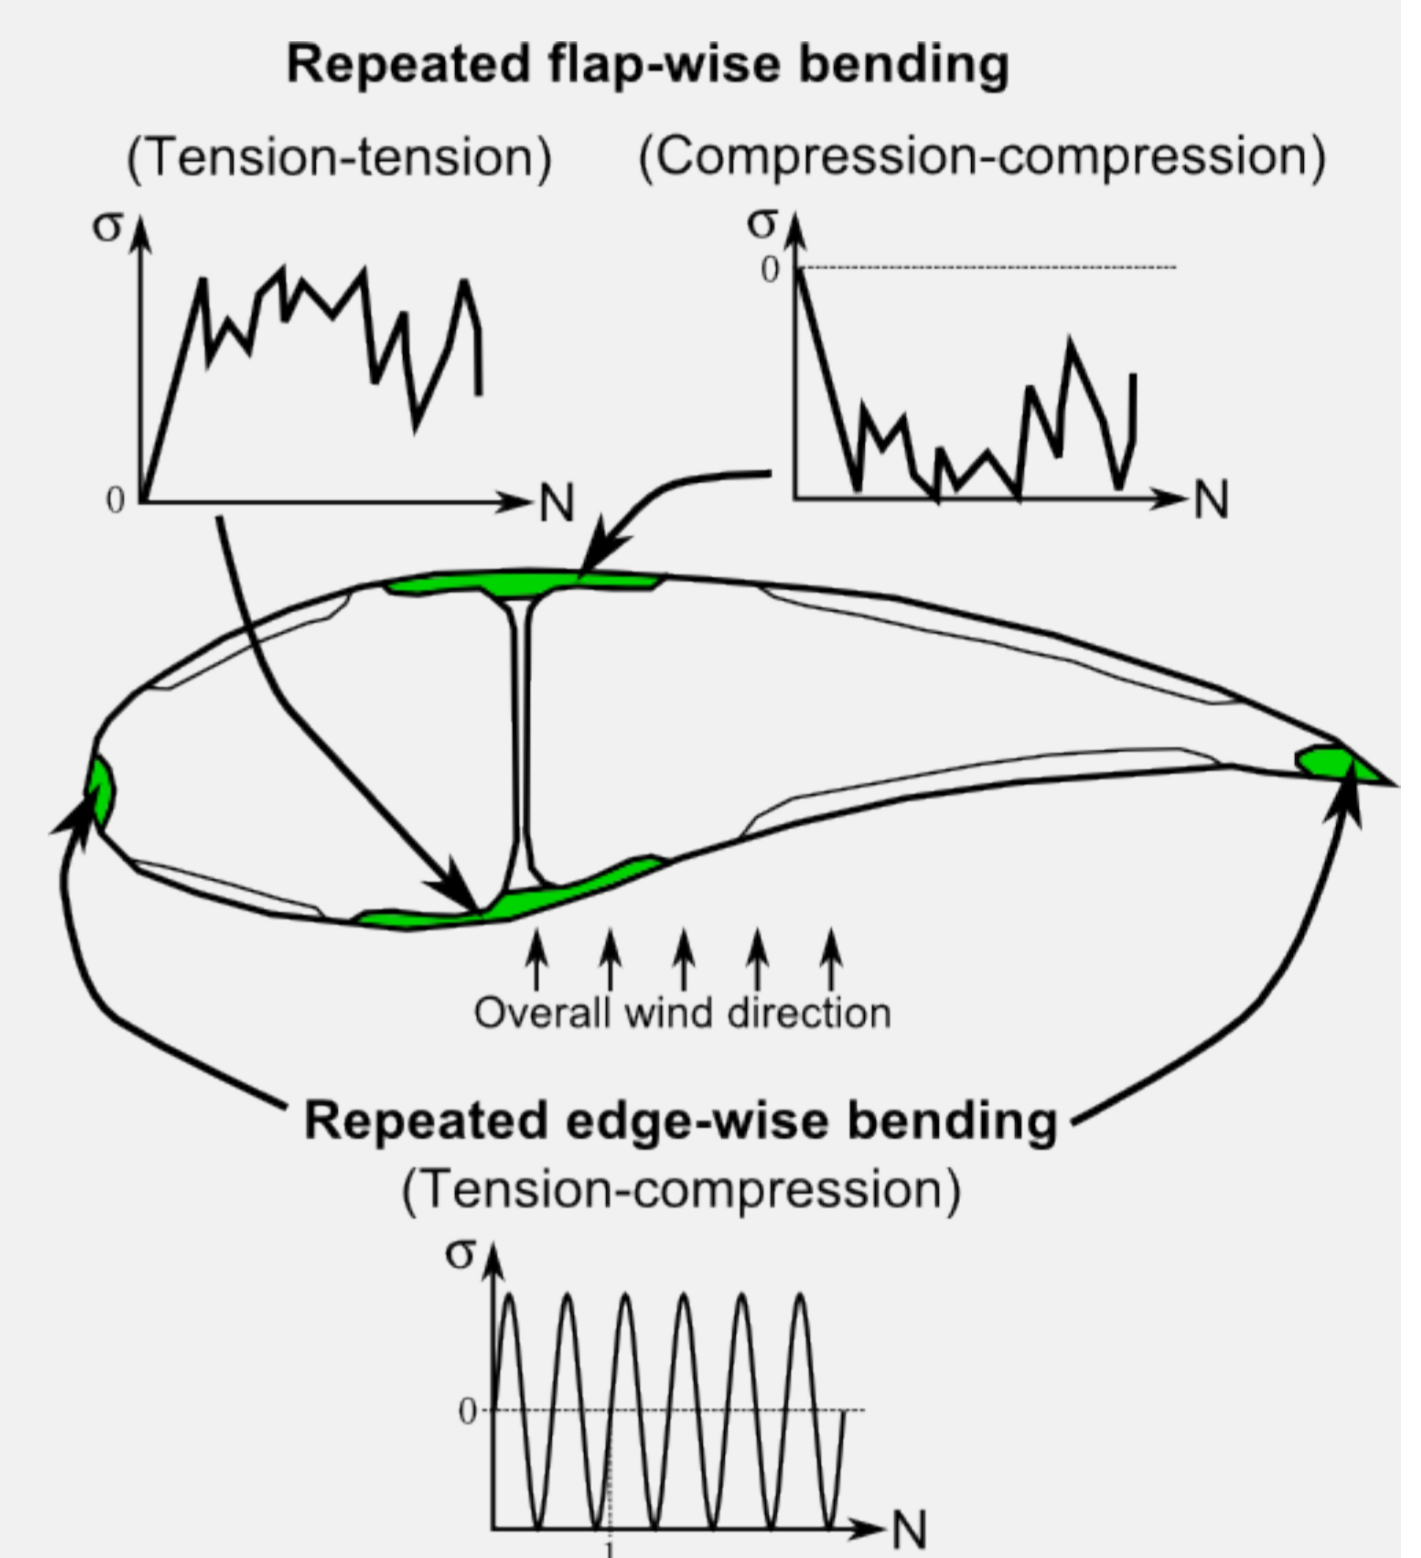
The above figure shows an example of a blade cross-section and an indication of the predominant loading types acting on the main beams made from UD glass fibre composite (green).

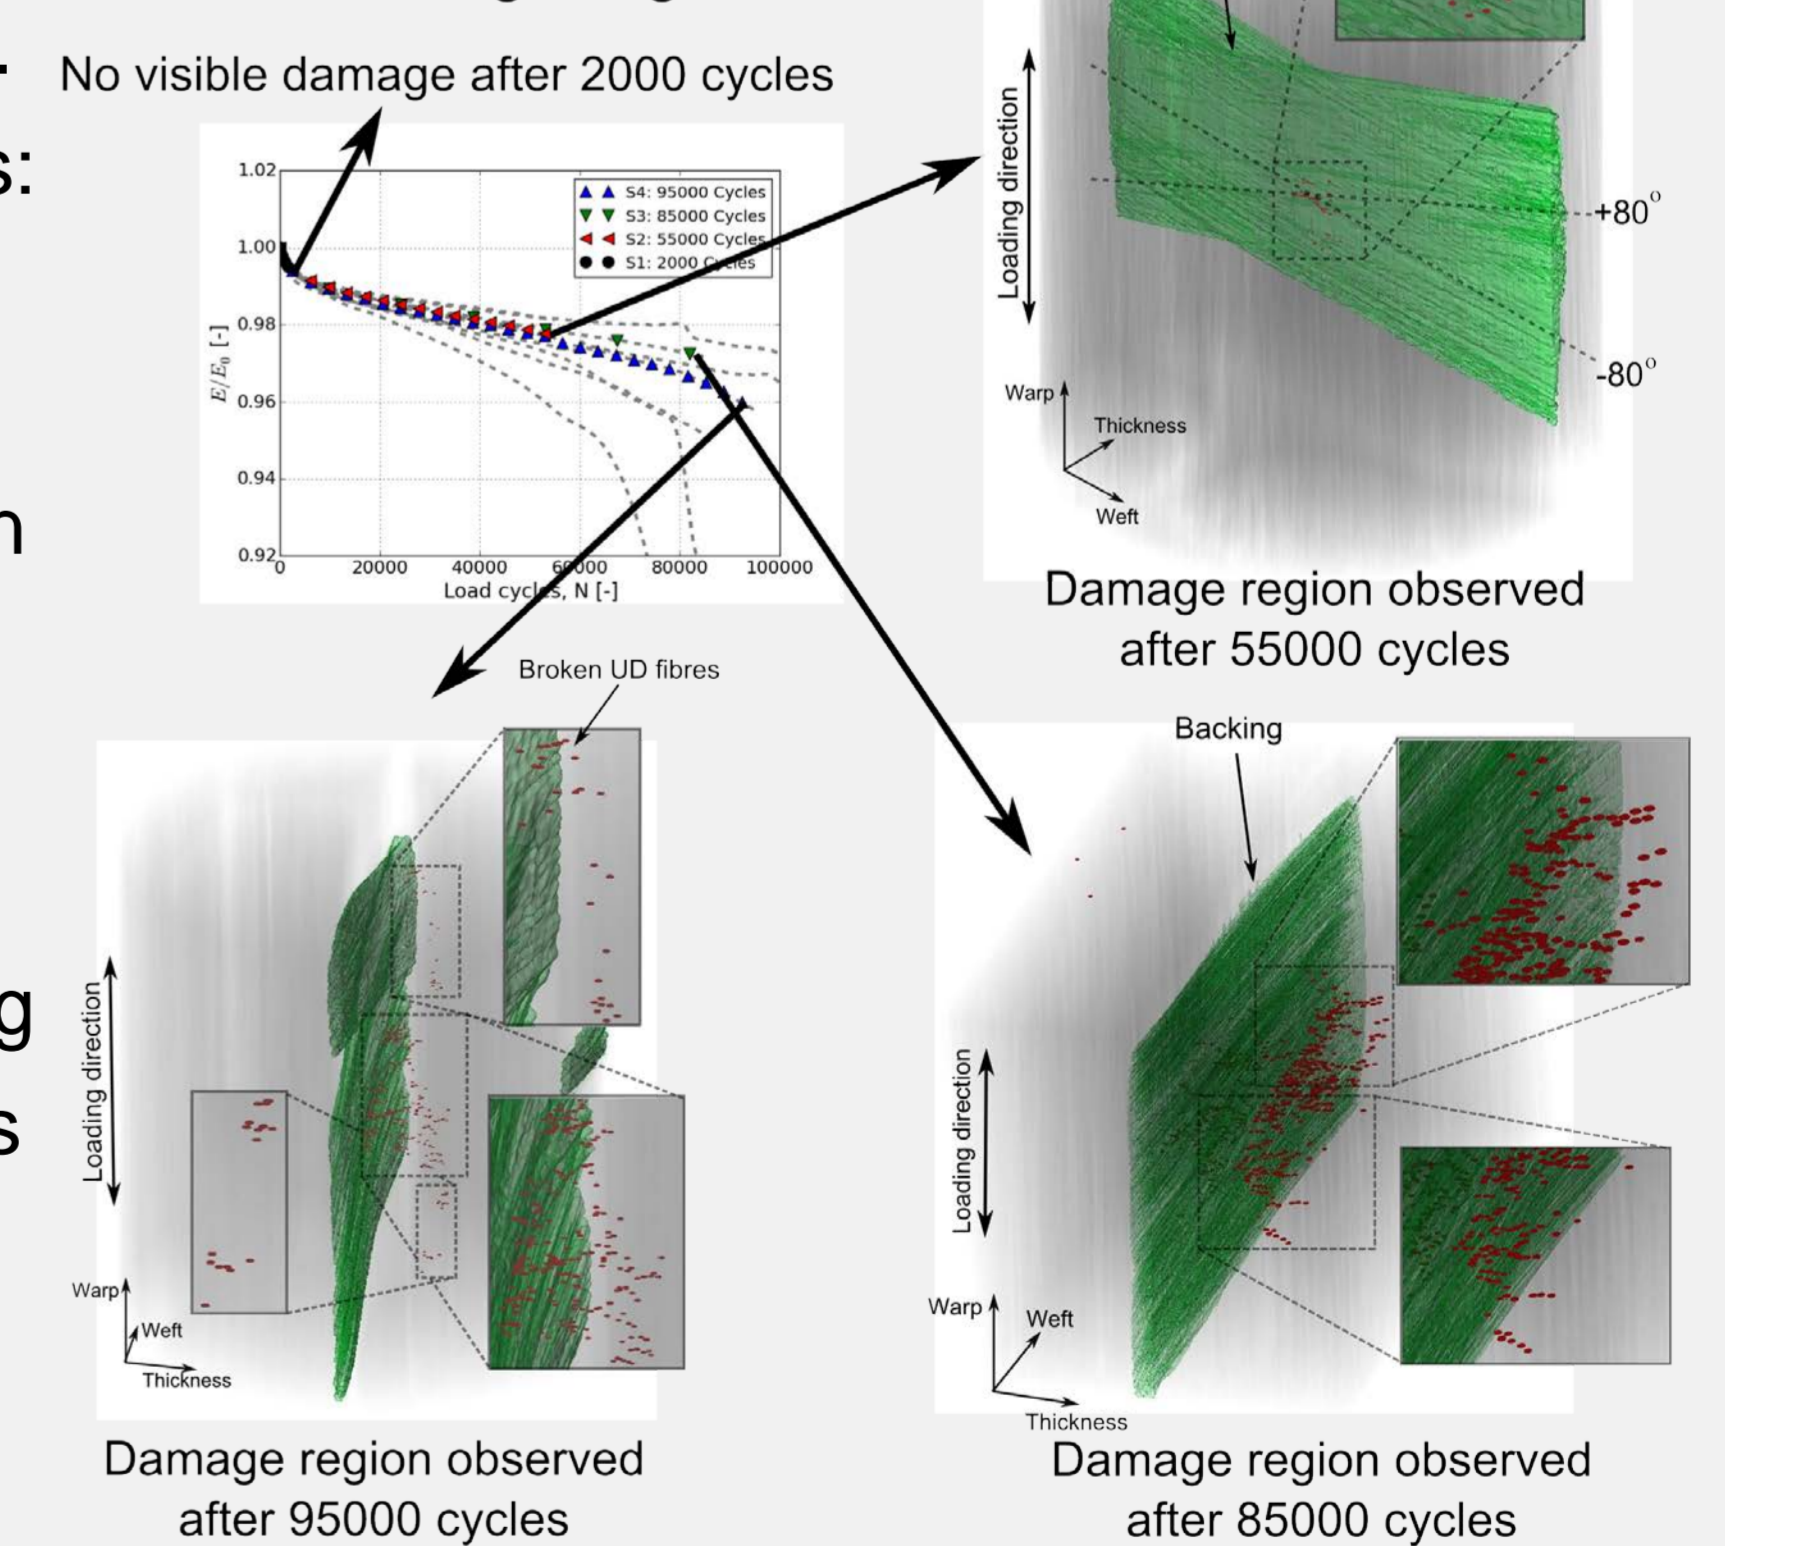
### Segmentation of UD fibre fractures at different damage stages

The UD fibre fractures were individually marked and shown in 3D. The main observations are as follows:

- UD fibre fracture regions are only seen where backing bundles intersect and at the same time is in contact with the UD bundle
- Damage is clearly a 3D phenomenon and there 2D observations might give misleading results and furthermore 2D models will be overly conservative
