Post-earthquake fire resistance of steel buildings

Jelinek, T. ; Zania, V.; Giuliani, Luisa

Published in:
Journal of Constructional Steel Research

Multiple hazards; Post-Earthquake Fire; Fire scenarios; Steel structure; Moment-resistant frame.

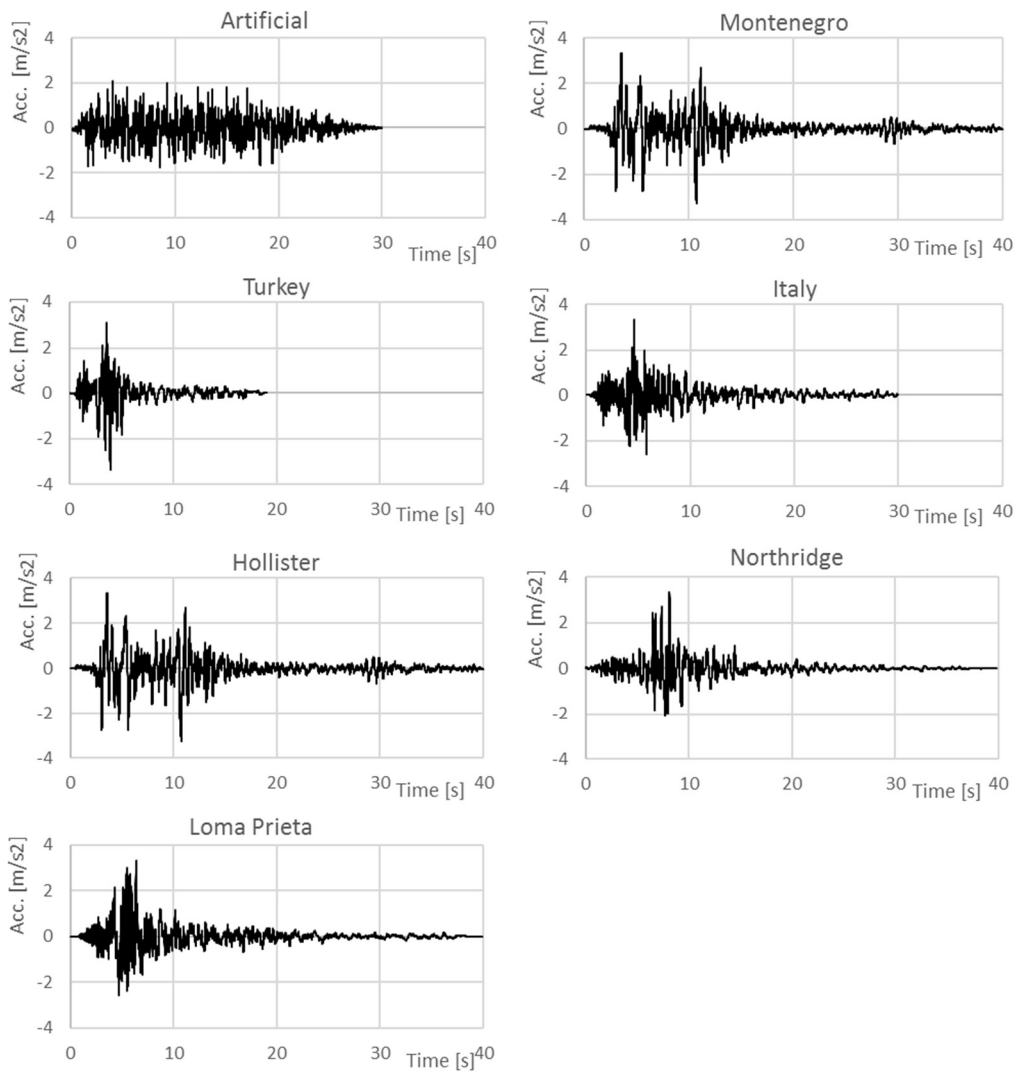
In order to determine structural response to earthquake, 7 acceleration time histories (accelerograms) were chosen from both European and US databases, plus 1 artificial accelerogram (see Table 1 and Figure 3).

Figure 3: All applied acceleration time histories (accelerograms) in earthquake response analysis.

All time histories were processed and base line correction and Butterworth type filtering for frequencies between 0.1 and 25Hz was applied. Accelerograms were then scaled to $PGA = 0.34$ g, which is 5% higher than the design PGA of the steel frame, in order to ensure that plastic deformations develop in the frame.

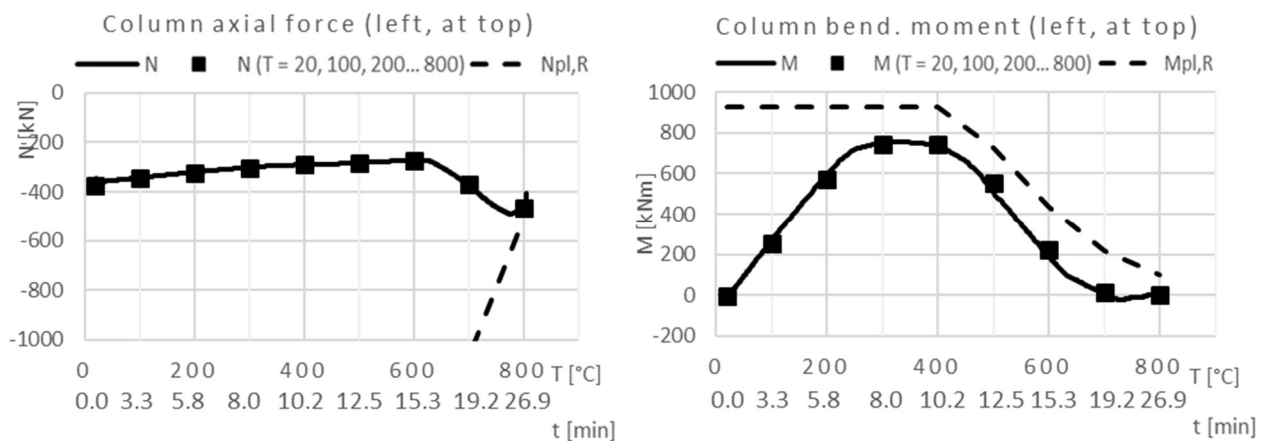
The behavior of structural elements during the collapse mechanism can be better understood by looking at the section forces of the beam and left column reported in Figure 10 and Figure 11 respectively with respect to the element temperature (upper charts) and time of fire exposure (bottom charts):

Figure 11: Axial force in the column (left charts) and moment at the top of the left column (right chart) in the A-1L scenario, plotted against the beam temperature (upper axis) and the time of fire exposure (bottom axis). The dotted lines in the left and right charts represent the axial and bending resistance, respectively.

- At the beginning of the fire, all heated elements expand in the longitudinal direction. While the expansion of the columns is quite limited, due to the restraint offered by the upper part of the frame, the expansion of the beam (left chart of Figure 10) is more significant and causes the left outer column outwards movement. This, in turn, causes an increment in the bending moment of the left column, as the flexural stiffness of the column opposes to the outer displacement of the beam (right chart of Figure 11).

- As the steel heating progresses, the steel mechanical properties degrade and the load bearing capacity of both beams and columns decrease (indicated with a dotted line in the charts of Figure 10 and Figure 11). Plastic hinges develop first at the beam-ends, inducing higher deflection and moment at the beam mid-span (right chart of Figure 10). Soon after, a third plastic hinge forms at mid-span of the beam, when it becomes a mechanism and loses its ability to carry the load.

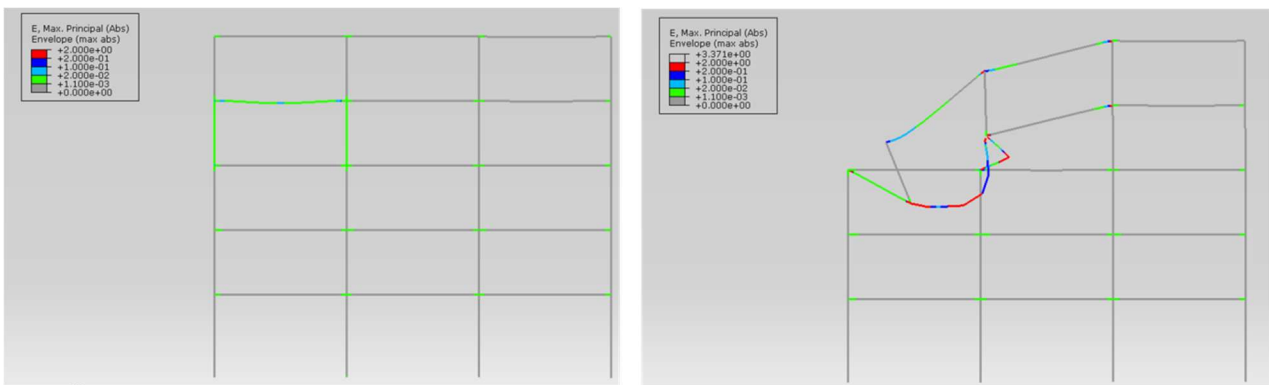
If the fire is assumed to develop in the left bay at the fourth floor (4L), the frame collapse is significantly delayed with respect to the previous 1L scenario and occurs around 45 min of fire exposure. This is due to the fact that, since the same steel profile is used for all columns, the utilization factor of the top columns, which carry less load, is much lower than for the bottom columns. The frame experiences a different failure mode, which leads to a partial collapse of the upper part of the frame. Also in this scenario, the DF analysis shows no significant difference in the failure mode and in the time of global collapse, which happens 1 minute later than in the PEF case.

Figure 14: Collapse of the frame for M-4L scenario (formation of three hinges at 14.9min - left, partial collapse at 44.8min - right)
