Impact fatigue damage of coated glass fibre reinforced polymer laminate

Fraisse, Anthony; Bech, Jakob Ilsted; Borum, Kaj Kvisgaard; Fedorov, Vladimir; Johansen, Nicolai Frost-Jensen; McGugan, Malcolm; Mishnaevsky, Leon; Kusano, Yukihiro

Published in:
Renewable Energy

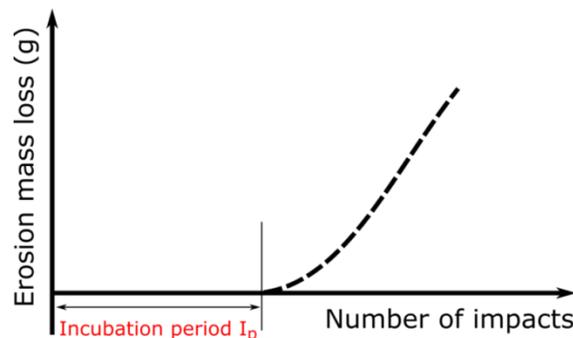
74 Figure 1. Schematic diagram of erosion mass loss as a function of the number of impacts, accompanying an
75 incubation period I_p at the initial stage of impacts.

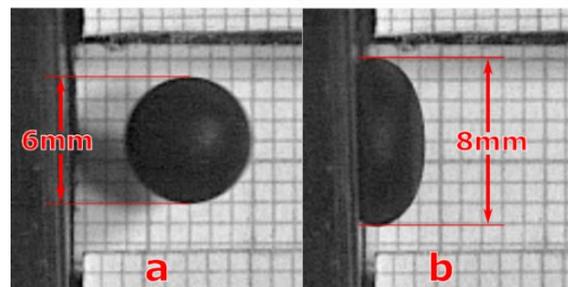
110 Figure 4. High-speed imaging of the 6 mm rubber balls captured using a Phantom v2512-fast high-speed
111 camera at 38016 fps $2.1\mu\text{s}$ exposure time. (a) just before impact travelling at 167.02 m s^{-1} . (b) the deformed
112 projectile at $\text{Ø}8 \text{ mm}$, $26.15 \mu\text{s}$ after the initial impact.

100 The projectiles used for impact testing are $\text{Ø}6 \text{ mm}$ balls made from Buna nitrile rubber (NBR60), with a shore
101 hardness of 60. The mass of each ball is 0.143 g giving each ball a density of 1.267 kg m^{-3} . The choice of
102 NBR60 for the projectiles is based on the need for a low-modulus material that would remain intact during
103 repeated impacts, while still having a density close to that of water. In order to reduce friction between the
104 barrel and the rubber ball while firing, a small amount of silicon oil lubrication was used to coat the rubber
105 balls. Figure 4 shows the projectile deforming upon impact with the target. Using high-speed imaging to
106 visualise this deformation, it can be seen that the degree of deformation is dependent upon impact speed,
107 ranging from $\text{Ø}6.9 \text{ mm}$ at 88 m s^{-1} to $\text{Ø}8 \text{ mm}$ at 167 m s^{-1} .

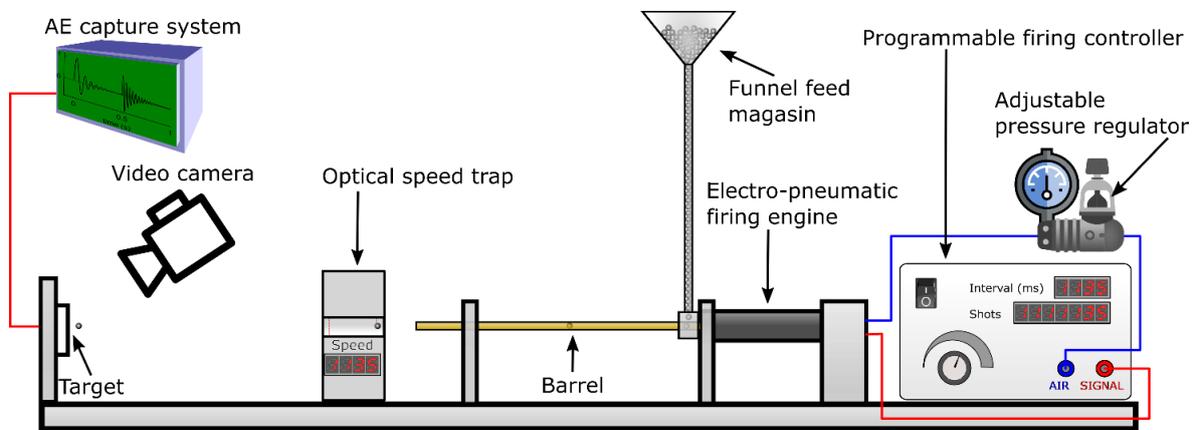
128 Figure 5. SPIFT setup.

115 The SPIFT repeatedly shoots rubber balls at a coated $15 \times 40 \times 5 \text{ mm}^3$ laminate. The shooter is a Valken V12
116 electro-pneumatic firing engine, driven by compressed air and containing a plunger and two magnetic valves.
117 The schematic setup is illustrated in Figure 5. The balls are fed by gravity into the firing mechanism from a
118 vibrating magazine hopper. The plunger lets the balls into the chamber one by one. After entering the chamber
119 the rubber ball is loaded into the barrel, whereupon compressed air is released to accelerate the rubber ball
120 through the barrel. After leaving the barrel the rubber ball passes through an optical speed trap (Airchrony
121 Mk.3) recording the exit velocity of the rubber ball. Having passed the speed trap the rubber ball hits the target.
122 The setup can shoot up to 5 rubber balls per second with velocities up to 170 m s^{-1} . The velocity is regulated

158 Figure 5 in section 2.3 shows the SPIFT setup with a single AE sensor attached to the reverse side of the coated
 159 laminate. A laboratory optimised Express-8 AE board and chassis system from Mistras Group¹ was used to
 160 detect and analyse the signals. As only a small space was available for instrumentation, a miniature Pico sensor²
 161 was used.

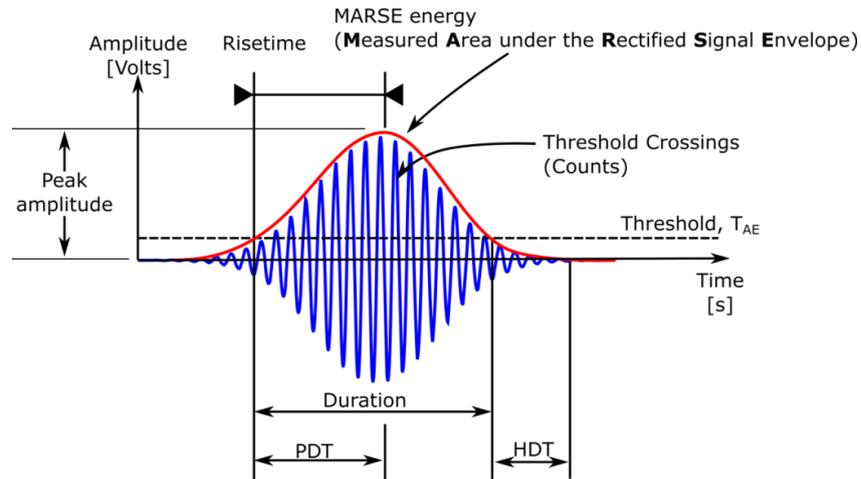
144 Figure 6. Amplified waveform schematically showing timing parameters and extracted AE features.

146 In order to extract relevant features from the transient waveform, user defined detection and timing parameters
 147 must be provided as illustrated in Figure 6. These include a threshold voltage (T_{AE}) above which an AE “hit”
 148 will be registered, a Peak definition time (PDT) specifying the time allowed after the detection of a “hit”
 149 to determine the peak value for that hit – if PDT is too long then false peak values are likely to be recorded. If
 150 too short, the true value may not be identified. Other timing parameters like hit definition time (HDT) and hit
 151 lockout time (HLT) must also be specified and can likewise result in incorrect waveform characterization if
 152 set incorrectly.

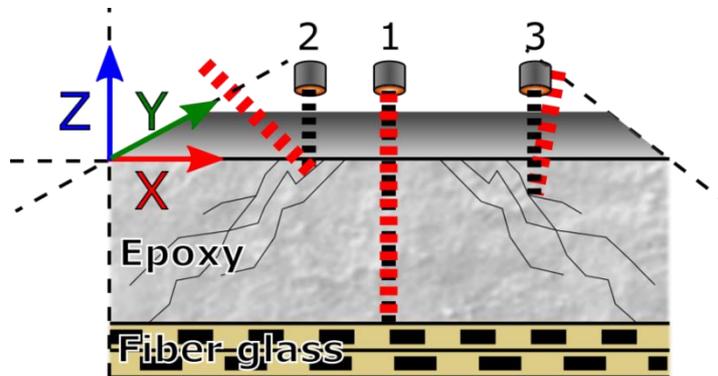
188 Figure 7. Scenarios of ultrasound interaction with defects. See the main text for further details.

170 A focused ultrasonic wave was sent into the material by the transducer and reflections from interfaces were
 171 recorded by the same transducer (Figure 7).

182 There are three scenarios describing the wave interaction with defects. In the first one (1), the ultrasound
 183 waves are reflected directly back from the laminate. Since the surface is normal to the sensor, the intensity of
 184 the reflected echo is strong. In scenarios 2 and 3 most of the ultrasonic wave is reflected at an angle which
 185 gives a weak response to the sensor. Table 1 summarises the parameters selected for the ultrasound scanning.

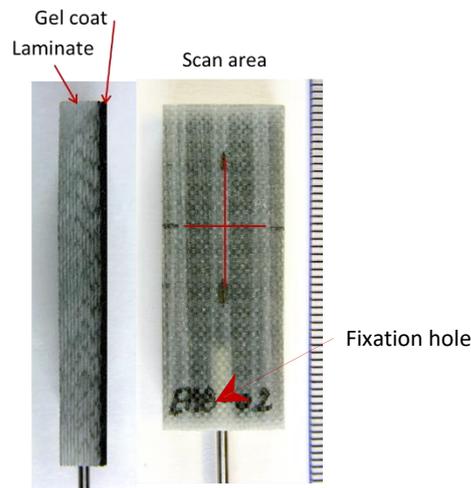
215 Figure 8. The coated laminate with mounted pin.

204 than 1 μm . In this study, the sample size was defined to be 15 mm wide and 40 mm long. This geometry has
 205 been defined in order to have a representative volume of the material to test and to ensure a good scan quality.
 206 3D ex-situ tomography was chosen as the characterisation technique for its nondestructive aspect and capacity
 207 to identify and follow the damage mechanisms in the coated laminate during impact fatigue. The repeatability
 208 of the method can be a challenge, and therefore special care was taken while mounting the samples in the
 209 scanner. As shown in Figure 8, a hole was drilled in the sample in which a pin was inserted to precisely index
 210 the specimen for each scan.

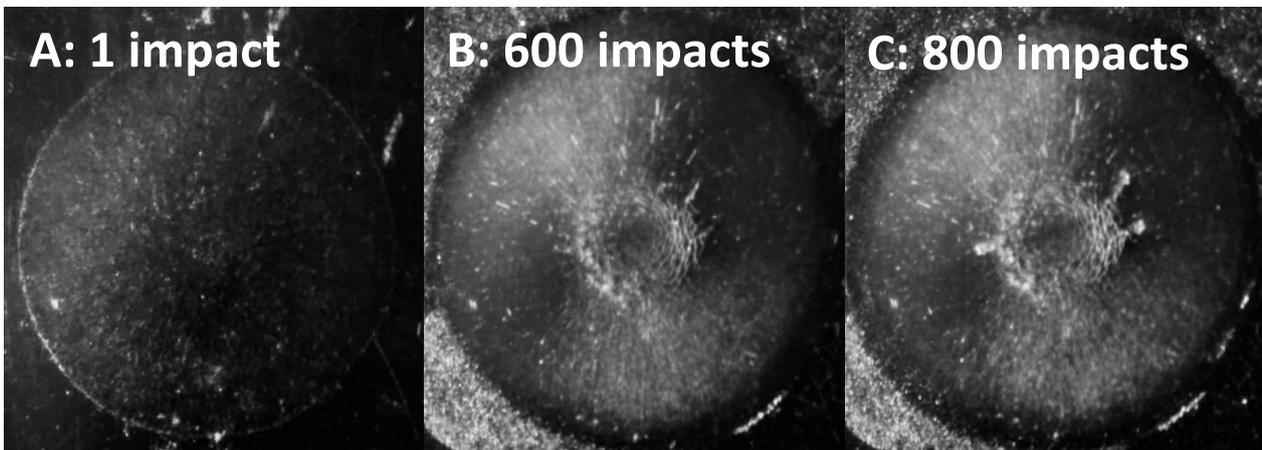
245 Figure 9. Images from the in-situ video capture showing different stages of testing impact speed 129.8 ± 0.82
246 m s^{-1} at impact frequency 2Hz. A: Impacted but visually undamaged. B: Impacted sample with circular crazing
247 evident in high-stress impact region. C: Impacted sample just after first material loss denoting the end of
248 incubation time.

255 From the captured visual data the incubation time was identified. End of incubation was determined by the
256 time at which the first material loss is observed denoting the onset of constant erosion (see Figure 9). In Figure
257 9, the image B exemplifies a sample close to the end of incubation, where a part of the coating is about to be
258 detached from the laminate. Hereafter, the partial removal of the coating is referred to as “damaged”.

259 Depending on the test conditions, the incubation time could be determined within 2-20 impacts. The higher
260 the impact speed, the more abrupt the change from un-damaged to damaged, whereas at lower impact speeds
261 the change was less abrupt. As seen in Figure 9, circular crazing is observed prior to erosion, and is consistent

279 After running several SPIFT series with AE sensing, it became apparent that a significant change was occurring
280 in the recorded AE signal for impact events at the immediate point where the coating was visibly damaged
281 (see image C in Figure 9). An example of the AE feature read-outs generated during one of these test series is
282 shown below.

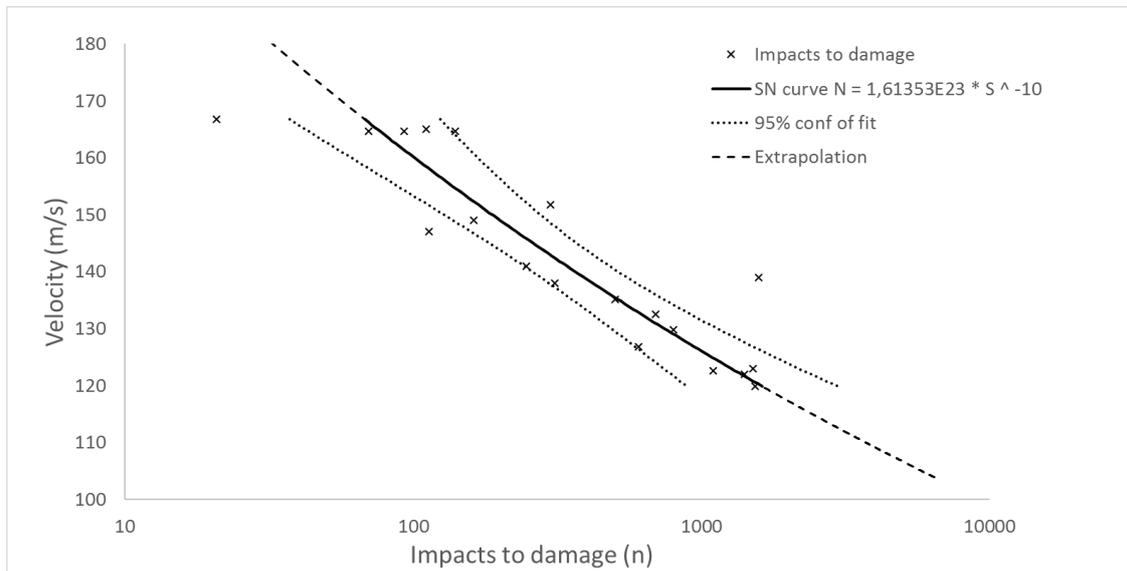
274
275 Figure 10. Semi-Log plot showing number of impacts to end of incubation at a set impact velocity fitted to a
276 power curve.

268 The data pairs (impacts to end of incubation, speed) are plotted in an SN or Wöhler diagram shown in Figure
269 10, where traditionally the independent parameter, velocity, is plotted on the vertical axis and the dependent
270 parameter, number of impacts before visible erosion, is plotted on the horizontal axis of a semi log. Such a
271 representation of data is known from fatigue testing of materials [17], where the number of load cycles causing
272 damage is shown as a function of the magnitude of each load cycle (for example stress range). The fatigue data
273 are fitted with a power function as shown in Figure 10.

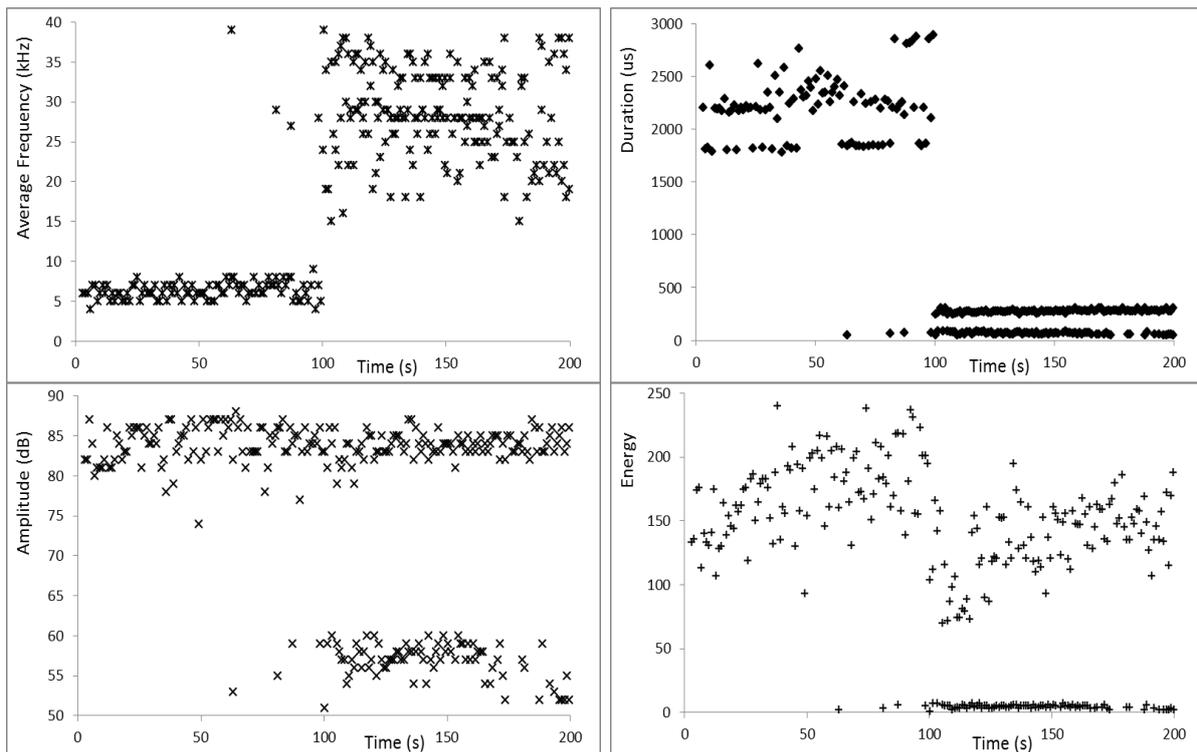
301 Figure 11. AE features during a typical SPIFT series at impact rate of 1 Hz; the coating is eroded after 100 s.

283 Figure 11 shows a sharp change in average frequency of the AE hits recorded during the SPIFT series occurring
284 at the point when the coating started to erode from the surface of the specimen. The group of hits from before
285 this point (coating intact) is distinct from the group of hits recorded afterwards (coating eroded).

286 Figure 11 also shows that there is a change in amplitude of the AE hits recorded during the SPIFT series at the
287 point when the coating is eroded from the surface of the specimen. In this case, the eroded coating results in
288 multiple hits being recorded for each rubber ball impact, similar to the problem described in section 2.5.
289 Ignoring these low amplitude secondary hits there is not a large change in amplitude following initial visible
290 coating damage.

293 A change in the energy of each AE hit recorded during the SPIFT series is observed at the point where the
294 coating is visually seen to be damaged. What is also apparent from this feature is that a progression can be
295 observed in the energy extracted from the AE hits as the impact series goes on. The energy content of the
296 individual hits seems to be increasing up until the point where the coating is damaged when a step change
297 (downwards) takes place. Following this, a similar progression of increasing energy for the individual AE hits
298 is again observed.

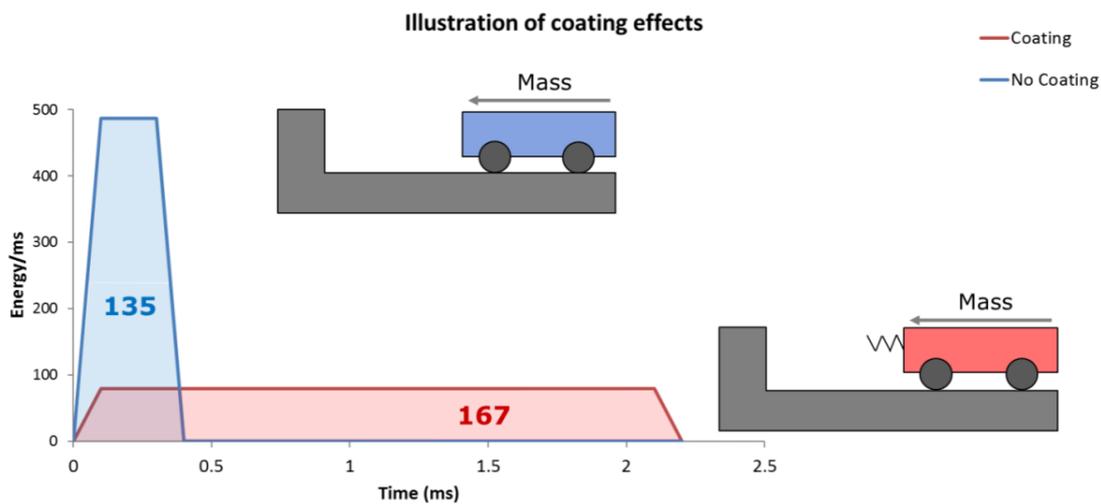
326 Figure 12. Coating effects illustration, comparison to crumple zone.

328 Illustrating the phenomena visually in Figure 12, we can see that although the hits on the specimen when the
 329 coating is intact contain slightly more absolute energy, this energy is distributed over a significantly longer
 330 period of time (over 2 ms) at a rate of 79 units of energy per ms. Whereas the hits when the coating is removed
 331 record energy at a rate of 487 units of energy per ms for slightly less than 0.3 ms total duration.

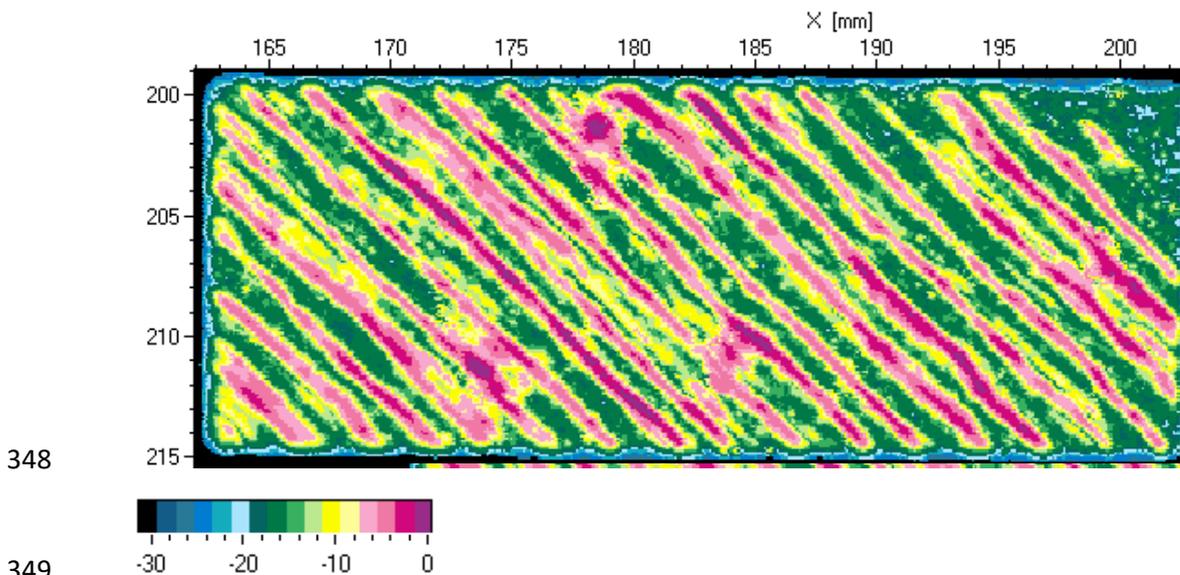
350 Figure 13. Ultrasonic scan from a specimen without impact damage (Specimen EMB-02). The 45° rovings of
351 the upper ply show as lines of low damping in the scan.

343 In Figure 13 a specimen was scanned before impact test. Reflection of ultrasonic waves happens when there
344 is a change in acoustic impedance Z . Using common values [9] for impedance Z of epoxy resins of between
345 $1.7\text{-}2.4$ (MPa s m^{-1}) and glass fibres $13.3\text{-}14.5$ (MPa s m^{-1}), it is clear that there is a significant difference in
346 impedance between the two materials. It is concluded in Figure 13 that the high signal area (yellow-magenta
347 lines) is the reflected signal form the first layer of fibres (45° oriented).

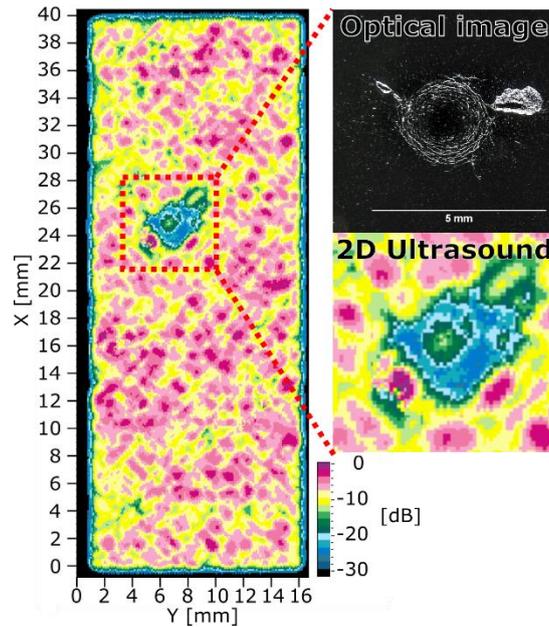
360 Figure 14. Scan from the specimen with impact damage from air gun overlaid with a visual image of the
 361 damaged sample. In the impacted area, there is a clear loss of signal compared to the surrounding area that
 362 shows the crosshatch pattern from the first and second glass fibre layers.

353 In Figure 14 the specimen was scanned after 140 impacts at 164 m s^{-1} . The scan shows the impacted area.

354 Looking closer at Figure 14 there is a circular area of light blue signal with a diameter of roughly 3mm. Despite
355 the sample having clear surface erosion damage, it is the area that shows circular crazing but no surface erosion
356 that influences the ultrasound scan most. Many factors can lower the strength of the reflected signal but likely
357 candidates are reflection or diffuse reflection of the incoming ultrasound signal as shown in Figure 7 in section
358 2.6.

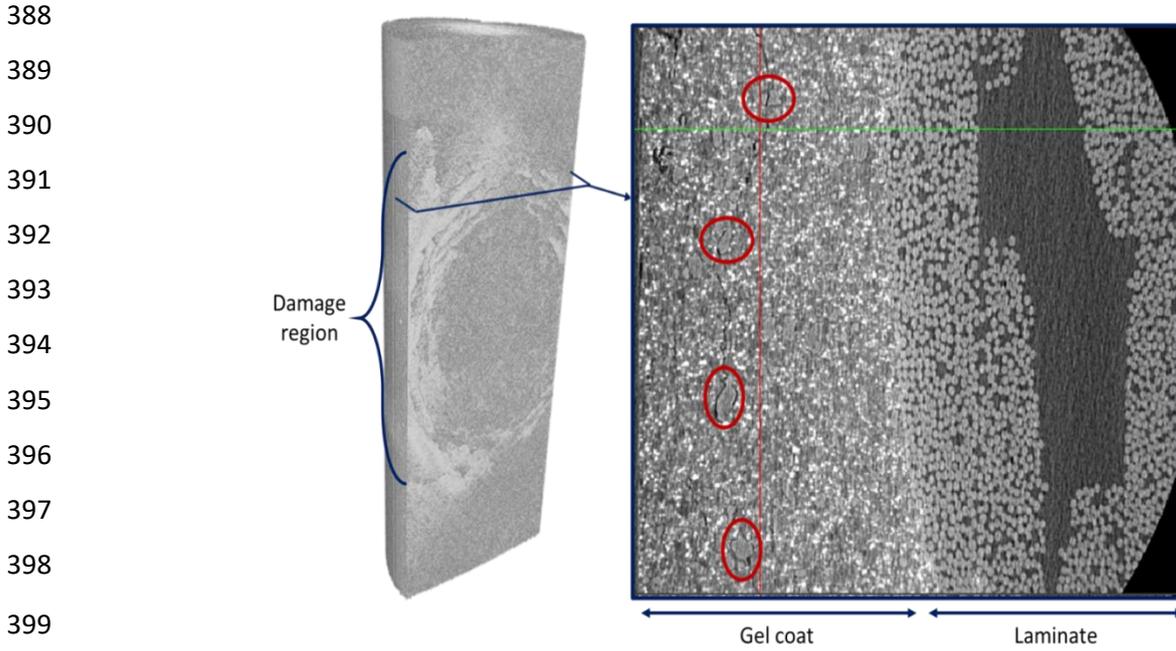
400 Figure 15. Damage mechanism in the gelcoat. Damaged region: 2.3-3.0 mm.

377 Damage mechanisms can be identified and followed using the 3D X-ray tomography. Figure 15 shows a 3D
 378 volume of the tested specimen. This scan is a superposition of three smaller scans (each 2 mm³). This procedure
 379 is called stitching and permits the study of a large volume with a small pixel resolution. The impact area is
 380 clearly observed and its diameter can be measured. It is found that several circular cracks were formed around
 381 the impact area.

382 First, the damage mechanisms appearing during single point impact fatigue need to be investigated in order to
 383 understand the failures. The observation indicates that this particular gelcoat includes large particle fillers that
 384 appear to be responsible for the crack initiation which occurred before visual damage of the partial coating
 385 removal. The fillers are acting as stress concentrating defects which facilitate the crack propagation within the

386 material (Figure 15). The total diameter of the damage region is 2.3 mm to 3.0 mm for this specific gelcoat
387 material.

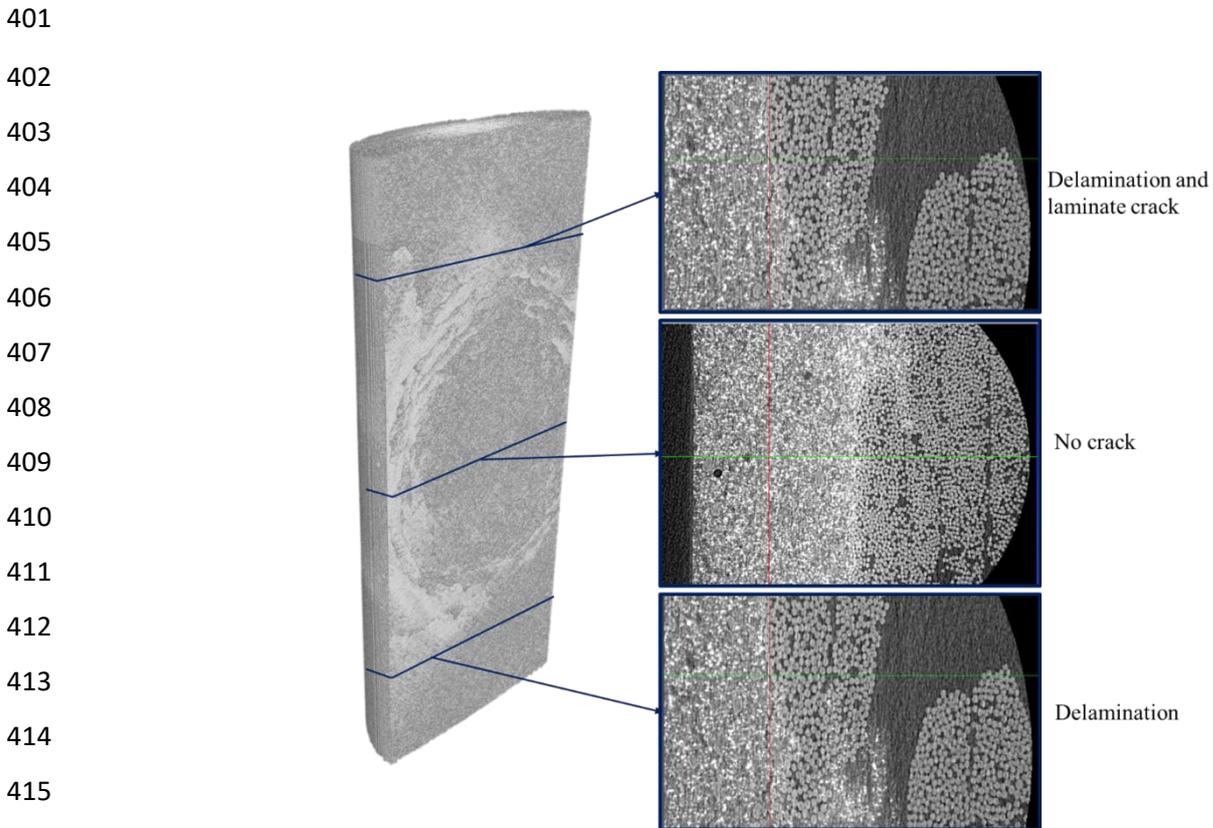
417 Figure 16. Damage localisation in the impact region.

418 A further study of the entire impact zone reveals an interesting phenomenon. At the centre of the impact zone,
 419 no cracks are identified in the gelcoat. Near the centre of the impact zone, there are no or only a few cracks.
 420 Moving from the centre towards the rim, the first cracks appear at around 75% of the outer diameter, and they
 421 increase in density near the edge of the zone. The cracks are ring-shaped at the surface of the gelcoat, and they
 422 extend into the gelcoat at an angle of 45° thus forming cone shaped crack surfaces. Outside the impact, cracks
 423 are running closer to the interface; delamination can be identified in this region (Figure 16). The conic shape
 424 of the impact cracks through the gelcoat thickness is to be expected and has been observed in other materials
 425 subjected to impact.

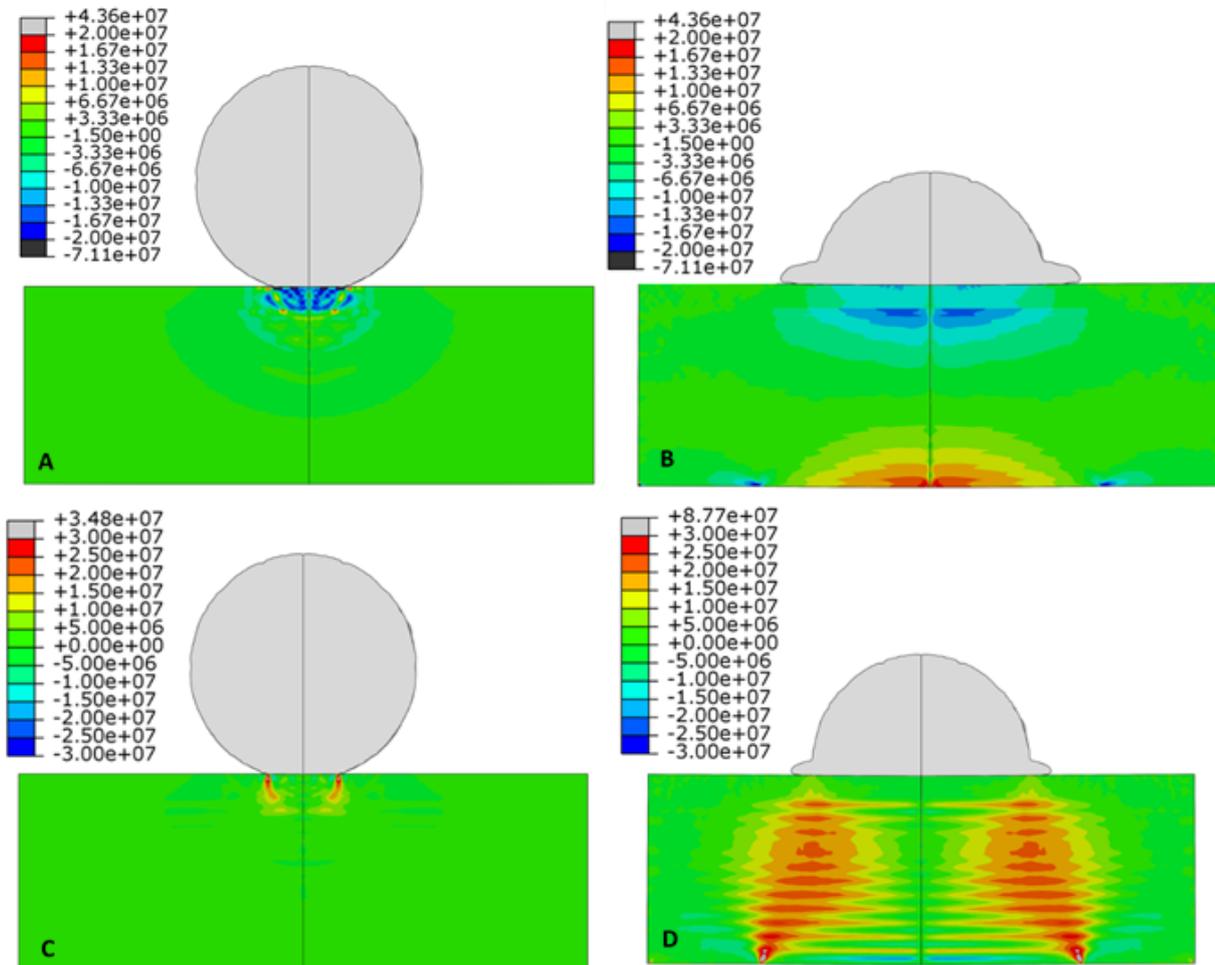
430 Figure 17. Stresses in the laminate under nitrile ball impact. A and B: σ_{11} stress at the transient (5 μ s), and
 431 quasi static stage (21 μ s). C and D: σ_{13} stress at the transient and quasi static stage.

433 The results of the simulations in tensile stress are shown in Figure 17. It can be seen that while at the beginning
 434 (transient stage of the impact), the highest stress is localised under the contact surface, at the quasi-static stage
 435 the high stress region forms in the depth under the surface. Similarly, rather high shear stresses form at the
 436 angle 30° to 45° under the contact surface.

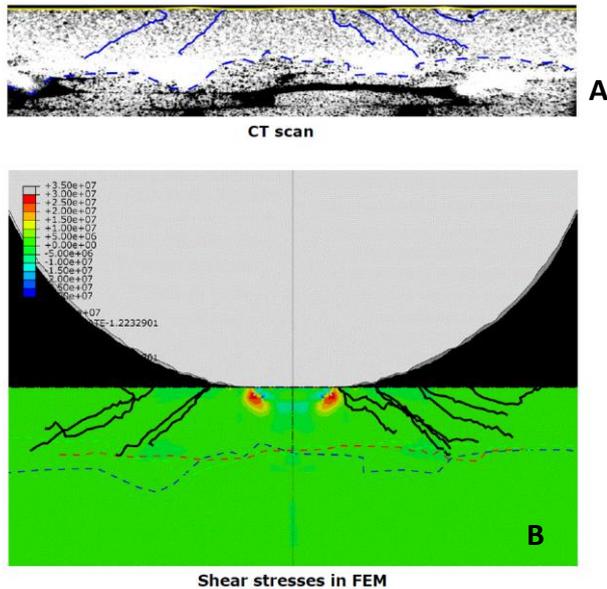
446 Figure 18. Comparison of the cracks observed in CT scan and the shear stress distribution as well as
447 delamination between the laminates and coating represented by the dashed lines. The blue lines in Figure A are
448 drawn on top of the observed cracks and superposed in B together with lines coming from two more tested
449 samples.

440 The results of simulations have been compared with experiments. CT scanning of the specimens revealed
441 cracks in gelcoat at 30 to 45° relative to the surface as shown in Figure 18. The cracks observed in the scan are
442 in agreement with the FEM simulation the shear stresses is also presented.
