## Pull-out behaviour of steel fibres in cracked concrete under wet–dry cycles – deterioration phenomena

**Marcos-Meson, V.; Solgaard, A.; Skovhus, T.L.; Jakobsen, U.H.; Fischer, G.; Edvardsen, C.; Michel, A.**

*Published in:*  
Magazine of Concrete Research

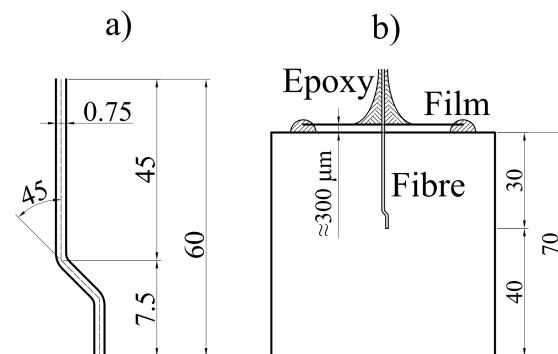
**Fig. 1.** Dimensions of a) steel fibre and b) pull-out specimen. Dimensions are expressed in mm. After [9].

The pull-out specimens investigated were cast using the mix-design presented in [9]. The total binder content was 426.3 kg/m<sup>3</sup> with 31 -wt.% fly ash replacement of the Portland cement, and the water to binder ratio was 0.34, see **Table 1**. The superplasticizer content was adjusted in the subsequent mixes to reach a flow diameter of 120±20 mm, measured according to EN 1015-3:1999 [21] and the air-entrainer content was adjusted to reach a level of entrained air of 3.0±0.5 vol.%, measured according to EN 413-2:2016 [22]. The steel fibre investigated was made of cold-drawn carbon-steel wire with a characteristic tensile strength of 1800 MPa, hooked ends (type 1 according to EN 14889-1:2006 [23]), a length of 60 mm and a diameter of 0.75 mm, see **Fig. 1a**.

The specimens exposed to saltwater and freshwater were partially pulled-out up to a slip value of 0.15 mm before the exposure. The upper surface of the specimens was covered with a 50×50 mm acetate film, leaving a separation between the film and the concrete surface of approx. 0.3±0.1 mm, mimicking exposure of a single fibre in cracked concrete environment. The part of the fibre exposed to the surface out was covered with heavy-duty marine-grade epoxy paint, see **Fig. 1b**.

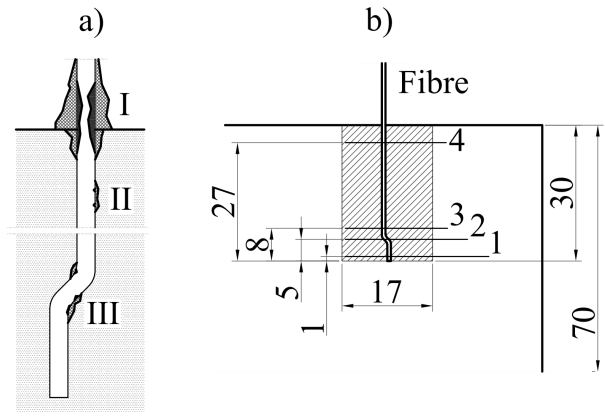
**Fig. 2.** Location of inspection areas of specimens: a) inspection areas for 3D optical profiles, after [9], and b) location of thin-sections and inspection area of polished sections.

interferometry profiler (Keyence VR-3000 G2) with a resolution of 0.1  $\mu\text{m}$ . The inspection was done on three locations of the fibre, shown in **Fig. 2a**: I) the steel exposed to the solution inside the artificial crack, II) the central part of the fibre stem, III) the intermediate part of the hook.

shown as a shaded area in **Fig. 2b**. The preparation process comprised: i) sawing of the specimen longitudinal to the fibre, at approx. 1 mm to the surface of the fibre, ii) vacuum resin impregnation, iii) grinding of the specimen surface until reaching the steel fibre, iv) vacuum resin impregnation, v) lapping and polishing until reaching the central axis of the fibre.

Thin-sections were prepared on four consecutive slices, perpendicular to the direction of the fibre, at the locations shown in **Fig. 2b**. The preparation process consisted on: i) sawing off four slices perpendicular to the direction of the fibre, ii) vacuum resin impregnation, iii) mounting of four slices into one section, iii) subsequent grinding, lapping and polishing to prepare the thin-section.

The inspection of the specimen exposed to wet-dry cycles of saltwater was done at the locations described in **Fig. 2**: I) at approximately 2 mm from

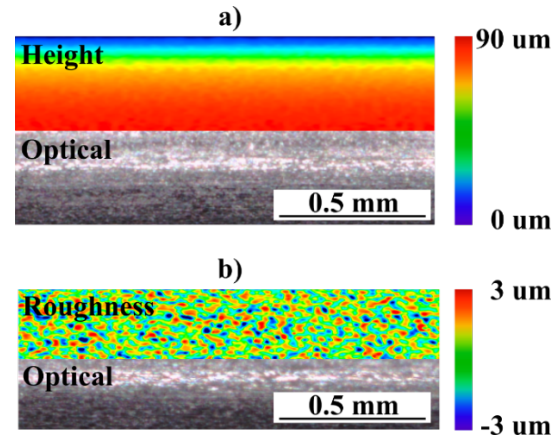
**Fig. 3.** 3D scans of fibre surface embedded in concrete, at the fibre stem, showing: a) original 3D scan with height profile, b) flattened surface with roughness profile.

Inspection of the surface roughness of the embedded fibre parts was done on a flattened profile, levelled to the mean profile of the 3D scan (as shown in **Fig. 3**). The analysis was done on two representative locations of the steel fibre: at the fibre stem (see **Fig. 5a-b**) and at the straightened part of the hook after pull-out (see **Fig. 5c**). Surface roughness parameters calculated according to (ISO 25178-2: 2012) are presented in **Table 3**.

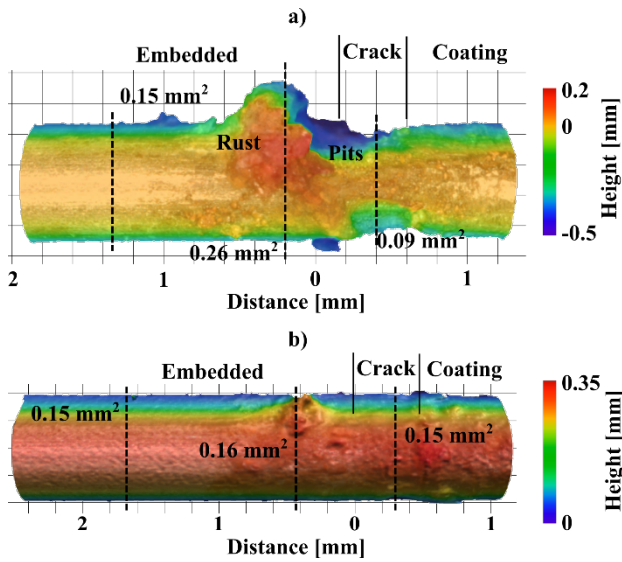
**Fig. 4.** 3D scan of fibre exposed to saltwater at the intersection with the crack for: a) specimen exposed to saltwater wet-dry cycles, and b) specimen exposed to freshwater wet-dry cycles. The colour map shows the relative height of the surface. The scanned cross-section at three locations was calculated in  $\text{mm}^2$  (the cross-section inspected was approx. 1/3 of the total cross-section of the fibre).

inside the matrix. Formation of corrosion products (i.e. rust) in this area for the specimen exposed to saltwater, led to an effective increase of the fibre cross-section (i.e. up to  $\approx 70\%$  increase in cross-section), see **Fig. 4a**. Alongside, there was a substantial reduction of the fibre's cross-section exposed inside the crack (i.e. up to  $\approx 40\%$  reduction of cross-section), which spread slightly into the matrix and the epoxy coating. This was not the case for specimens exposed to freshwater, see **Fig. 4b**, which showed a minor variation in the fibre cross-section due to corrosion.

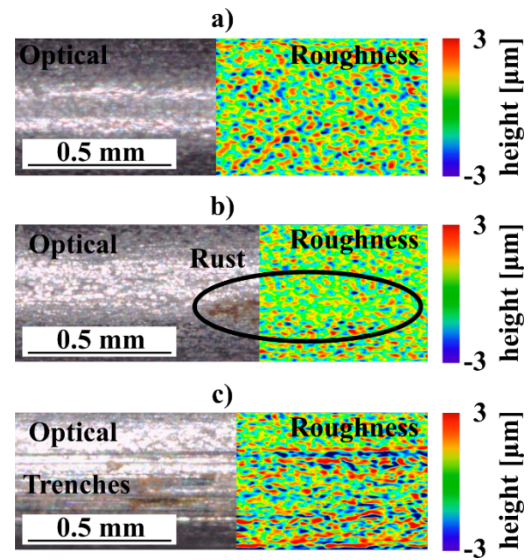
**Fig. 5.** 3D scans of fibre surface embedded in concrete: a) surface roughness at the stem of an exposed fibre (2S-I); b) surface roughness around a rust spot at the stem of an unexposed fibre (4S-I), c) surface roughness at the straightened section of the hook of a pulled-out fibre (2S-II).

The steel surface showed a generally uniform distribution of peaks and pits at the steel surface, see **Fig. 5a**. Localized areas presenting rust stains were found in exposed and unexposed specimens, in the latter these were attributed to oxygen corrosion during storage, handling and preparation of the specimens. Yet, the presence of rust spots did not alter substantially the average roughness measured of the inspected surface, slight decrease of roughness was observed instead (see **Fig. 5b**). Conversely, there was a clear difference in roughness of the fibres after pull-out in the hook region, as shown in **Fig. 5c**. The steel presented deep longitudinal “trenches” at the straightened hook, which can be attributed to the friction between the steel surface and the surrounding matrix during the pull-out process. Thus, indicating that this area transferred most of the friction during pull-out. The roughness parameters presented in **Table 3** confirm that, at the fibre stem, fibres are similar to each other, regardless of the exposure conditions; while major increase in roughness was measured at the hook region of pulled-out fibres, regardless of the exposure conditions as well.

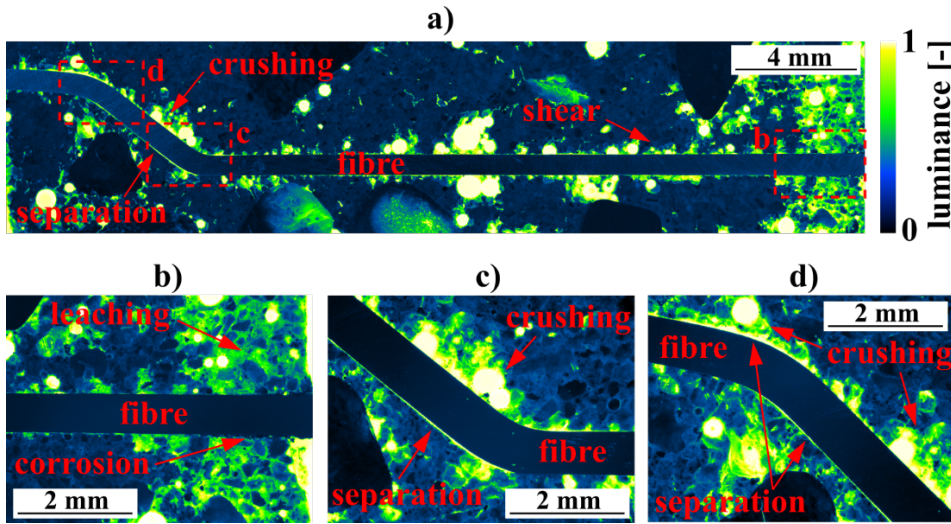
**Fig. 6.** Polished section of partially pulled-out steel fibre, exposed to freshwater wet-dry cycles (specimen 2P), showing relative UV luminance values for: a) overview of the fibre with indication of local damage; b) intersection of the fibre with the artificial crack; c) first bend of the hook; d) second bend of the hook. The annotations in red indicate damage and features observed in the section under visible and UV light up to x5 magnification.

partially-pulled fibre is shown in **Fig. 6** as the relative luminance values of a micrograph under UV fluorescent light. The results show areas with voids, higher porosity or mechanical damage in light green/yellow colour and denser areas in darker blue colour.

The results presented in **Fig. 6a** show that there is an increase in porosity at the outermost 2 – 3 mm of the specimen, inside the artificial crack, which are attributed to leaching and carbonation of the matrix during the exposure. In this case, there is accumulation of corrosion products at the outermost 2 mm of the fibre, which block separation damage and pores in the matrix around this part of the fibre, see **Fig. 6b**. There is substantial porosity and damage along the stem of the fibre, yet the damage does not seem to form a continuous path along the fibre stem, see **Fig. 6a**. Most of the mechanically-induced damage to the matrix concentrates around the fibre hook, see **Fig. 6a**. The side of the hook that faces the pull-out direction generally presents crushing damage, while the opposite side is separated a few micrometres from the matrix, as shown in **Fig. 6 c,d**. This damage is localized around the hook bends, see **Fig. 6c,d**. There was no indication of additional transformation of the matrix around the fibre due to exposure at this scale, e.g. autogenous healing or carbonation of the cement paste.

with this method. Part of the additional porosity observed at the outermost section (**Fig. 7a**), may be as well linked to leaching processes in the matrix adjacent to the crack, as shown in **Fig. 6a**.

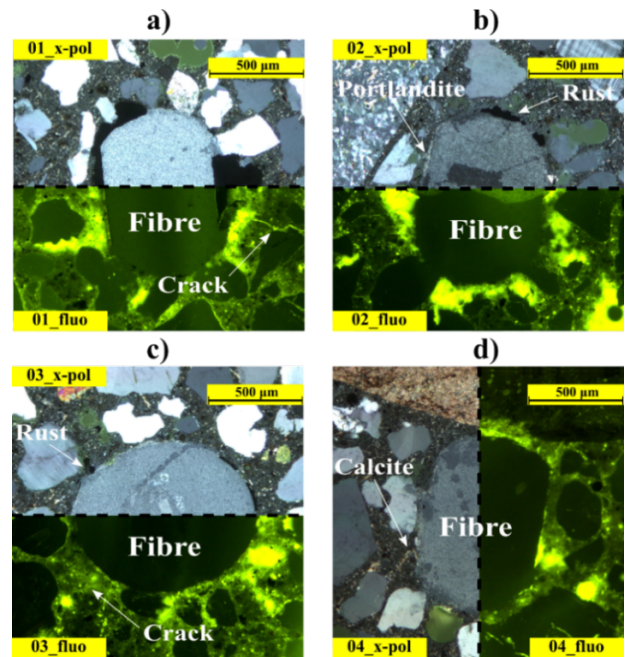
**Fig. 7.** Thin-section of partially pulled-out fibre exposed to saltwater (specimen 1T), under cross-polarized and UV fluorescent light, at selected locations: a) at the intersection of the fibre with the simulated crack (location I); b) at the stem of the fibre (location II); c) at the centre of the fibre hook (location III); and d) at the end of the fibre hook (location IV). Locations correspond to the ones described in **Fig. 2**.

Results from the inspection of thin-sections are presented for selected cross-sections of the fibre in one specimen exposed to wet-dry cycles of saltwater (see **Fig. 7**), and selected features of various exposed and unexposed specimens (see **Fig. 8**). The micrographs presented comprise overlays of the inspected areas under cross-polarized and UV-fluorescent light, denoted in the figures as “x-pol” and “fluo”, respectively.

the intersection of the fibre with the artificial crack (**Fig. 7a**), II) at the end of the stem, close to the first bend of the hook (**Fig. 7b**), III) at the second bend of the hook (**Fig. 7c**), IV) at the straight end of the hook (**Fig. 7d**).

The micrographs taken under UV fluorescent light show substantial mechanical damage at the matrix adjacent to the fibre, particularly at the hook bends (**Fig. 7b,c**) and at the intersection of the fibre with the crack (**Fig. 7a**). This damage generally comprises well-defined radial cracks smaller than 10  $\mu\text{m}$  (**Fig. 7a**), and overall increase in porosity (**Fig. 7b,c**). The latter may be related to crushing of the matrix around the fibre, which appears smeared in the thin-section and cannot be fully investigated at the scales observed

Corrosion products were found at the intersection of the fibre with the crack (**Fig. 7a**), filling porosity and damage around the fibre. There is also smaller accumulation of rust at some locations in the hook region, filling as well separation between the matrix around the steel, see **Fig. 7b,c**. Portlandite and calcite were observed at the interface between the matrix and the fibre, which correspond to dissolution and precipitation and of calcium-based phases (i.e. reprecipitation), that eventually carbonated.

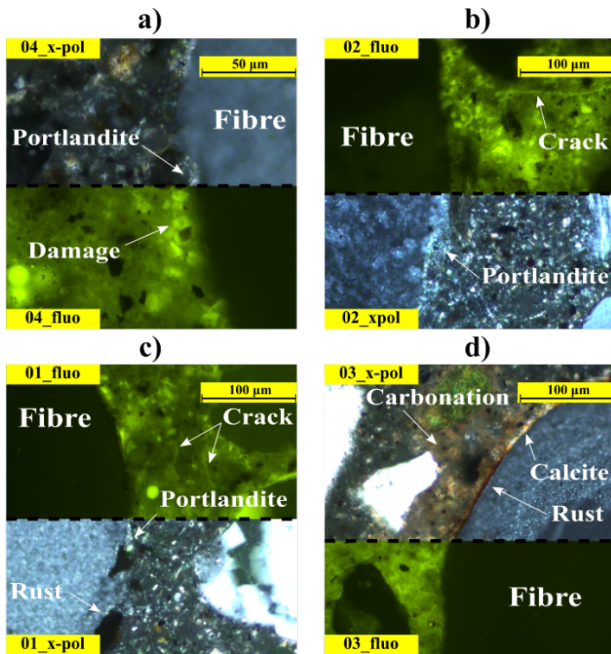
**Fig. 8.** Thin-section of steel partially pulled-out fibre under cross-polarized and UV fluorescent light, for selected exposures: a) unexposed specimen (specimen 3T at location II); b) specimen exposed to freshwater (specimen 2T at location III); c) specimen exposed to saltwater (specimen 1T at location II); and d) specimen exposed to saltwater (specimen 1T at location III).

A closer inspection of the damage and reprecipitation processes at the interface between the fibre and the matrix is presented in **Fig. 8**. The interface of an unexposed fibre, see **Fig. 8a**, generally did not show a distinctive microstructure compared to the bulk paste or the interface of an aggregate; nonetheless, local defects such as pores or mechanical damage were also found. There was limited mechanical damage to the matrix around the stem of the fibre (**Fig. 8a**), which presented minor re-precipitation of cryptocrystalline portlandite in some cases. In the case of the exposed specimens, most of the voids generated along the fibre surface during pull-out were generally lined with either cryptocrystalline portlandite (see **Fig. 8b**), and corrosion products (iron oxides) in fewer cases (**Fig. 8c**). Some locations

showed carbonation of the matrix around the fibre at damaged areas, where the interface and surrounding voids were filled by a combination of corrosion products and calcite (**Fig. 8d**).

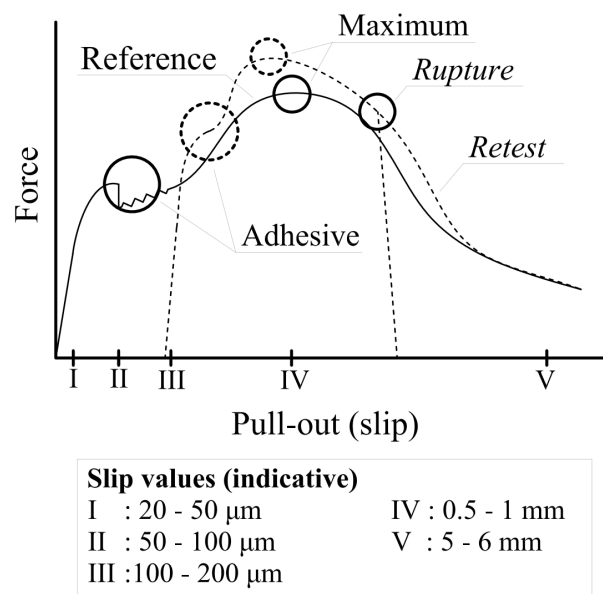
**Fig. 9.** Representation of changes in the pull-out forces transferred in partially pulled steel fibres exposed to wet-dry cycles, after [9].
