AQUADA: Automated quantification of damages in composite wind turbine blades for LCOE reduction

Published in:
Wind Energy

RESEARCH ARTICLE

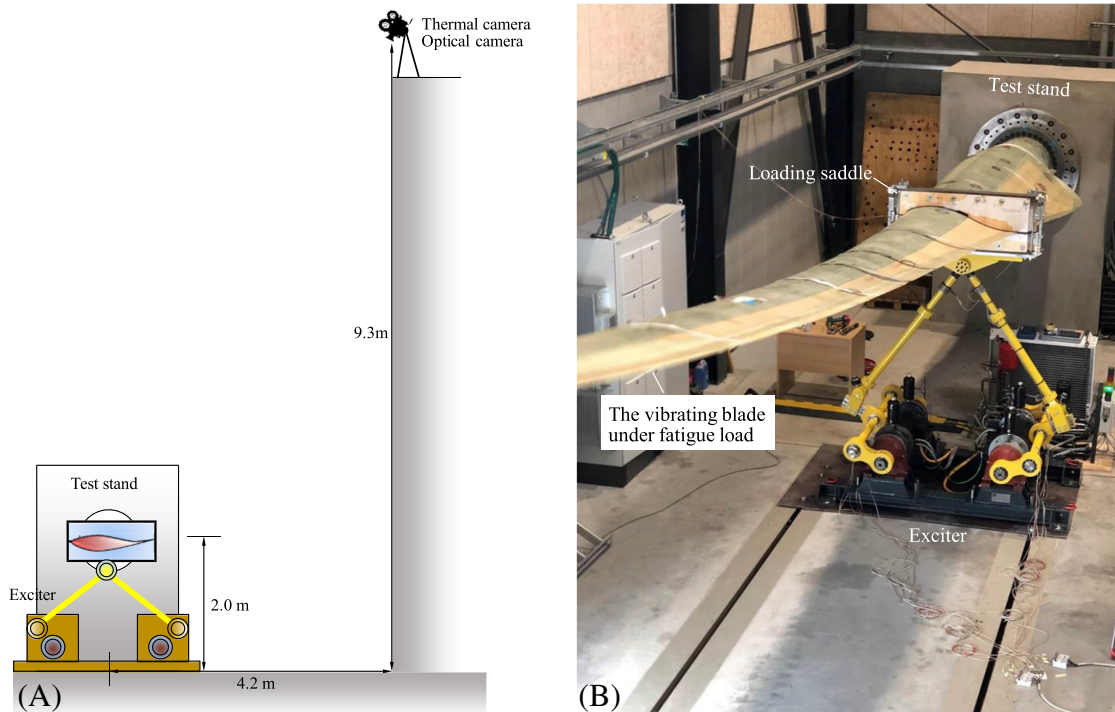
FIGURE 1 The test setup of the blade under a fatigue test. (A) The overall test setup viewed from the blade tip towards the blade root. The blade is mounted on a test stand with its suction side facing the ground. A thermal camera and an optical camera take images from 9.3 m above the ground. (B) The blade under biaxial fatigue that is excited by a ground-based dual-axis exciter. The exciter applies both flapwise and edgewise loading simultaneously to the blade, mimicking combined loading conditions of the blade in operation

We demonstrate the AQUADA method in the laboratory. A 14.3-m full-scale wind turbine blade is tested under biaxial fatigue that mimics more realistic combined loading conditions in operation. The test is conducted in the DTU Large Scale Test Facility, in which the temperature is constant. The blade is mounted on a test stand and is loaded by a ground-based exciter to simulate the operational load conditions of the blade in the field, see Figure 1. An infrared thermal camera is placed 9.3 m above the ground and measures the temperature of the blade during the test. A regular optical camera is placed at the same location to provide ground truth images for comparison. The distance between the thermal camera and the blade is comparable to the distances when a drone with a thermal camera is used in the field inspection with the turbine halted.¹⁸ Although no drone is used in this study, the test setups are made to mimic the inspection distance when the thermal camera is mounted on a drone.

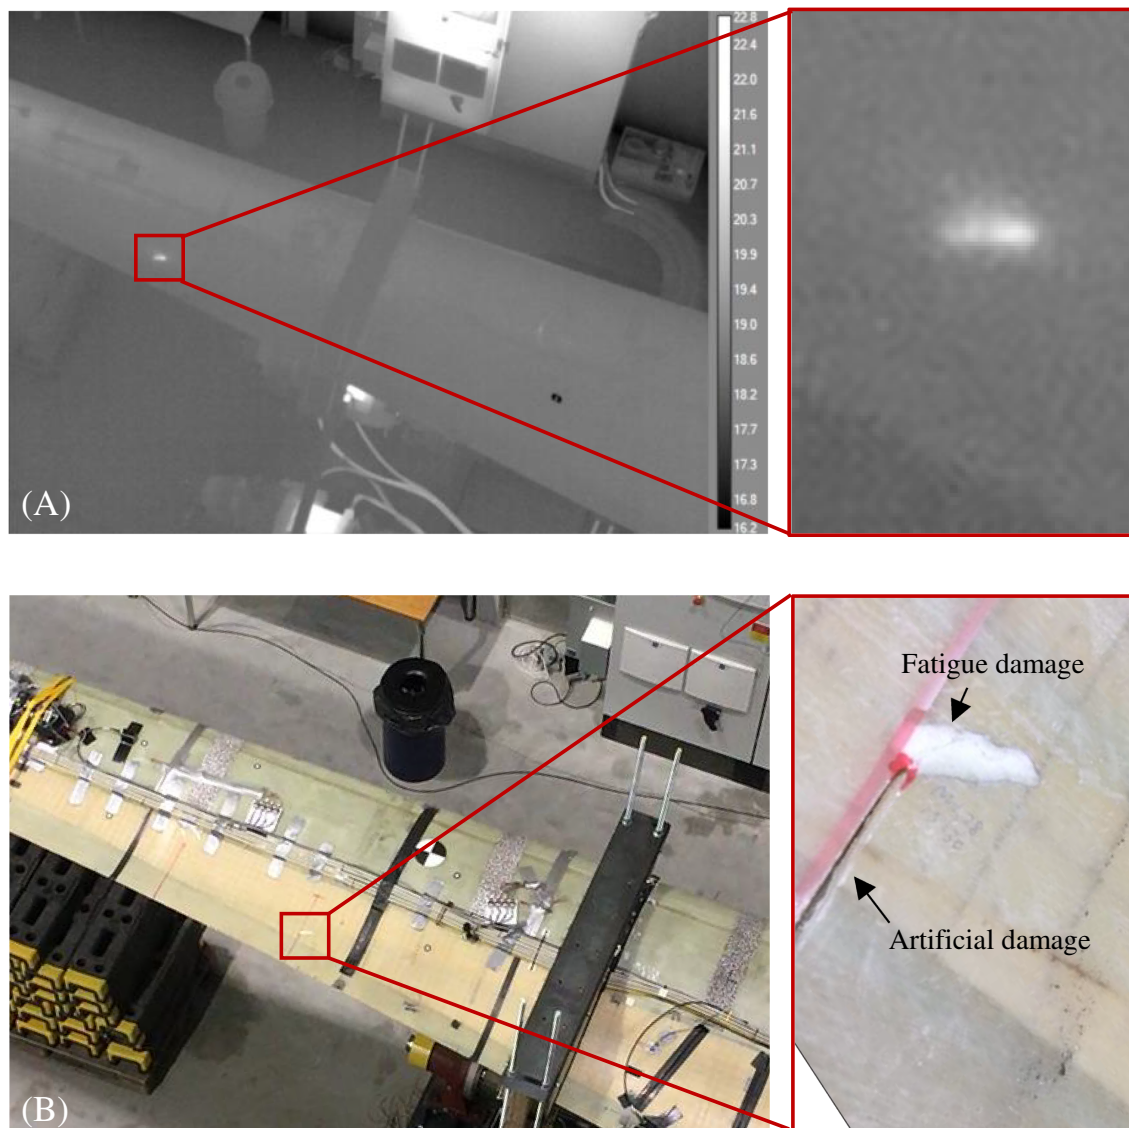
FIGURE 3 Fatigue damage initiates at the artificial damage during the blade test. (A) A thermal image of a local heat up at the tip of the artificial damage. Thermal footprints from the laboratory environment including the exciters are also captured in the image. (B) An optical image of the same location provides comparisons to the thermal image of the blade damage. Surface features, such as cables, markers, and tapes, that are prevalent in the optical image have negligible thermal footprints, making the blade damage under fatigue easy to identify

During the fatigue test, blade damages initiate from artificially introduced damages, sharp geometric transitions, and manufacturing-induced defects. When the blade damages progress, they generate thermal footprints due to rubbing and friction of materials along and inside cracks,^{20,21} which distinguish them from the surface features that are captured in optical images but irrelevant to the structural integrity. Figure 3 shows a comparison between a thermal and an optical image of a blade region where the artificial damage, that is, a transverse cut through the entire trailing edge, has been introduced. During the test, a hot spot appears in the thermal image due to a significant local heat up at the crack growing from the tip of the transverse cut. The hot spot has a higher temperature than the rest of the blade, making it is easy to be recognized. The blade

contains many surface features, such as cables, markers, and tapes, that are prevalent in the optical image but have negligible thermal footprints in the thermal image. It is difficult to identify the blade damage from the optical image without knowing its whereabouts a prior, but it is rather easy to locate the abnormalities from the thermal image. The actual geometry of the cracks agrees with that detected in the thermal image.

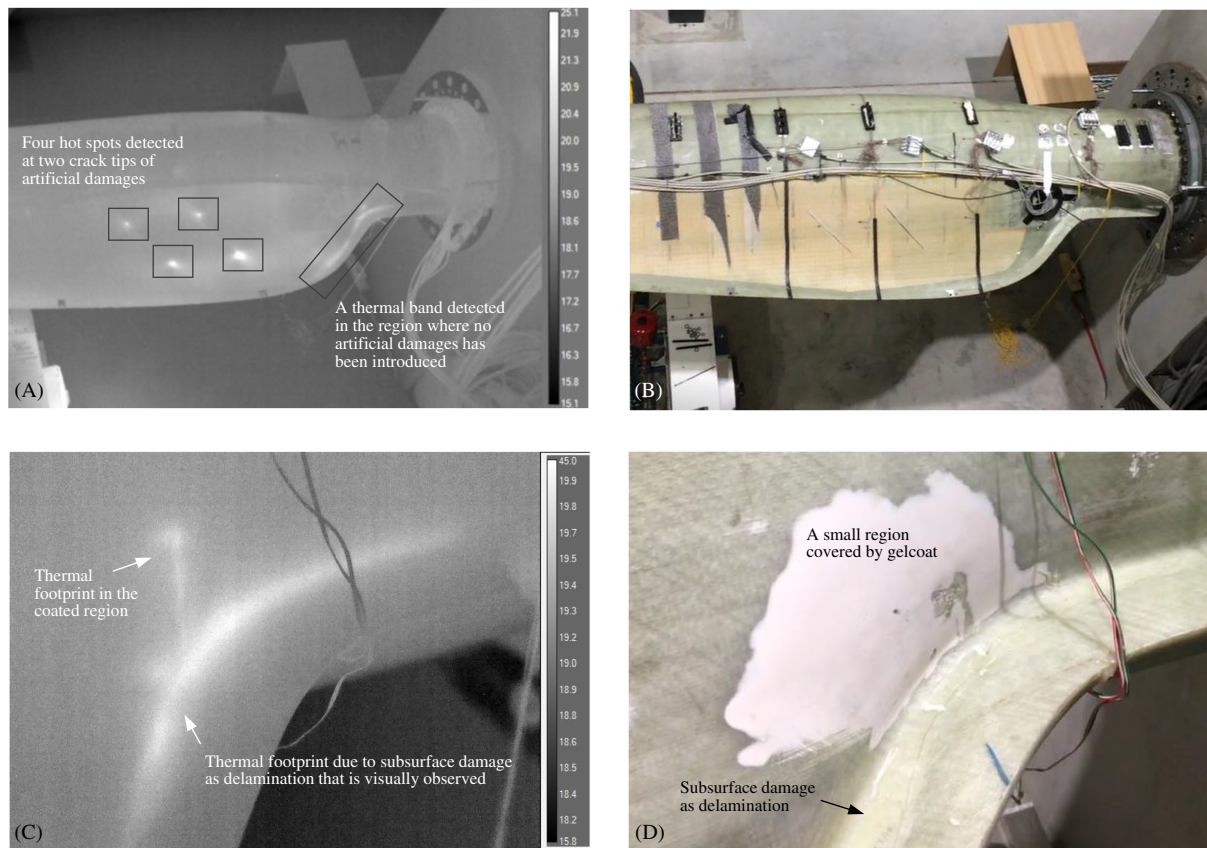
FIGURE 5 Blade damage detection in the blade root region during the fatigue test. (A) An overview of thermal footprints detected from multiple sites. (B) An optical image of the same region shows that the blade damages are unrecognizable amid many surface features. (C) A close-up of the thermal footprints shows two distinct thermal features, with one being the curved thermal band due to the visually apparent delamination and the other being a vertical band that is not visual due to the filler cover. (D) An optical image shows the visually apparent subsurface damage in the form of delamination and a small region covered by the filler. Actually, after a careful examination using a microscope, we found tiny surface cracks blinking in the coated region during the fatigue test. A significant vertical crack is found after the filler is removed and verifies the observed thermal footprint, see Figure 6

Other regions of the blade show similar results. Figure 5 shows the thermal images of the blade region close to the root with comparison to their counterpart optical images. Remarkably, four hot spots are observed at two cracks introduced as artificial damages in the sandwich panels, Figure 5A,B. Besides, two distinct thermal footprints are found in the root transition region of the blade, Figure 5C. These two thermal footprints are generated naturally during the fatigue test as no artificial damages have been introduced there. An optical image, Figure 5D, shows that one thermal footprint is due to the subsurface damage in the form of delamination while the other is covered by filler and is visually unrecognizable. Inspection after removing the filler finds out that here exists subsurface damage in the form of laminate fracture in a vertical direction, agreeing with the detected thermal footprint in this location, see Figure 6.

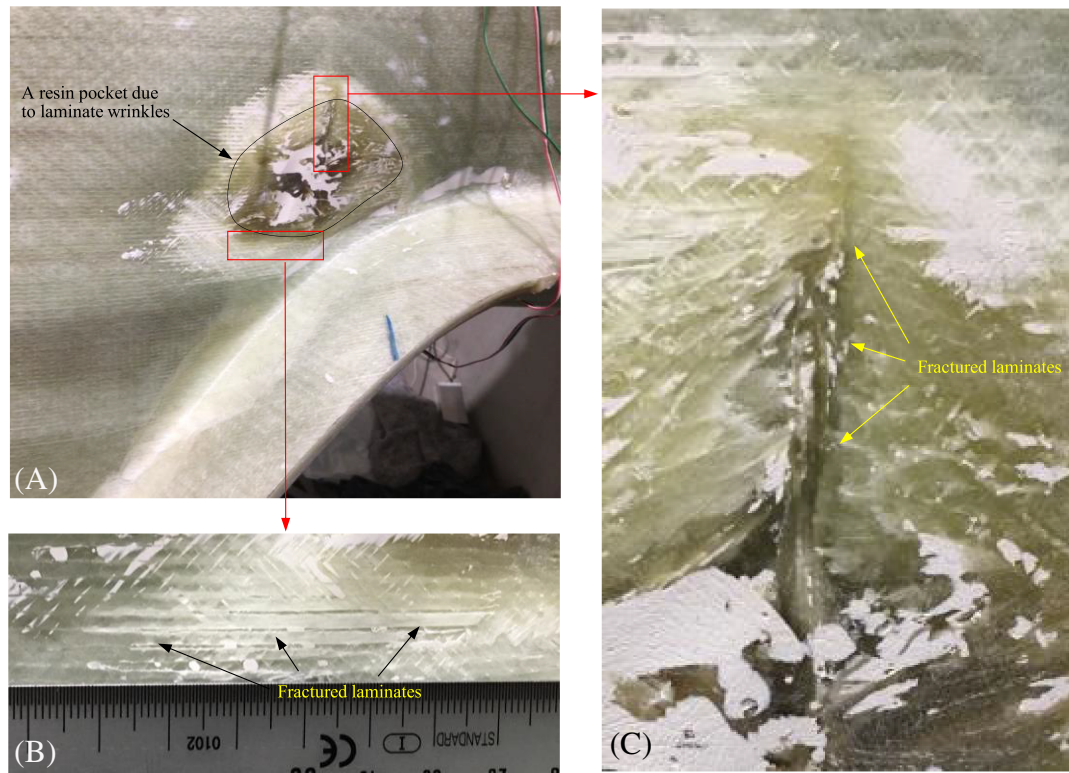
FIGURE 6 The close-up optical images of the region initially covered by the filler. The filler is removed to verify detection from the thermal images of Figure 5C. (A) The exposed region is found to have had a resin pocket due to internal damage in the form of laminate wrinkles induced during manufacturing. (B) The subsurface damage in the form of laminate fracture is observed as longitudinal cracks, which show noticeable, although not significant, thermal footprints in Figure 5C in the main manuscript. (C) The subsurface damage in the form of laminate fracture due to wrinkles runs vertically, leading to a significant thermal footprint that can be detected even when it was covered by the filler as shown in Figure 5C,D

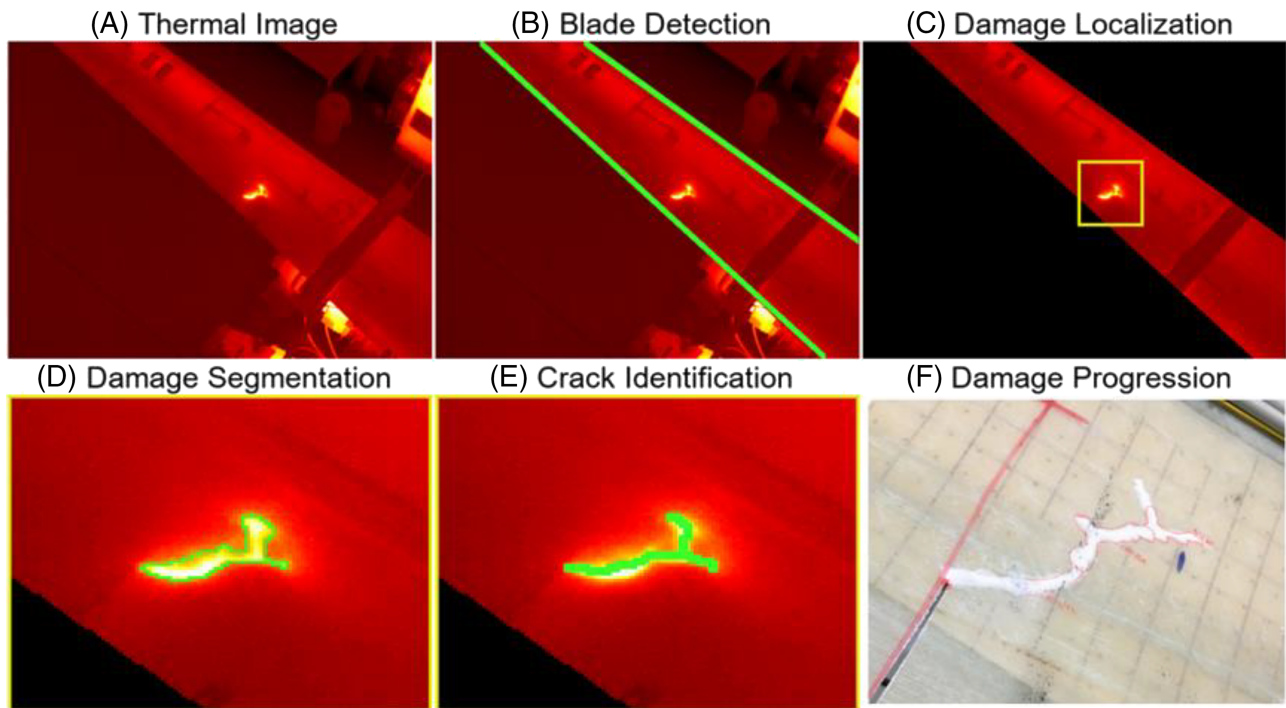
FIGURE 7 The automated analysis tool works on the thermal image. (A) the original thermal image taken from the thermal camera includes thermal footprints of the blade damage of interest, the exciter and the laboratory environment. (B) Detection of blade edges enables the identification of the blade within which the thermal footprints are of interest. (C) The damage is localized within the blade with other thermal abnormalities outside of the blade neglected. (D) Segmenting the damage based on intensity thresholding. (E) Identifying the crack by skeletonizing the damage segmentation to detail the damage geometry. (F) An optical image of the damage showing the detailed crack geometry agrees with the final result of the automated image process tool. All the thermal images are presented in a Redhot color map for better visualization and green colors are presented as positive detections

Manual vision analysis of thermal images for blade damages is challenging in nature as there can be other objects with higher temperature response in the images taken from field.²⁹ The thermal image in Figure 7A exemplifies this situation and shows significant thermal footprints from the exciter and the laboratory environment besides that from the blade damage of interest. First, we use Hough transforms^{30,31} algorithm to detect lines in images to identify two edge lines of the blade, Figure 7B. This technique identifies the location of the blade with more than 99% accuracy, for example, correctly in 744 frames out of 750 frames in this example. Next, within the region of the identified blade location, a high-temperature location is searched using intensity thresholding.³² The location of the hot spot indicates the detected blade damage, Figure 7C. Once the location of the damage is identified, the area around it is cropped to further investigate the area with more details. The blade damages in consecutive frames are segmented based on intensity thresholding³² Figure 7D and later are skeletonized³³ to capture its detailed geometry, Figure 7E. The final result of the automated image process tool agrees with the optical image as shown in Figure 7F.

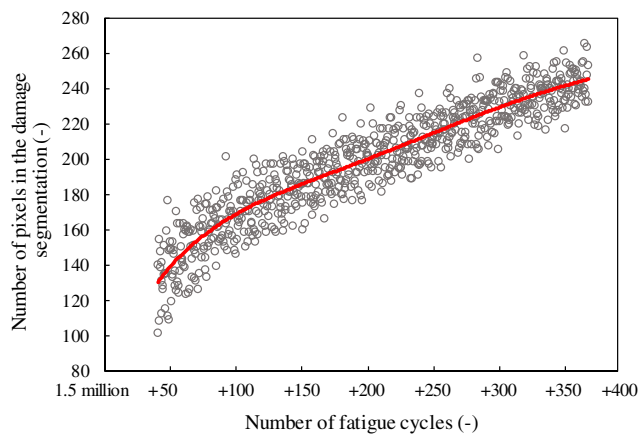
FIGURE 8 Scatter plot of the number of pixels in the damage segmentation with the increase of the fatigue cycle number. A fifth-order polynomial fitting shown in a red curve shows the gradual growth of the damage size. Noting the slope of the curve remains the same after the initial fatigue cycles. See Video S1

Considering that the damage progresses under fatigue and so does the size of its thermal footprint, we measure the size of the damage in the number of pixels within the damage segmentation in each thermal image video frame. After the blade is tested under fatigue for approximately 1.5 million cycles, we apply the automated image process tool to the thermal image video and count the number of pixels in the damage segmentation, see Figure 8. The data points show the size of the damage in the number of pixels changes with the number of fatigue cycles when the thermal image video is taken. A regression curve with a polynomial of fifth order is plotted in red color and it characterizes the damage growth

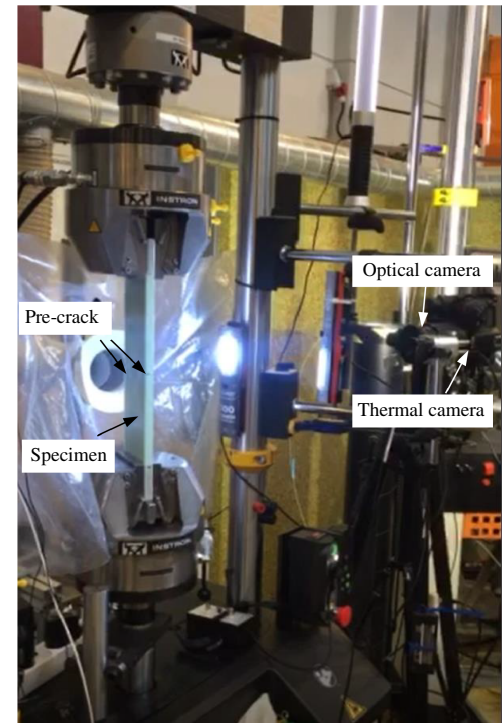
FIGURE 9 Validation test. The precracked sandwich specimen under fatigue loading with an optical and thermal camera taking images in the entire test. The damage state of the specimen is mechanically measured with the increase of fatigue cycles. The measured damage state is compared with the one quantified using the developed image process tool. In total, six specimens are tested and all results showed a similar trend to the one presented in Figure 10. The detailed test validation campaign will be published in a separate work as it is outside of the scope of the current focus in this study

To prove that the damage state quantified by the thermal image process tool truly reflects the actual physical damage, we conduct material tests and compare the mechanically measured damage state to that obtained from the image process tool. Six precracked sandwich specimens similar to these used in the blade are tested under uniaxial fatigue, see Figure 9. Six sandwich specimens are made by vacuum infusion using biaxial glass fiber fabrics, PVC foams, and epoxy, that is, $[\pm 45_2/\text{Foam}/\pm 45_2]$. The nominal size of the specimens is 100 mm \times 400 mm \times 13 mm. They are precracked and three sandwich specimens are painted whereas the other three are unpainted. Tension-tension fatigue is applied to all specimens with $R = 0.1$. The stiffness of the specimens at the i th cycle is the slope, E_i , from the linear regression of the measured stress-strain curve. The stiffness loss is defined as $1 - E_i/E_0$, where E_0 is the initial stiffness. The damping of the specimens, D_i , is defined by the normalized energy loss in the material during the i th cycle, and it is measured by the area of the stress-strain hysteresis divided by the reference area based on the

amplitudes of the strain and the stress of the i th cycle. A thermal camera takes thermal images regularly throughout the fatigue test until the specimens fail. An RGB optical camera is synchronized to take optical images for the ground-truth comparison. The thermal image process tool quantifies the damage state which agrees with the stiffness loss and the damping measured during the fatigue.

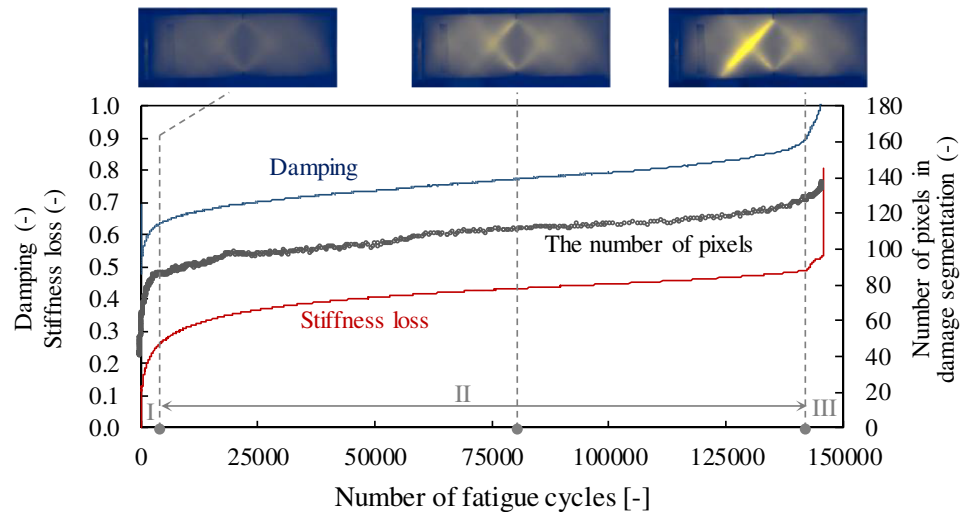
FIGURE 10 The damage state quantified by the image process tool agrees well with the stiffness loss and the damping of the specimen that are mechanically measured from the test. Three distinct phases, I: start, II: stable, III: fail, are observed during the fatigue life shown together with typical thermal images. A constant slope of the curve indicates a stable damage growth in phase II, in which an increase of slope characterizes a phase III response as the specimen approaches failure

The damage state of the specimens is measured as the degradation of mechanical properties, that is, the stiffness loss and the increase of damping with the number of fatigue cycles. Thermal images of the specimens under fatigue are taken and processed using the developed tool to count the number of pixels in the damage segmentation. Figure 10 shows the results from one exemplary specimen. It can be seen that the damage state quantified by the tool agrees well with two mechanical measurements during the entire fatigue life, proving that the developed tool can be used as a reliable quantitative remote measurement of the physical damage state.
