AQUADA: Automated quantification of damages in composite wind turbine blades for LCOE reduction

Published in:
Wind Energy

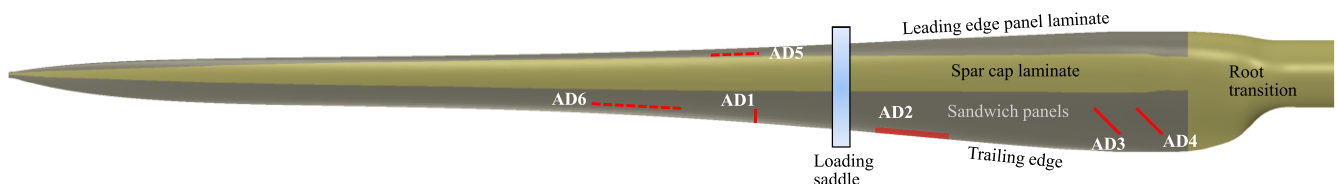
FIGURE 2 The artificial damages (AD) introduced in the blade. They are produced by cutting laminates, sandwich panels, and adhesive bondlines using a diamond saw. The focus of the test is to examine the thermal footprints of progressive damages, so it is considered to be less important how the damages were introduced. Only the artificial damages on the pressure side facing the cameras are investigated by thermal imaging in this study and they are depicted with solid lines. The blade is encastered on a test stand and fatigue loaded at 5.3 m where a loading saddle is connected to the ground-based exciter

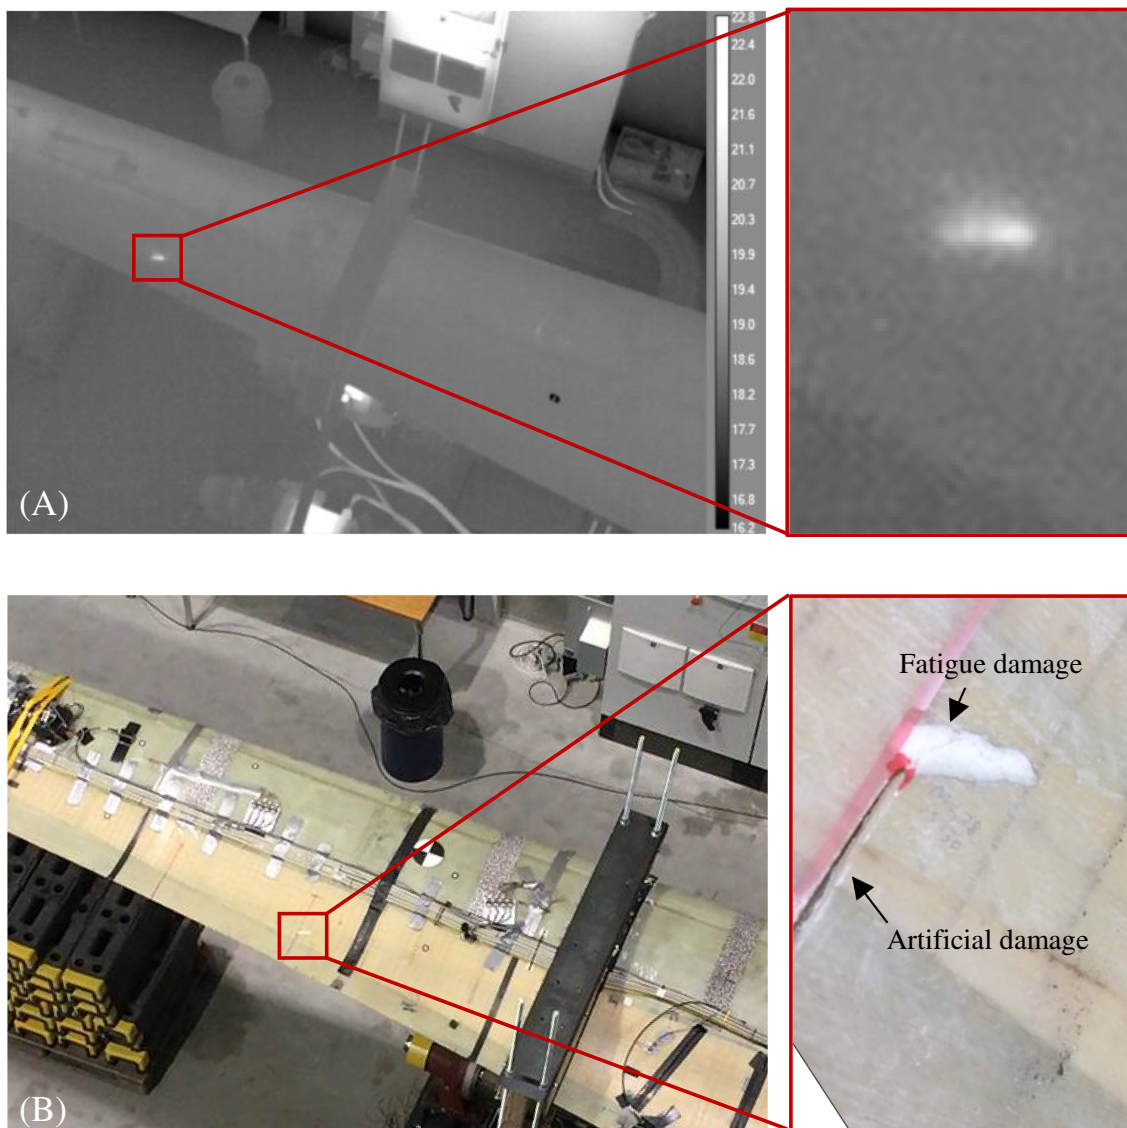
FIGURE 3 Fatigue damage initiates at the artificial damage during the blade test. (A) A thermal image of a local heat up at the tip of the artificial damage. Thermal footprints from the laboratory environment including the exciters are also captured in the image. (B) An optical image of the same location provides comparisons to the thermal image of the blade damage. Surface features, such as cables, markers, and tapes, that are prevalent in the optical image have negligible thermal footprints, making the blade damage under fatigue easy to identify

contains many surface features, such as cables, markers, and tapes, that are prevalent in the optical image but have negligible thermal footprints in the thermal image. It is difficult to identify the blade damage from the optical image without knowing its whereabouts a prior, but it is rather easy to locate the abnormalities from the thermal image. The actual geometry of the cracks agrees with that detected in the thermal image.

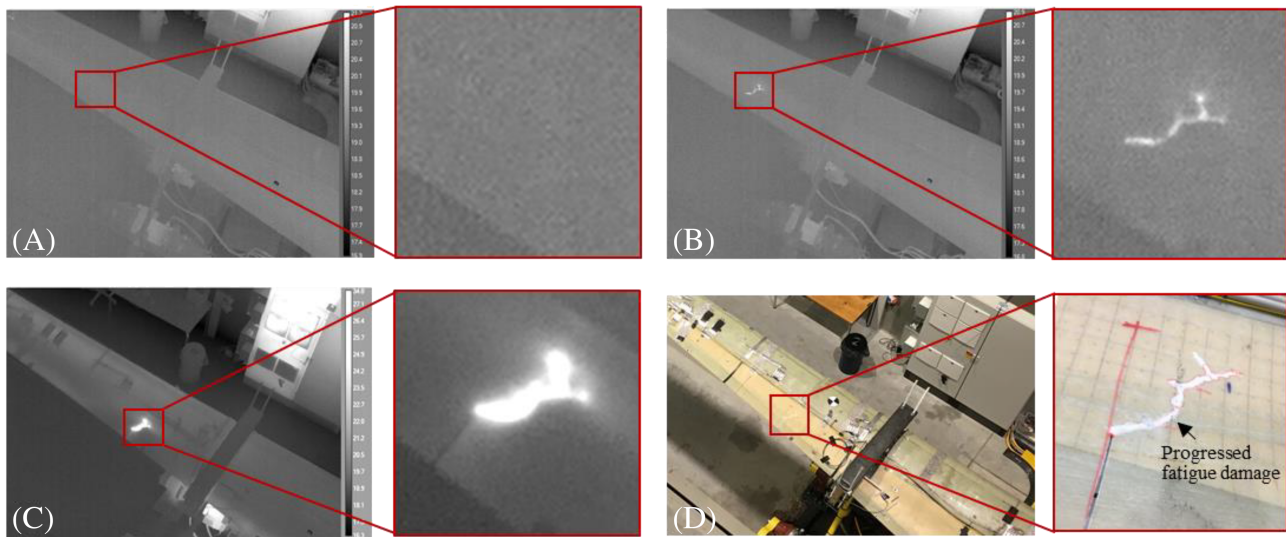
FIGURE 4 The thermal and optical images of the blade with progressed damages. (A) No thermal footprints is observed when no fatigue load is applied to the blade. (B) Soon after the fatigue test, the thermal contour shows the progressed damage compared to the previous observation when the blade is less fatigued. (C) The damage continues to progress and dissipate heat to the adjacent materials, prompting the increase of the damage size. (D) An optical image of the progressed damage showing that the complex geometry of the progressed damage is well captured by the thermal image

The blade damage progresses during the test. Figure 4 shows the thermal images of the blade in the same region with considerably progressed damage. When no fatigue loading is applied to the blade, no temperature variation is observed around the damaged region, Figure 4A. A short time after the fatigue loading, a clear thermal footprint appears with a larger size than the one detected when the blade is less fatigued, Figure 4B. Continuing fatigue loading causes the area of the thermal contour to increase due to more heat generated at the crack front where the crack is growing, prompting further damage progress. Figure 4C. An optical image of the damage, Figure 4D, shows that the thermal image captures the actual geometry of the progressed fatigue damage quite well.

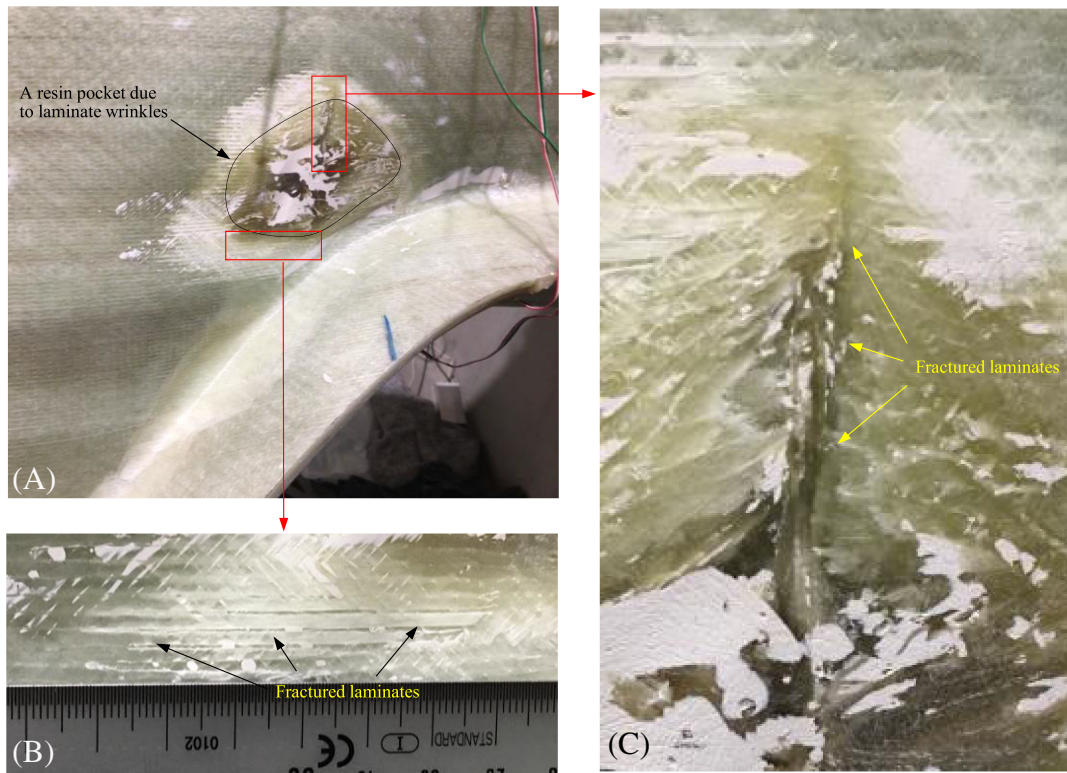
FIGURE 6 The close-up optical images of the region initially covered by the filler. The filler is removed to verify detection from the thermal images of Figure 5C. (A) The exposed region is found to have had a resin pocket due to internal damage in the form of laminate wrinkles induced during manufacturing. (B) The subsurface damage in the form of laminate fracture is observed as longitudinal cracks, which show noticeable, although not significant, thermal footprints in Figure 5C in the main manuscript. (C) The subsurface damage in the form of laminate fracture due to wrinkles runs vertically, leading to a significant thermal footprint that can be detected even when it was covered by the filler as shown in Figure 5C,D

Other regions of the blade show similar results. Figure 5 shows the thermal images of the blade region close to the root with comparison to their counterpart optical images. Remarkably, four hot spots are observed at two cracks introduced as artificial damages in the sandwich panels, Figure 5A,B. Besides, two distinct thermal footprints are found in the root transition region of the blade, Figure 5C. These two thermal footprints are generated naturally during the fatigue test as no artificial damages have been introduced there. An optical image, Figure 5D, shows that one thermal footprint is due to the subsurface damage in the form of delamination while the other is covered by filler and is visually unrecognizable. Inspection after removing the filler finds out that here exists subsurface damage in the form of laminate fracture in a vertical direction, agreeing with the detected thermal footprint in this location, see Figure 6.

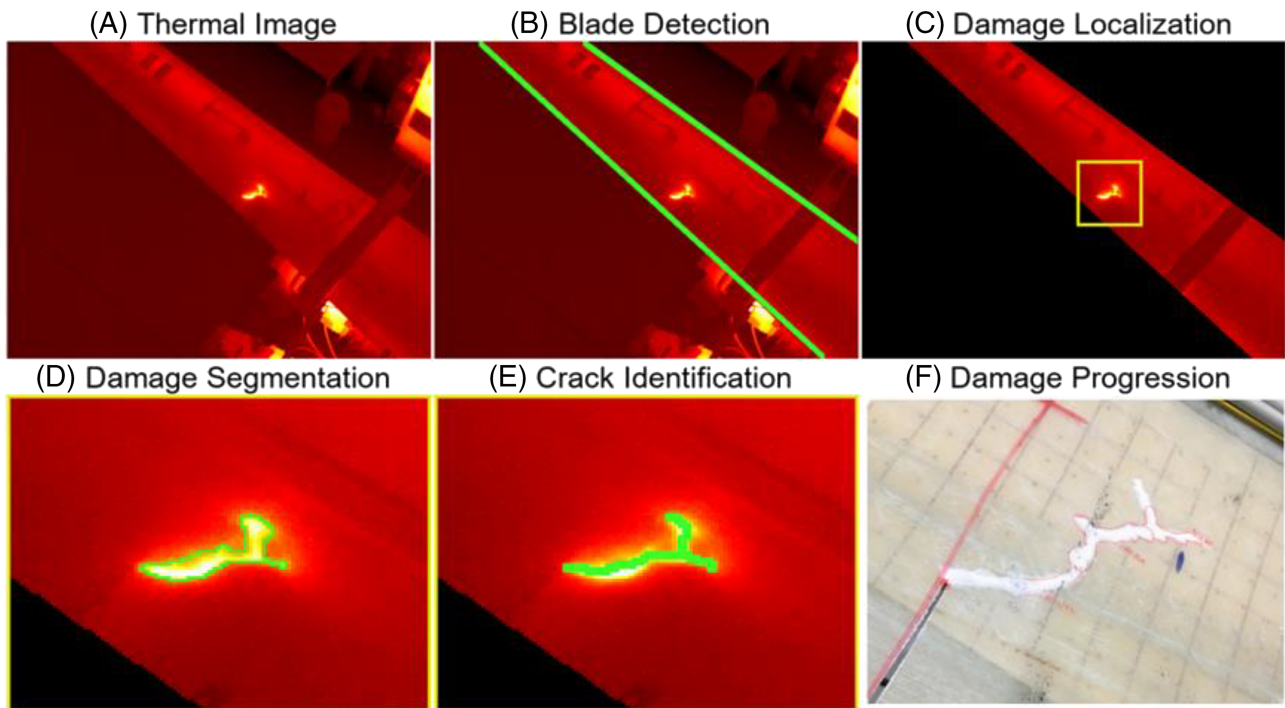
FIGURE 7 The automated analysis tool works on the thermal image. (A) the original thermal image taken from the thermal camera includes thermal footprints of the blade damage of interest, the exciter and the laboratory environment. (B) Detection of blade edges enables the identification of the blade within which the thermal footprints are of interest. (C) The damage is localized within the blade with other thermal abnormalities outside of the blade neglected. (D) Segmenting the damage based on intensity thresholding. (E) Identifying the crack by skeletonizing the damage segmentation to detail the damage geometry. (F) An optical image of the damage showing the detailed crack geometry agrees with the final result of the automated image process tool. All the thermal images are presented in a Redhot color map for better visualization and green colors are presented as positive detections

Manual vision analysis of thermal images for blade damages is challenging in nature as there can be other objects with higher temperature response in the images taken from field.²⁹ The thermal image in Figure 7A exemplifies this situation and shows significant thermal footprints from the exciter and the laboratory environment besides that from the blade damage of interest. First, we use Hough transforms^{30,31} algorithm to detect lines in images to identify two edge lines of the blade, Figure 7B. This technique identifies the location of the blade with more than 99% accuracy, for example, correctly in 744 frames out of 750 frames in this example. Next, within the region of the identified blade location, a high-temperature location is searched using intensity thresholding.³² The location of the hot spot indicates the detected blade damage, Figure 7C. Once the location of the damage is identified, the area around it is cropped to further investigate the area with more details. The blade damages in consecutive frames are segmented based on intensity thresholding³² Figure 7D and later are skeletonized³³ to capture its detailed geometry, Figure 7E. The final result of the automated image process tool agrees with the optical image as shown in Figure 7F.

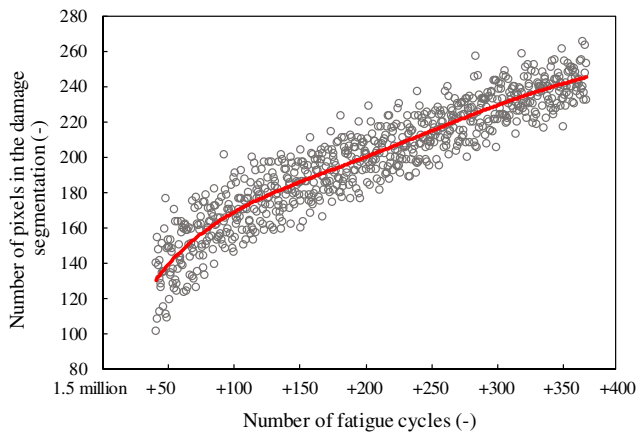
FIGURE 8 Scatter plot of the number of pixels in the damage segmentation with the increase of the fatigue cycle number. A fifth-order polynomial fitting shown in a red curve shows the gradual growth of the damage size. Noting the slope of the curve remains the same after the initial fatigue cycles. See Video S1

Considering that the damage progresses under fatigue and so does the size of its thermal footprint, we measure the size of the damage in the number of pixels within the damage segmentation in each thermal image video frame. After the blade is tested under fatigue for approximately 1.5 million cycles, we apply the automated image process tool to the thermal image video and count the number of pixels in the damage segmentation, see Figure 8. The data points show the size of the damage in the number of pixels changes with the number of fatigue cycles when the thermal image video is taken. A regression curve with a polynomial of fifth order is plotted in red color and it characterizes the damage growth

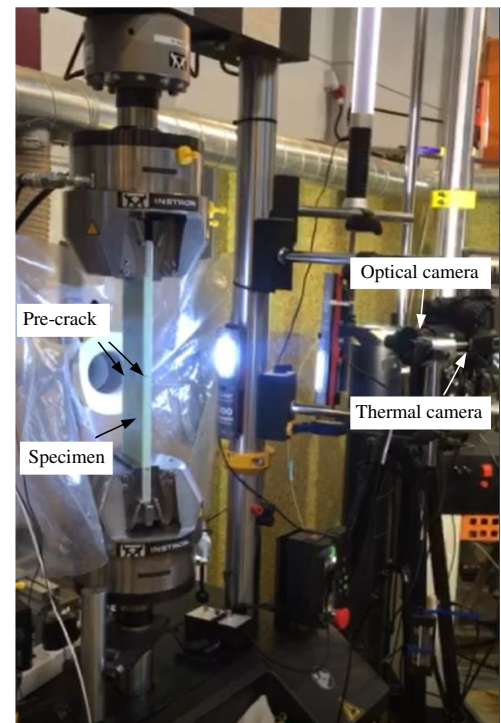
FIGURE 9 Validation test. The precracked sandwich specimen under fatigue loading with an optical and thermal camera taking images in the entire test. The damage state of the specimen is mechanically measured with the increase of fatigue cycles. The measured damage state is compared with the one quantified using the developed image process tool. In total, six specimens are tested and all results showed a similar trend to the one presented in Figure 10. The detailed test validation campaign will be published in a separate work as it is outside of the scope of the current focus in this study

To prove that the damage state quantified by the thermal image process tool truly reflects the actual physical damage, we conduct material tests and compare the mechanically measured damage state to that obtained from the image process tool. Six precracked sandwich specimens similar to these used in the blade are tested under uniaxial fatigue, see Figure 9. Six sandwich specimens are made by vacuum infusion using biaxial glass fiber fabrics, PVC foams, and epoxy, that is, $[\pm 45_2/\text{Foam}/\pm 45_2]$. The nominal size of the specimens is 100 mm \times 400 mm \times 13 mm. They are precracked and three sandwich specimens are painted whereas the other three are unpainted. Tension-tension fatigue is applied to all specimens with $R = 0.1$. The stiffness of the specimens at the i th cycle is the slope, E_i , from the linear regression of the measured stress-strain curve. The stiffness loss is defined as $1 - E_i/E_0$, where E_0 is the initial stiffness. The damping of the specimens, D_i , is defined by the normalized energy loss in the material during the i th cycle, and it is measured by the area of the stress-strain hysteresis divided by the reference area based on the

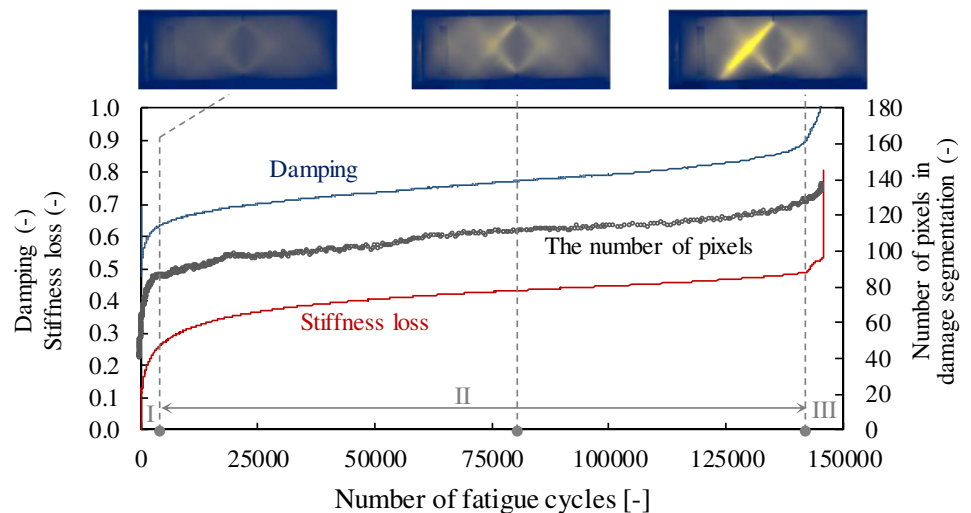
FIGURE 10 The damage state quantified by the image process tool agrees well with the stiffness loss and the damping of the specimen that are mechanically measured from the test. Three distinct phases, I: start, II: stable, III: fail, are observed during the fatigue life shown together with typical thermal images. A constant slope of the curve indicates a stable damage growth in phase II, in which an increase of slope characterizes a phase III response as the specimen approaches failure

The damage state of the specimens is measured as the degradation of mechanical properties, that is, the stiffness loss and the increase of damping with the number of fatigue cycles. Thermal images of the specimens under fatigue are taken and processed using the developed tool to count the number of pixels in the damage segmentation. Figure 10 shows the results from one exemplary specimen. It can be seen that the damage state quantified by the tool agrees well with two mechanical measurements during the entire fatigue life, proving that the developed tool can be used as a reliable quantitative remote measurement of the physical damage state.
