## PD-pulse characteristics in rotating machine insulation

Conference Record of the IEEE International Symposium on Electrical Insulation

PD-PULSE CHARACTERISTICS IN ROTATING MACHINE INSULATION

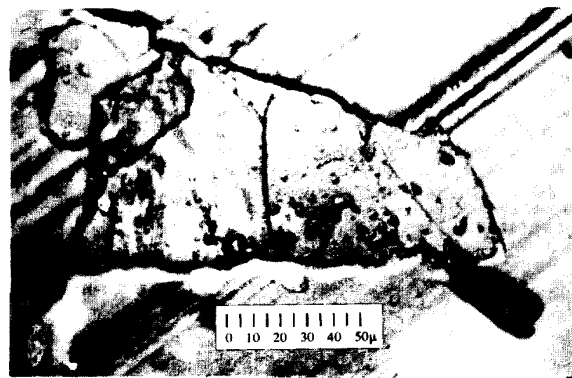
Fig.1 Typical surface structure of the epoxy impregnated mica tape with mica flakes protruding from the clear epoxy. The lines visible in the epoxy are caused by the surface of the mould.

The base material for the samples was 0.25mm thick epoxy impregnated mica sheets, the surface of which was controlled under an optical microscope. As can be seen in Fig.1, the one surface was characterized by uncovered mica flakes embedded in the epoxy. The back surface consisted of clear epoxy only with the glass fibres visible just beneath the surface.

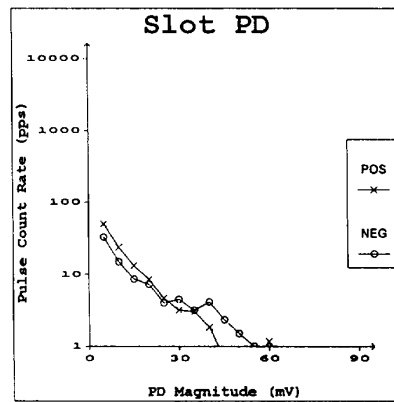
**Fig.10** Typical amplitude distribution (TGA measured) Diel./met. void located at A. SSC at slot end. Test Voltage: 5 kV.

Again, comparable results were obtained for all kinds of defects. An example of amplitude, as well as amplitude/phase distributions is shown in Fig.10 and Fig.11

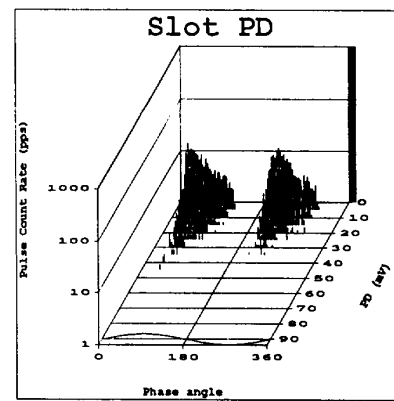
**Fig.11** Typical amplitude/phase distribution (TGA measured) Diel./met. void located at A. SSC at slot end. Test Voltage: 5 kV.
