Post-earthquake fire resistance of steel buildings

Jelinek, T. ; Zania, V.; Giuliani, Luisa

Published in:
Journal of Constructional Steel Research

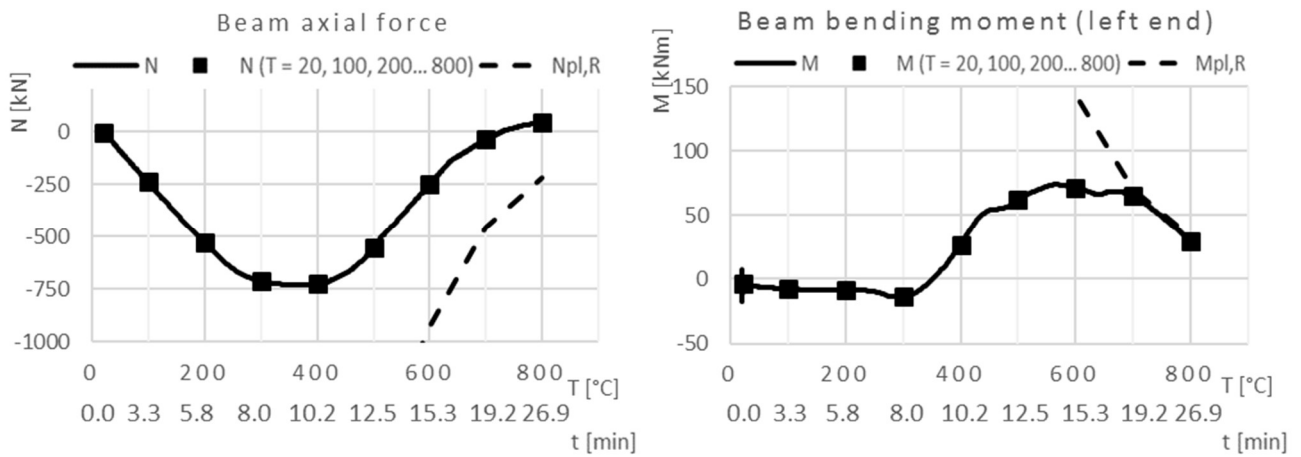
Figure 10: Axial force in the beam (left charts) and moment at the beam left end (right charts) in the A-1L scenario, plotted against the beam temperature (upper axis) and the time of fire exposure (bottom axis). The dotted lines in the left and right charts represent the axial and bending resistance, respectively.

The behavior of structural elements during the collapse mechanism can be better understood by looking at the section forces of the beam and left column reported in Figure 10 and Figure 11 respectively with respect to the element temperature (upper charts) and time of fire exposure (bottom charts):

- At the beginning of the fire, all heated elements expand in the longitudinal direction. While the expansion of the columns is quite limited, due to the restraint offered by the upper part of the frame, the expansion of the beam (left chart of Figure 10) is more significant and causes the left outer column outwards movement. This, in turn, causes an increment in the bending moment of the left column, as the flexural stiffness of the column opposes to the outer displacement of the beam (right chart of Figure 11).

- As the steel heating progresses, the steel mechanical properties degrade and the load bearing capacity of both beams and columns decrease (indicated with a dotted line in the charts of Figure 10 and Figure 11). Plastic hinges develop first at the beam-ends, inducing higher deflection and moment at the beam mid-span (right chart of Figure 10). Soon after, a third plastic hinge forms at mid-span of the beam, when it becomes a mechanism and loses its ability to carry the load.

- After the formation of the mechanism, the beam deflection increases rapidly, while the axial stresses in the beam begin to decrease (left chart of Figure 10) and the left column is called back inward. This behaviour, caused by the nonlinear effect of the beam elongation, is often responsible for triggering a catenary in the beam, as described in Aiuti et al. [33]. In this case, the value of the

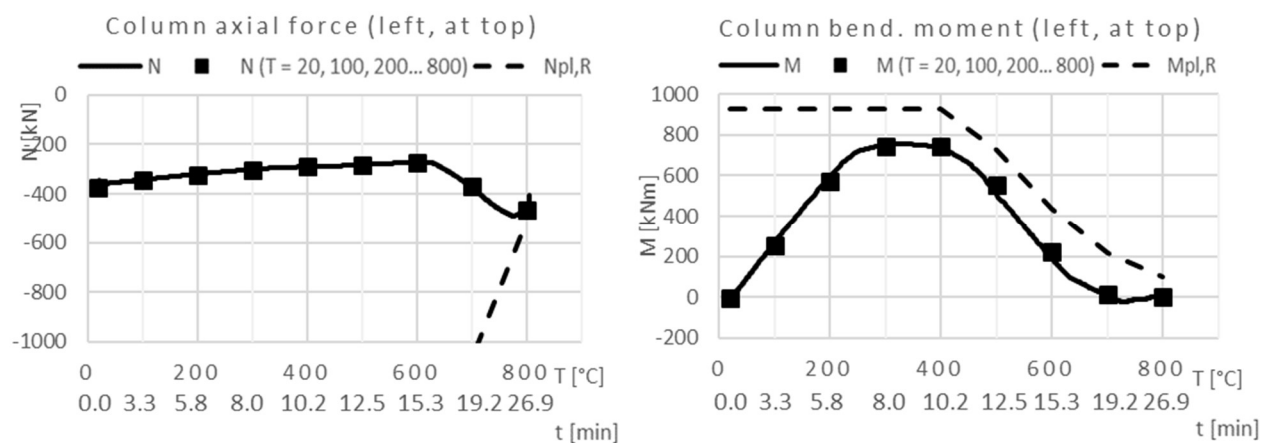
Figure 11: Axial force in the column (left charts) and moment at the top of the left column (right chart) in the A-1L scenario, plotted against the beam temperature (upper axis) and the time of fire exposure (bottom axis). The dotted lines in the left and right charts represent the axial and bending resistance, respectively.
