## Degradation mechanisms of amine-cured epoxy novolac and bisphenol F resins under conditions of high pressures and high temperatures

*Published in:*  
Progress in Organic Coatings

**Keywords:** epoxy novolac; epoxy bisphenol F; corrosion; high pressures; high temperatures; coatings;

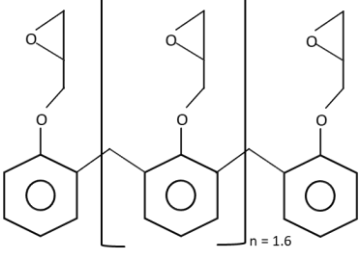
Table 1. Molecular structures of raw materials used for the EN coating.

<b>Formulation 1</b>	<b>Epoxy Novolac (EN) coating (<math>f = 3.6</math>)</b>		
<b>Raw Materials</b>	<b>Molecular Structure</b>	<b>Epoxide equivalent weight</b> [g/mol of epoxide]	<b>Epoxide content</b> [mmol/kg of epoxy resin]
DEN 438 Novolac resin

176 – 181	5525 - 5680
<b>Curing agents</b>	<b>Molecular structure</b>		
DEAPA Adduct – Curing agent 1
