## Microplastics Emission from Eroding Wind Turbine Blades: Preliminary Estimations of Volume

*Published in:*  
Energies

# Microplastics Emission from Eroding Wind Turbine Blades: Preliminary Estimations of Volume

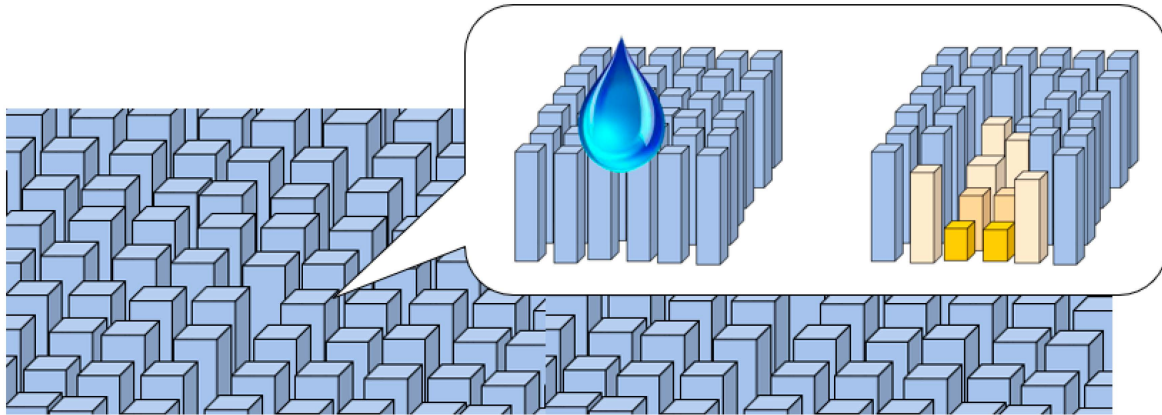
The mean size of the removed fragments must also be defined as a parameter or estimated from the measurements and literature data. The position where failure occurs is chosen randomly based on the impact location. It is assumed that an impacting droplet that causes failure affects an area with a radius equal to the droplet radius. If an impact occurs near a damaged area, the failure position is chosen randomly but in a way that increases the size of the damaged area. This is to resemble the failure observations from RET. When failure occurs, the heights of the affected material points are reduced by the removed fragment size. Figure 2 shows the schema of how the height of a given point is

reduced as a result of droplet impact and the resulting damage. The model parameters were calibrated by RET (rain erosion tester) datasets of viscoelastic polyurethane coatings.

**Figure 2.** Schema of the discretized model of surface roughening due to droplet impact used in [15].

In the model [15], a simplified geometry of the blade’s surface is discretized as a number of material elements. Surface erosion by multiple droplet impacts is modeled through the removal of these material elements. The impact positions of the droplets were generated as random values based on a uniform random distribution, and a probability of failure is used to determine failure and material removal. For each impact, the probability of failure  $p_{fail}$  is calculated as a Weibull probability function:

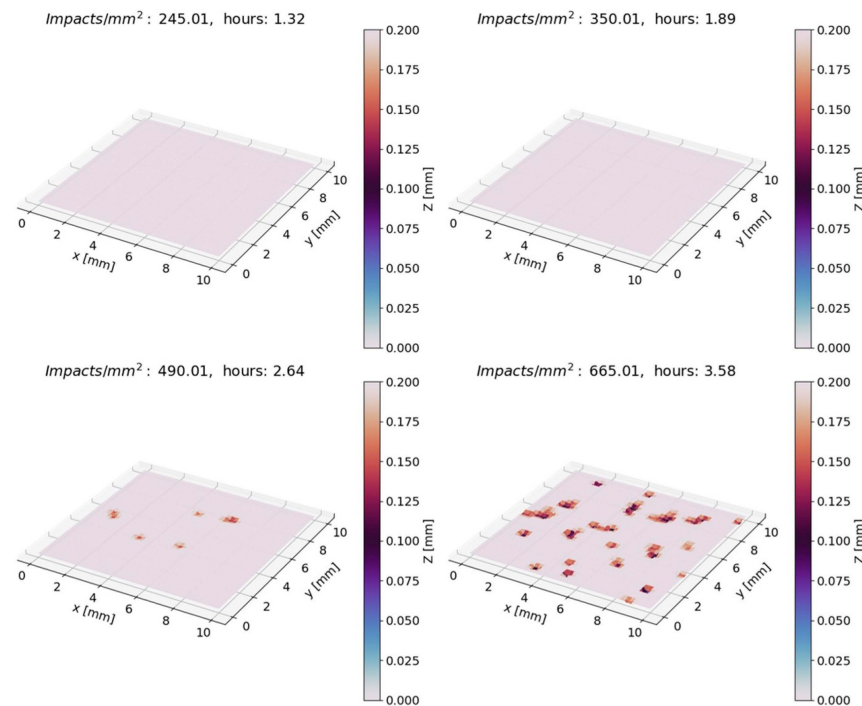
**Figure 3.** Predicted evolution of surface damage by using 3D surface roughness plots of the coating's surface. Reprinted from [15].

Figure 3 shows the calculated roughness evolution of the blade surface. The results of this simulation are shown in Figure 4, with coating volume loss increasing with time. Assuming an average tip speed of 90 m/s, 1000 mm of rain annually, and a mean rain intensity of 1 mm/h, one can obtain 15 mm<sup>3</sup>/cm<sup>2</sup> volume loss per year.

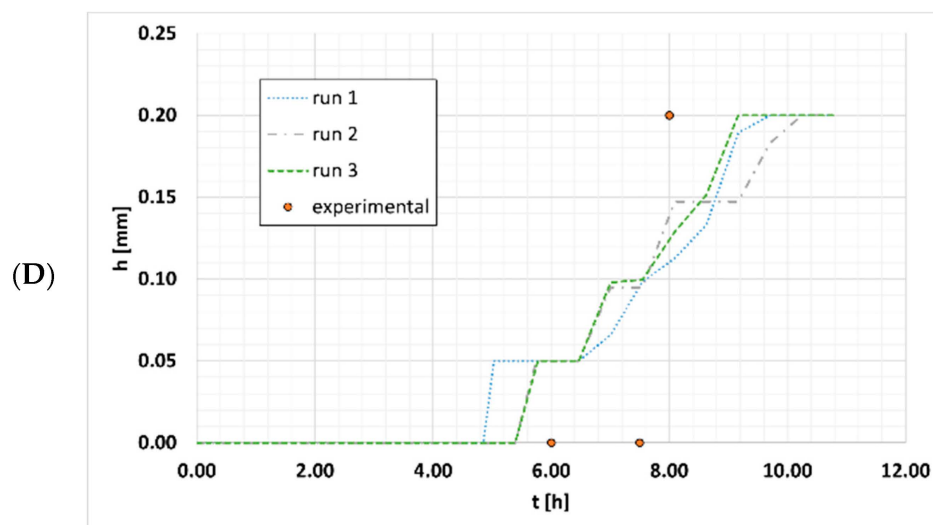
Figure 5. Cont.

**Figure 5.** Comparison of erosion depth predictions with experimental RET data for coatings 269-1 (A), 269-3 (B), 269-4 (C), and 269-5 (D).

The model is further validated by comparing it with the erosion depth measurements from the RET data. The RET data are available from the project DURALEEDGE [9] and contain measurements for the end of incubation and breakthrough times from three samples tested in an R & D-style test machine. Four polyurethane-based coatings were tested, which are named 269-1, 269-3, 269-4, and 269-5. For the tests, the maximum tip speed was around 125 m/s, and the mean droplet size was 2.4 mm with a flow rate of 65 L/h. The predictions of the model for the maximum depth of erosion are performed by using the calibrated parameters from [15], and the required input is the number of impacts per  $\text{mm}^2$  or the total rain impingement from the V-N or V-H curve of each coating. Since the end of incubation and breakthrough measurements are extracted from an area of the samples with approximately a tip speed of 120 m/s, the number of impacts per  $\text{mm}^2$  or the total rain impingement is extracted for this tip speed. The number of impacts per  $\text{mm}^2$  for a tip speed of 120 m/s, as extracted from the V-N curves, was 146.56, 300.347, 251.319, and 1111.52 for coatings 269-1, 269-3, 269-4, and 269-5, respectively. The number of impacts per  $\text{mm}^2$  can be directly related to testing time by using equations to calculate the impact rate for the applied testing conditions for the R & D-style RET. The comparison graphs are presented in Figure 5. The depth for the breakthrough of the coatings is considered at 0.2 mm, which is the thickness of the coating layers in the RET samples. Three runs are used to account for the randomness in the impact positions and failure probability.

The predictions are in the range of the experimental measurements for both the end of incubation and breakthrough times. Coating 269-4 reaches breakthrough almost immediately after the end of the incubation, and the predictions are not able to capture this. However, the end of incubation time is predicted well. The predictions for the other coatings are reasonable and validate that the model can provide reasonable predictions.

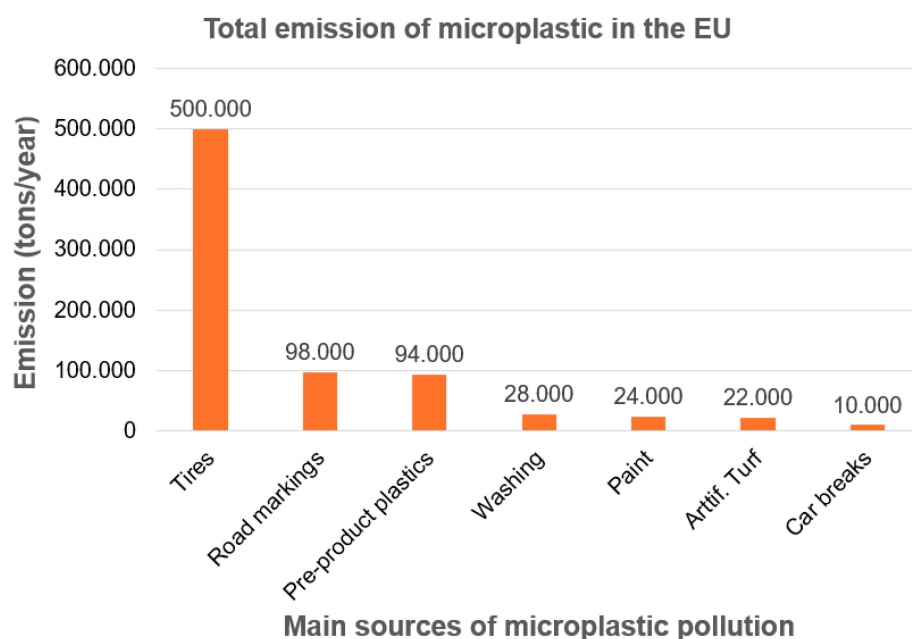
Figure 8. Data on the emission of microplastic in the EU in 2016.

In order to rank the level of microplastic pollution from wind turbines, a number of reports and other publications about microplastic pollution were reviewed. According to [25], the annual emission of microplastics is up to 5.6 million metric tons, and up to 1.5 million tons appear in the world’s oceans [26]. The main sources of microplastic pollution are textiles, car tires, and ship painting [27]. The data are summarized in Figure 8. The figure shows that there are three main sources of microplastic pollution: car tires, road markings, and pre-product plastics. The data provide the maximum possible amount of microplastics.

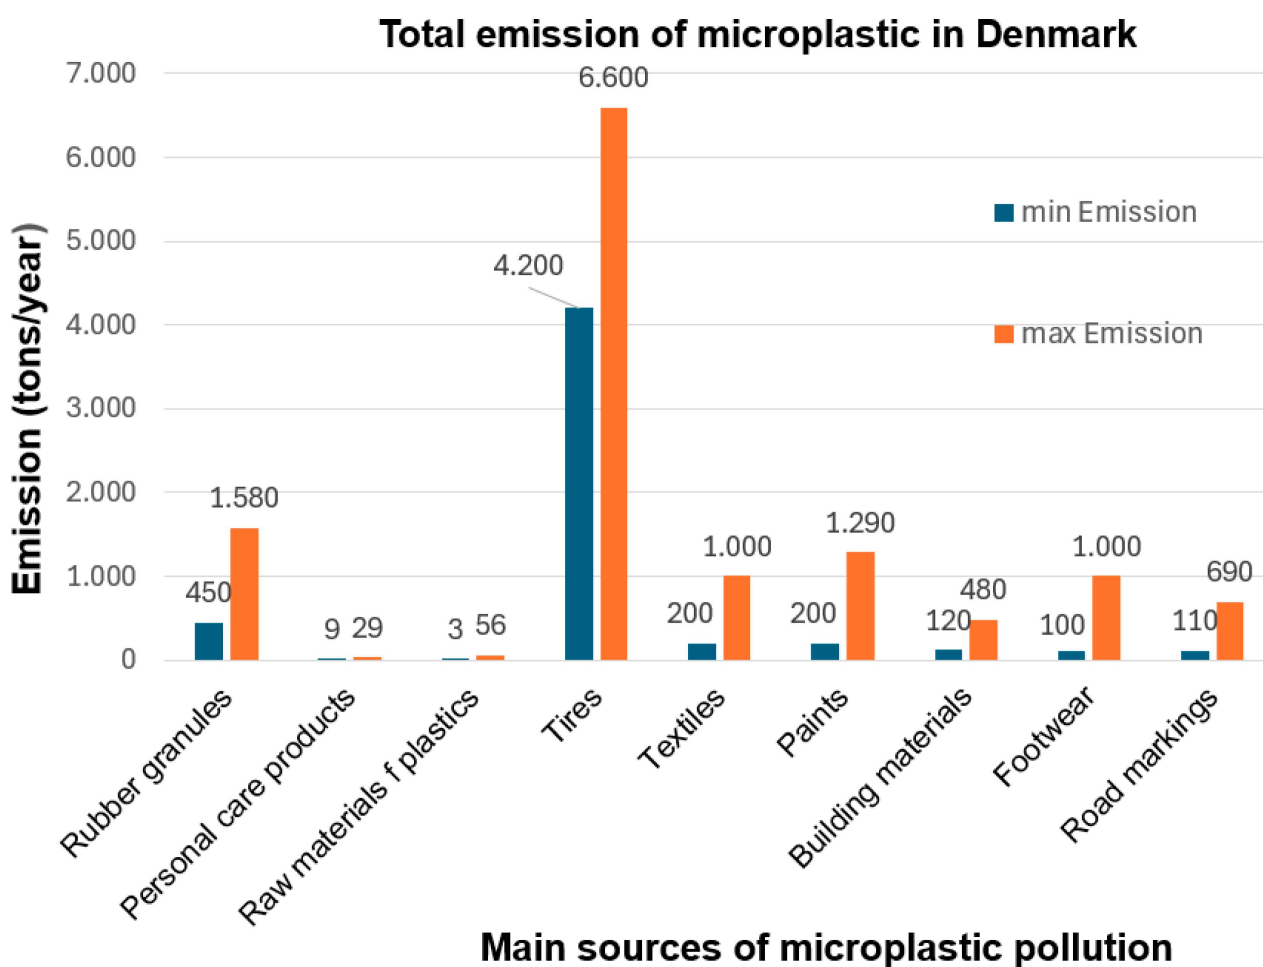
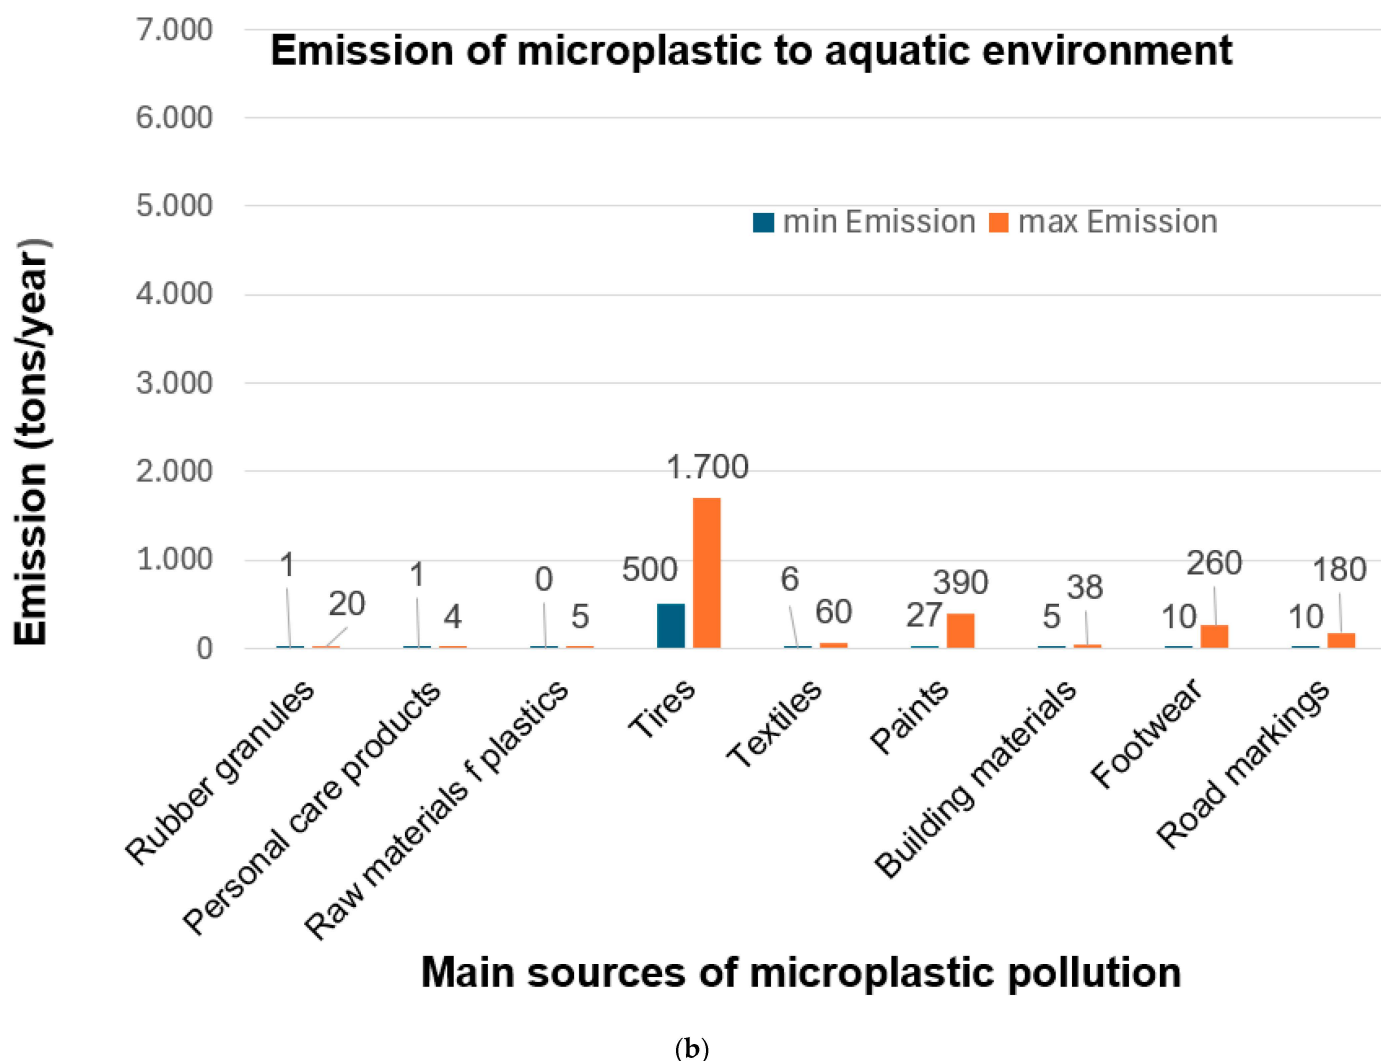
**Figure 9.** Microplastic pollution in Denmark: (a) total emission of microplastics and (b) emissions to the sea.

In Figure 9, we illustrate the data on microplastic emission in Denmark [28–30]. As in Figure 8, we observe that car tires, paints, and textiles are the primary sources of microplastic pollution. Therefore, the total emission of microplastic to the Baltic and North Seas can be estimated to be up to 3100 tons/year.
