Partial discharge patterns and surface deterioration in voids in filled and unfilled epoxy

Holbøll, Joachim; Henriksen, Mogens

I E E E International Symposium on Electrical Insulation. Conference Record

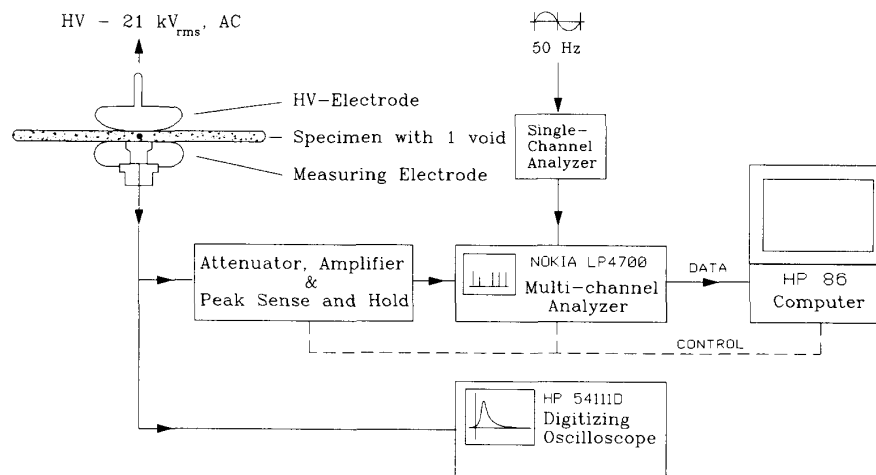
Pulse detection and analysis was performed with the measuring system shown in fig.1.

PD detection was based on in-line measurements of the discharge current through a 50Ω measuring impedance formed by oscilloscope and analyzer. The apparent charge is calculated by the time integral of the current pulse $i(t)$ visible on the oscilloscope, and the calibration of the system is performed by relating this value to the signal read by the analyzer.

Fig.1: Measuring system

Computer controlled pulse phase and pulse height analyses were continuously performed for each sample under the aging tests.

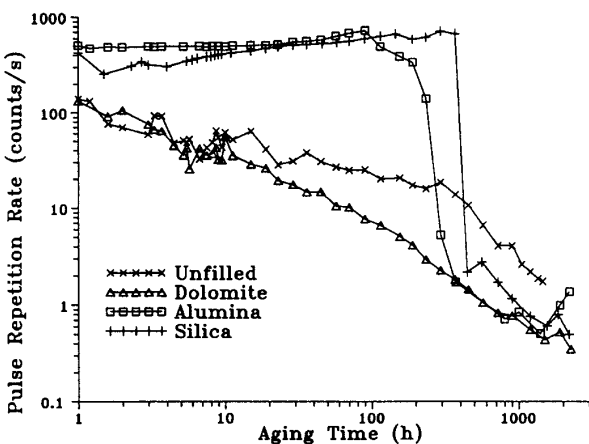
Fig.2 and fig.3 show the pulse repetition rate and the maximum detected apparent charge as the average of the results from 5 specimens for each material combination.

Fig.2: Pulse repetition rate as a function of aging time.

Discharges in voids in unfilled and dolomite filled epoxy showed a periodical discharge activity, which decreased continuously, while the maximum apparent charge was nearly constant. Discharges in alumina and silica filled epoxy showed a continuous and slowly increasing activity, until it after 2-300 hours within few hours dropped with a factor near 1000 to the level of the other materials and changed to periodical characteristic. The maximum apparent charge before this transition was about 20 dB below the one of unfilled and dolomite filled specimens. After the transition the maximum apparent charge of all filler specimens reached the same level. The change of the discharges' character in alumina and silica filled epoxy also resulted in a change of the charge distribution. Fig.4 shows the charge distribution after the transition.

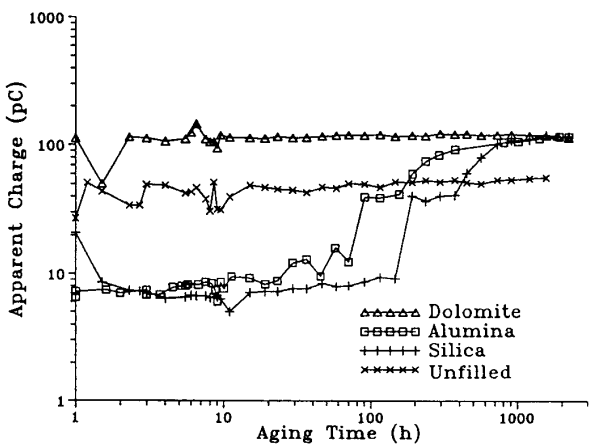
Fig.3: Maximum apparent charge as a function of aging time.

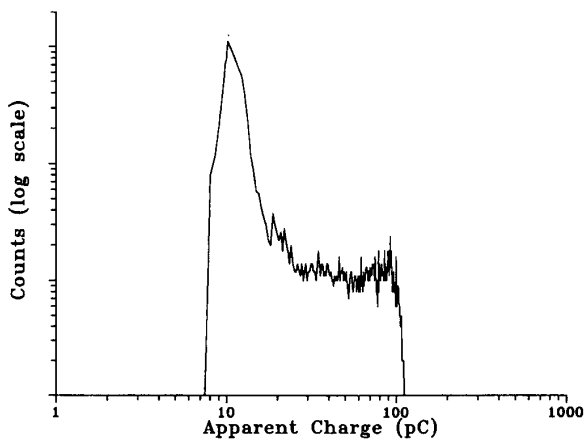
Fig.4: Typical distribution of the apparent charge for discharges in voids in unfilled and dolomite filled epoxy. Similar to the distribution for alumina and silica filled epoxy after transition to periodical activity.

Before the transition to periodical activity alumina and silica showed a charge distribution consisting only of a large number of discharges of about 10 pC.

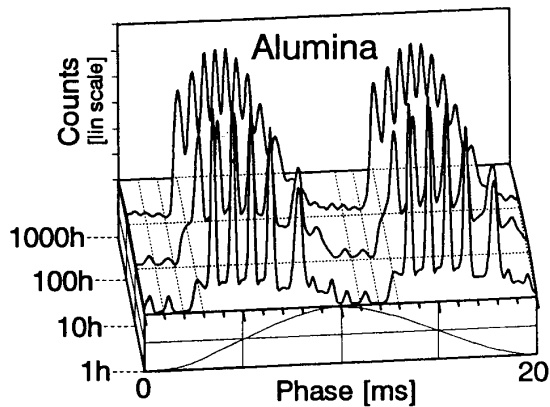
In fig.5 and fig.6 can be seen the phase distributions of pulses from the discharges. Again, unfilled and dolomite filled epoxy showed comparable characteristics, as did alumina and silica.

Fig.6: Phase distribution of pulses from discharges in voids in alumina filled and silica filled epoxy as a function of aging time.

Phase analyses of discharges in the unfilled and dolomite filled specimens showed a decreasing activity, decreasing inception voltage, and a discharge pattern with only few and difficult to define pulse concentrations. The phase distributions of alumina and silica filled epoxy were characterized by very well defined pulse concentrations increasing from 5 to 9 per halfcycle before the transition to periodic activity.
