3D X-ray CT of fatigue damage in fibre composites

Jespersen, K. M., Zangenberg Hansen, J., Lowe, T., Withers, P. J., & Mikkelsen, L. P. (2016). 3D X-ray CT of fatigue damage in fibre composites. Poster session presented at 24th International Congress of Theoretical and Applied Mechanics, Montreal, Canada.

3D X-ray CT of fatigue damage in fibre Blade cross-section Unidirectional (UD) composites

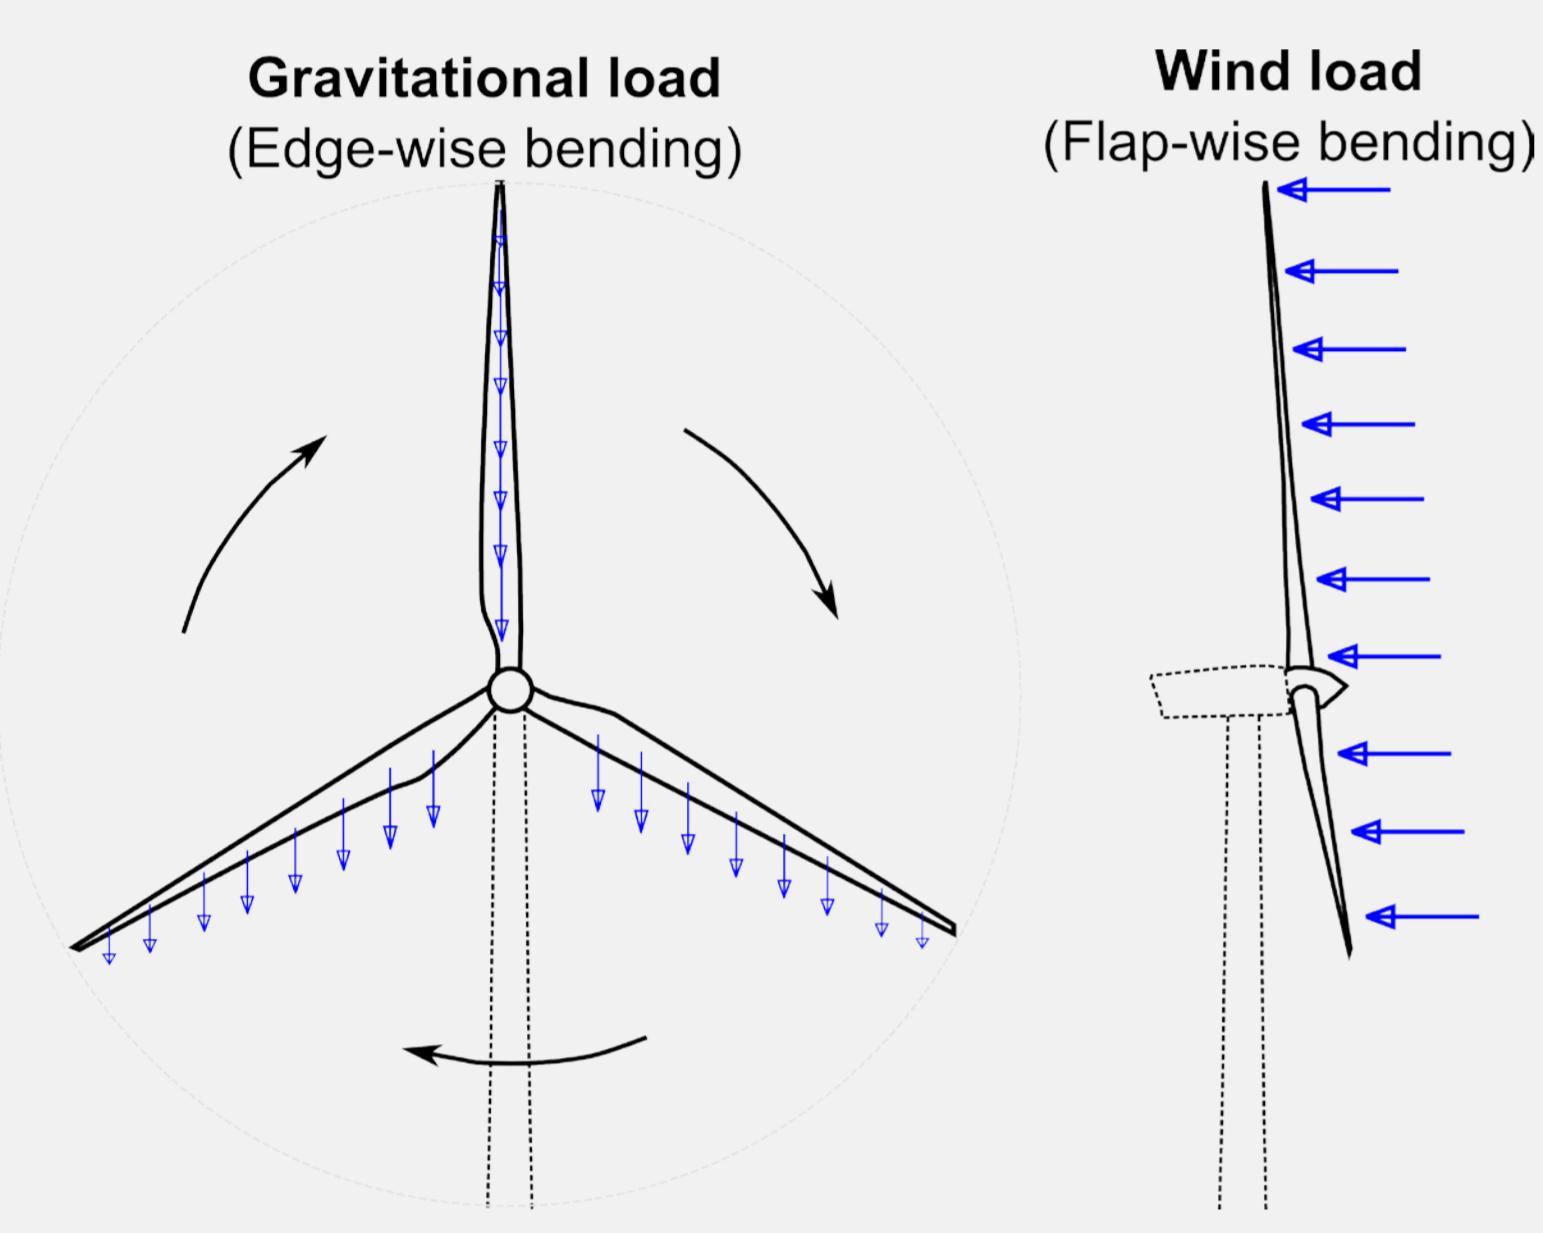
The above figure shows the main loads on wind turbine blades. The rotation of the blade causes the gravitational load on the blade to change direction twice (two load cycles) during a single rotation. Furthermore, the wind variation causes repeated loading with high variation.

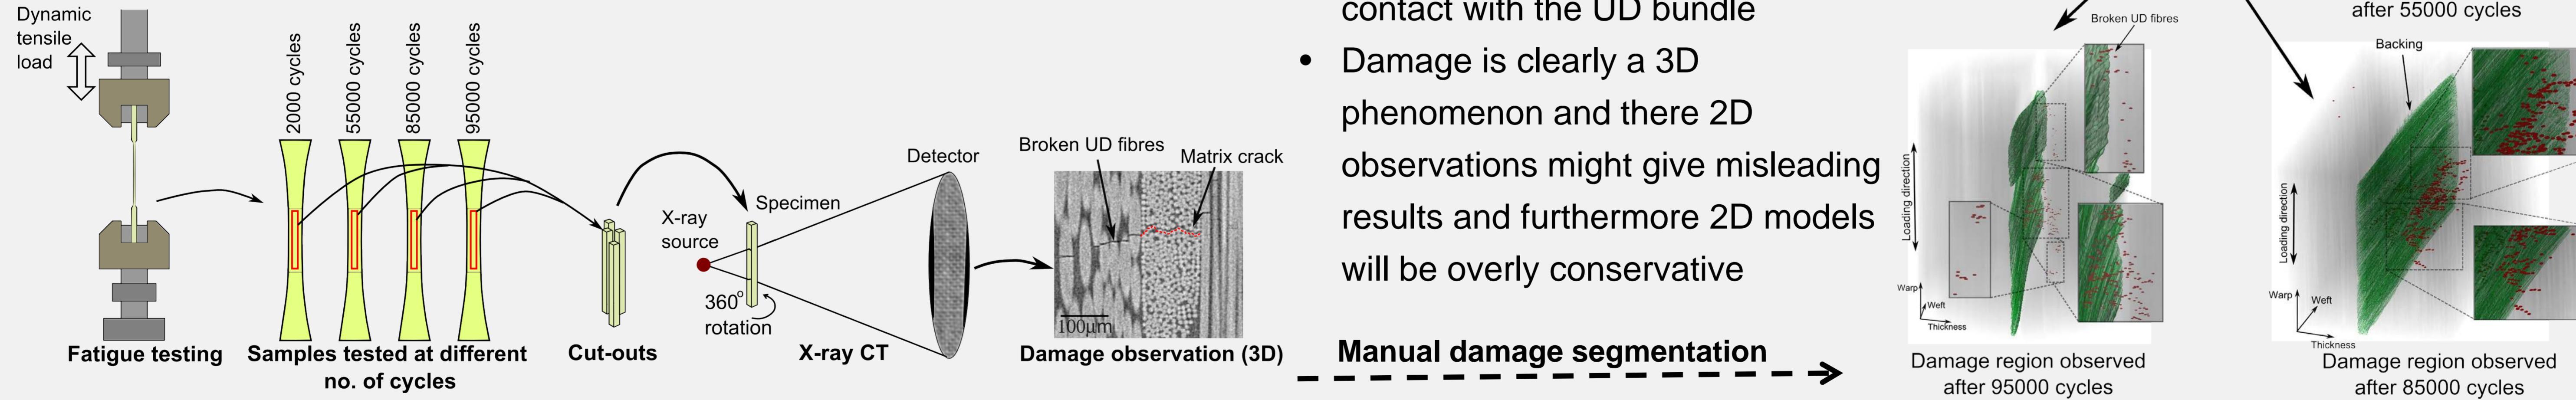
Fatigue tests (R=0.1) were carried out on four 410mm long butterfly shaped specimens and stopped at different number of cycles. X-ray CT experiments were performed on a Zeiss X-radia Versa 520. As the image resolution in Xray CT scans is decreasing for increasingly large cross-sections, cut-outs are considered to obtain high resolution (1.2 µm voxel resolution). This results in a small field of view (2.4mm), however high resolution is necessary to see individual UD fibre fractures.

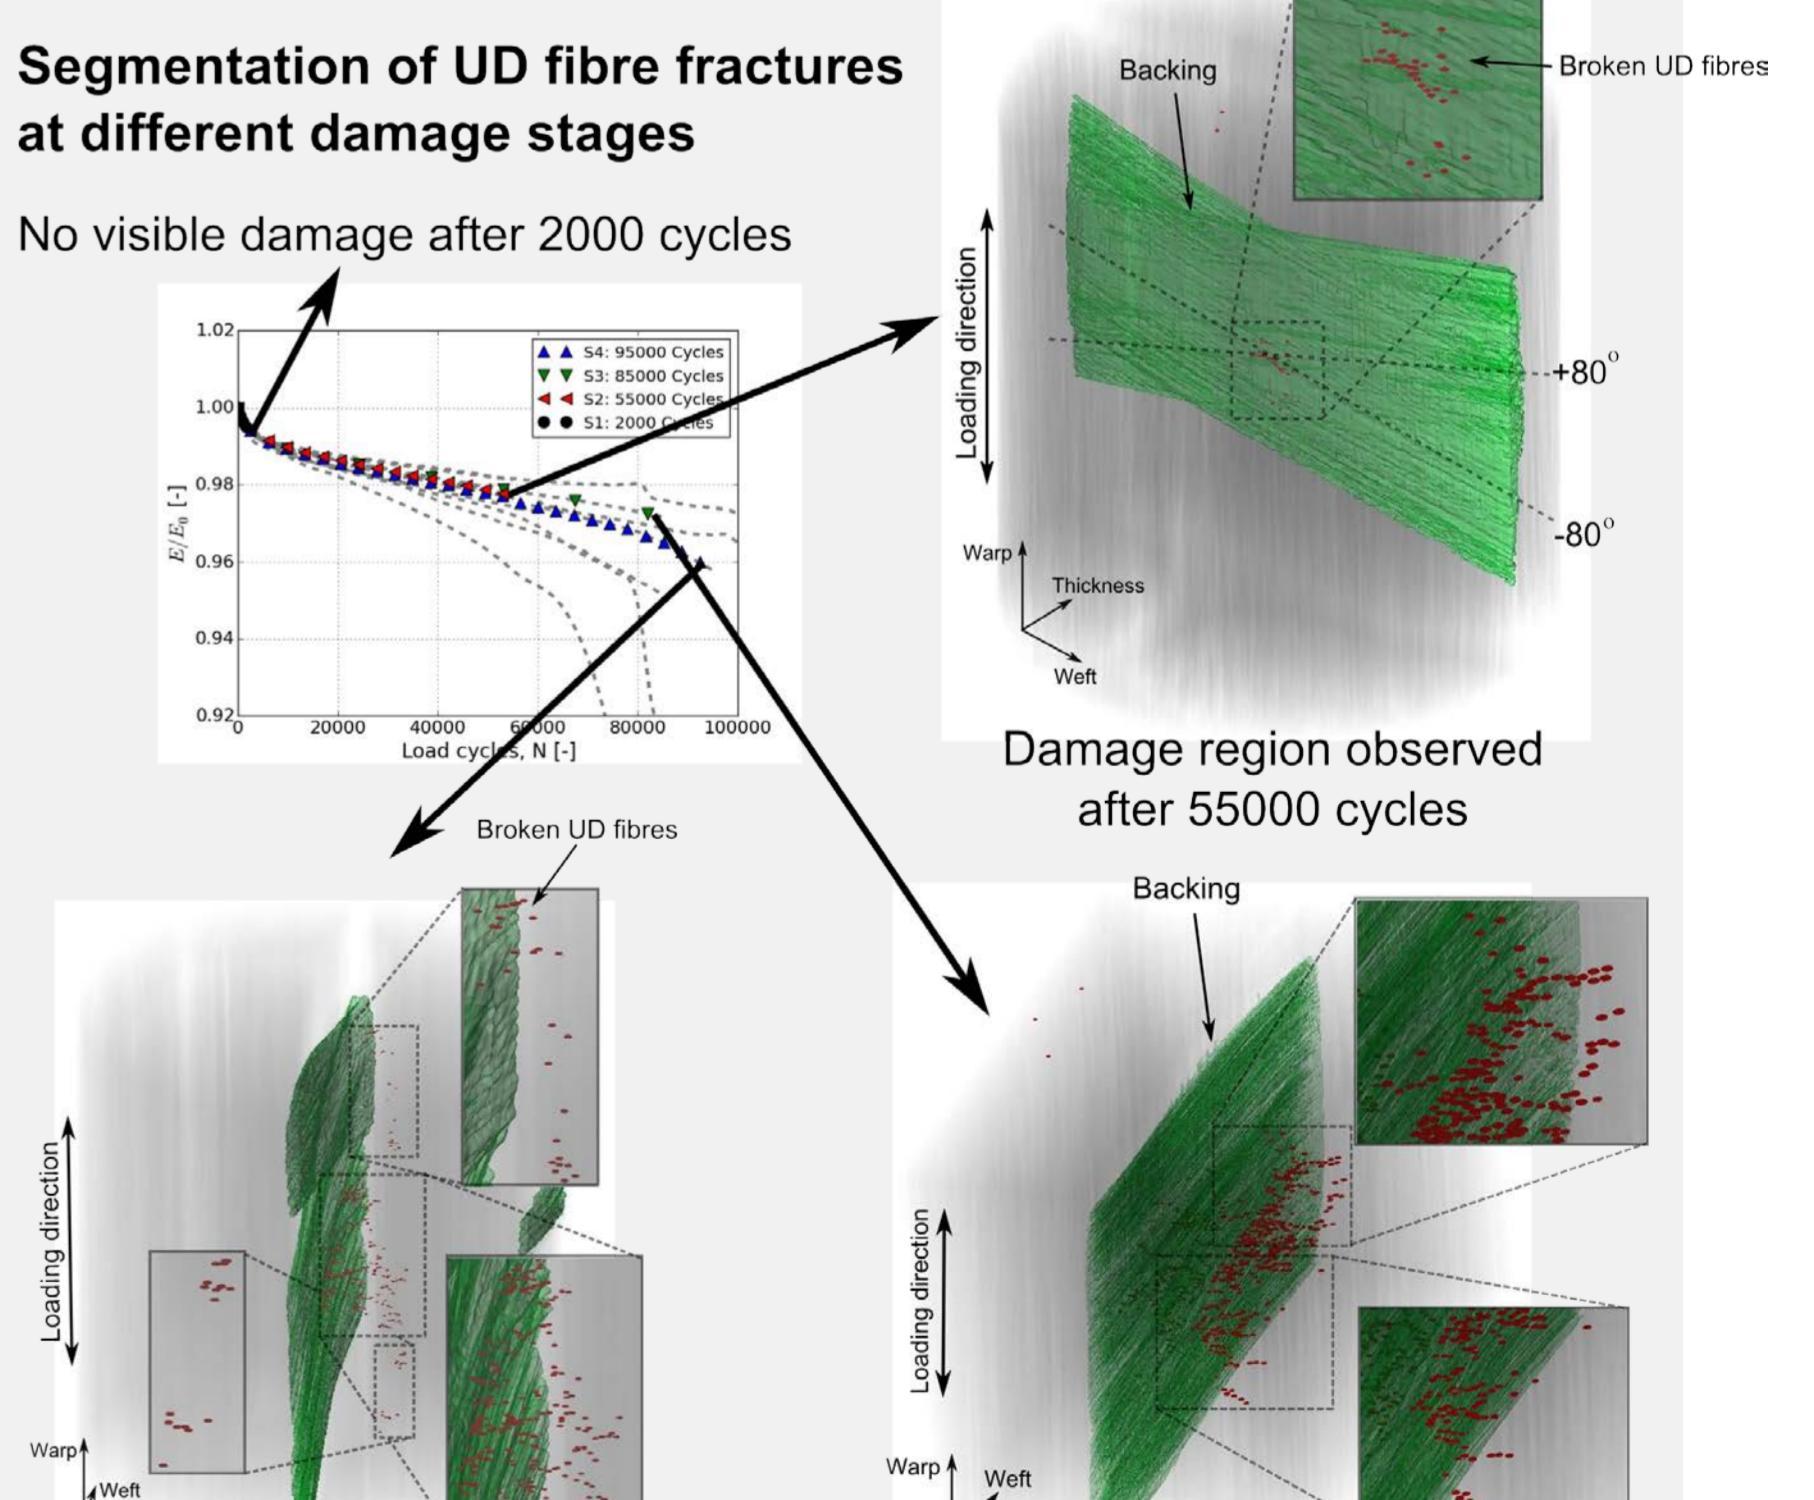
The UD fibre fractures were individually marked and shown in 3D. The main observations are as follows:

- UD fibre fracture regions are only seen where backing bundles intersect and at the same time is in contact with the UD bundle

damage was found to appear as local UD fibre fracture regions close to the so-called supporting backing layer, which seemed to have an important role in the location of the damage initiation. Furthermore, the damage appeared as 3D regions containing both clusters and chains of fibre fractures, and it was concluded that considering this problem in 3D seemed to be important in order to obtain realistic results.
