Publication date: 2016

Hansen, T. K., Larsen, P. K., Hansen, K. K., Bjarløv, S. P., & Peuhkuri, R. H. (2016). A lime based mortar for thermal insulation of medieval church vaults. Paper presented at Historic Mortars Conference 2016, Santorini, Greece.

A lime based mortar for thermal insulation of medieval church vaults

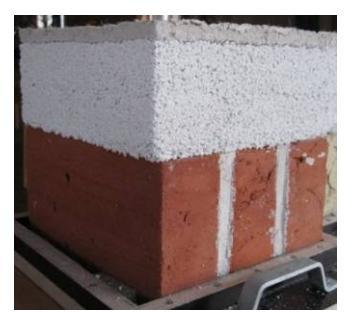
Figure 1: Model of vault construction with insulation mortar; ¹/₂ brick thick vault, 100 mm insulation mortar and 10 mm cattle hair reinforced mortar

which was why the lime based perlite mortar was developed and tested for this intended use. Lime is compatible with the existing clay fired bricks and lime mortar joints, and perlite is a naturally occurring volcanic rock type, expanded under heat loads. The insulation mortar is able to lie directly on the existing vault, following the rounded geometry. For increased load bearing capacity, a thin layer of lime mortar reinforced with cattle hair is applied on top of the insulating mortar. A model of the insulated vault is seen in Figure 1.

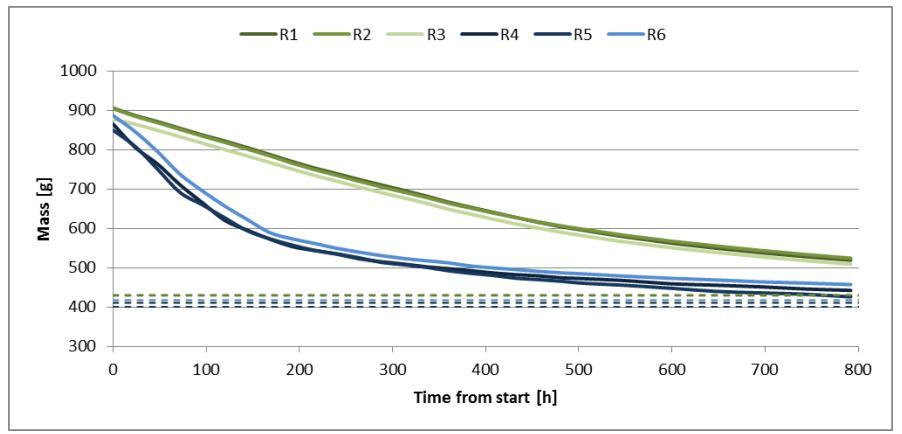
Figure 2: Mass whilst drying of specimens. Specimens numbered 1-3 have been subjected to an air velocity of 0 m/s, specimens numbered 4-6 have been subjected to an air velocity of 3 m/s. The dotted lines represent dry-weight of specimens

For the drying experiment, each specimen was sealed on all sides except one for determined drying area. The specimens were saturated by capillary suction, hereafter they were placed in a climate chamber at approximately 22-25°C and 64-70% relative humidity, for daily monitoring of the drying process by weighing. In the experiment, half of the specimens were subjected to 3 m/s air velocity, and the rest 0 m/s air velocity.

The results of capillary suction showed, that LBM Test Method 1 had more reliable results than the Karsten tube measurements, as more specimens were tested in LBM, and the standard deviation found to be 5 times lower than Karsten tube. On the other hand, the results did not differ outrageously, and it was found that the capillary suction in the insulation mortar is higher than both brick and lime mortar [3]. It is seen in the drying progress depicted in Figure 2 that the air velocity has a big influence on the drying rate, as the mass of these specimens drastically reduced in the first 200 hours. After 200 hours the drying curve levels out. At the end of the experiment, specimens subjected to air movement are closer to initial weight, dry weight, but the difference at this point is not substantial. The value of 3 m/s for air movement is not realistic in the church attic however the air is not still, as there are many leakages in these roofs. The experiment showed that in the course of 1 month, capillary saturated insulation mortar can almost dry completely with air movement from 0-3 m/s. The cup-test revealed a more than 3

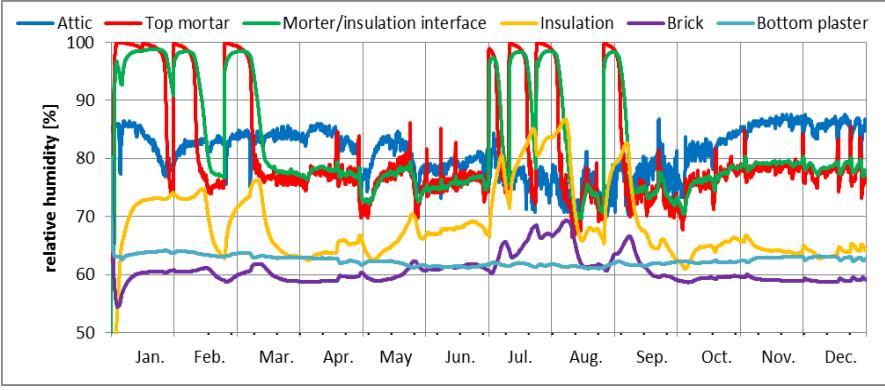
Figure 3: Yearly simulation of church vault with 100mm insulation mortar

Simulation results of relative humidity through the construction are expressed in Figure 3.

The simulation results indicated that only the upper three output points were clearly affected by the exterior water loads. The exterior water loads added in winter and summer, seemed to have a significant influence on humidity conditions in layers down to the middle of the insulation layer, but not further, towards the brick layer. It was seen, that the interface area between brick and insulation, as well as the middle of the brick layer, was influenced during summer periods, but to no severe extent. In the summer period the superficial layers dried out quicker than in winter due to increased temperature, which also made the vapour pressure in the attic increase and cause the deeper penetration of moisture during summer. Neither the bottom part of the brick or the bottom layer of plaster was affected by the external water loads at any time.

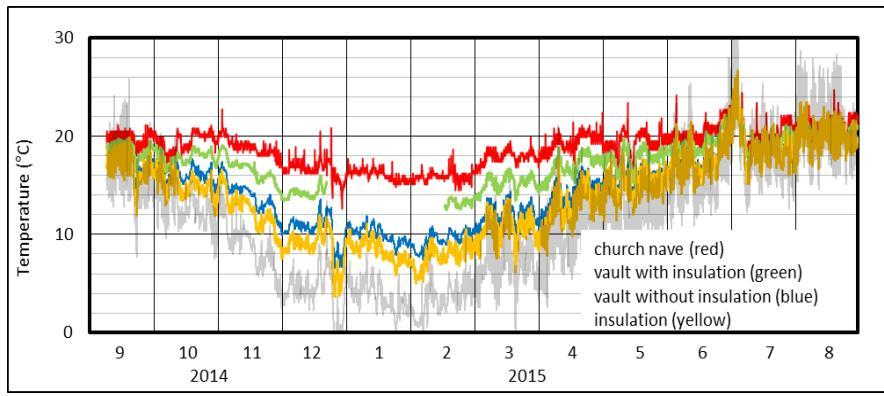
Figure 4: Temperature measurements from Annisse Church

Results from in situ measurements of temperature and relative humidity are shown in Figure 4 and Figure 5.

The temperature measurements, seen in Figure 4, show that the temperature of the insulated vault was 2-3° warmer than the un-insulated vault during winter. The temperature measured in in the insulation was slightly colder than the uninsulated vault. In the summer period, the temperature in both vaults and in insulation were very similar. The measured relative humidity is depicted in Figure 5. It is seen that the humidity in the insulated vault is initially a bit higher than the uninsulated vault, but due to drying of building moisture, the insulated vault reaches humidity levels resembling interior conditions within ½ year. The humidity measured in the insulation mortar, is higher for a while, with a peak in October 2014. The peak was likely caused by the carbonization process of lime, which expels water, also explaining the high humidity declining in the insulation layer. In the period where the humidity reaches 100 % in the insulation, it is seen to not affect the underlying brick in any essential way. The relative humidity in the uninsulated vault has less variation.

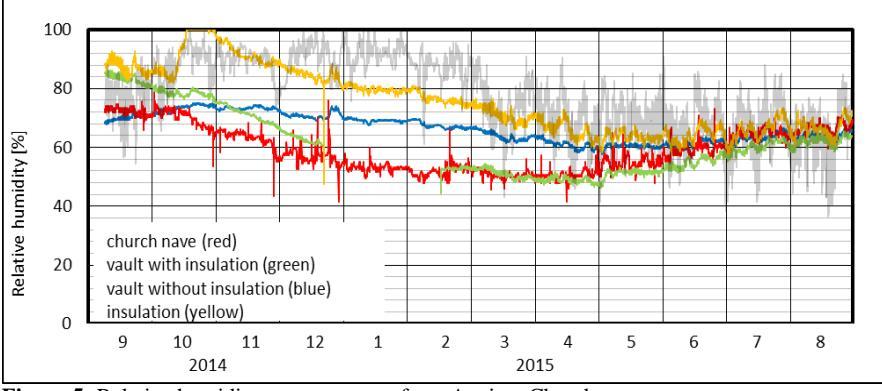
Figure 5: Relative humidity measurements from Annisse Church
