Hygrothermal assessment of external walls in Arctic climates: Field measurements and simulations of a test facility

Published in: Building and Environment

Publication date: 2023

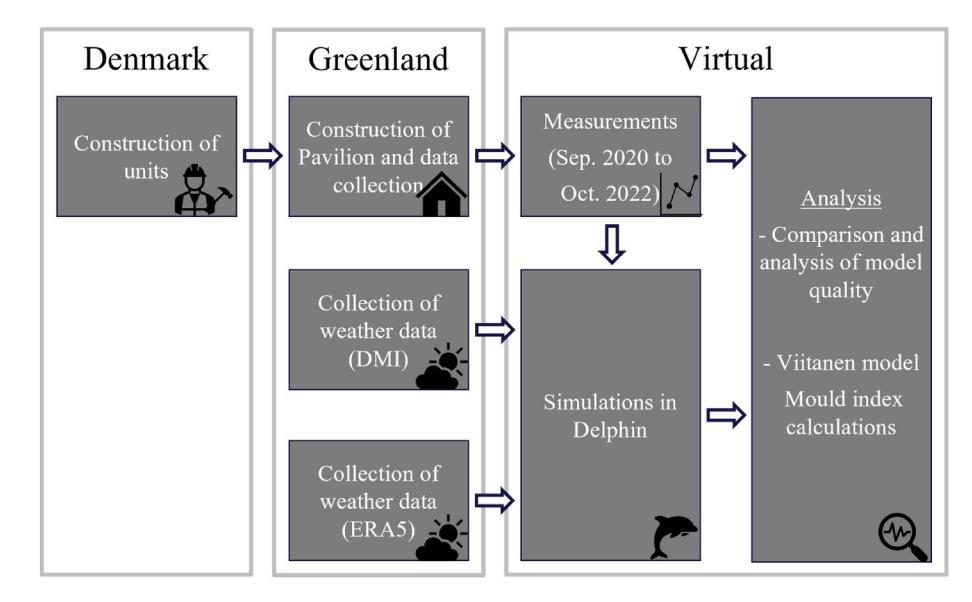
Fig. 1. Relation between collected data and applied methods during this study.

This study is based on experimental data from the test pavilion in Nuuk and hygrothermal simulations produced using the software Delphin. Delphin is a Coupled Heat, Air, Moisture and Pollutant Simulation for Building Envelope Systems (CHAMPS-BES) simulation tool, which has been verified by Nicolai et al. [24]. This section first introduces the pavilion, the different integrated constructions, and descriptions of how the data were analysed, compared, and assessed. This is followed by a thorough description of the hygrothermal simulation method. Finally, the investigation of the risk of mould growth using the Viitanen model implemented in WUFI VTT [25] is described. The process flow of this study, from data collection to analysis, is presented in Fig. 1.

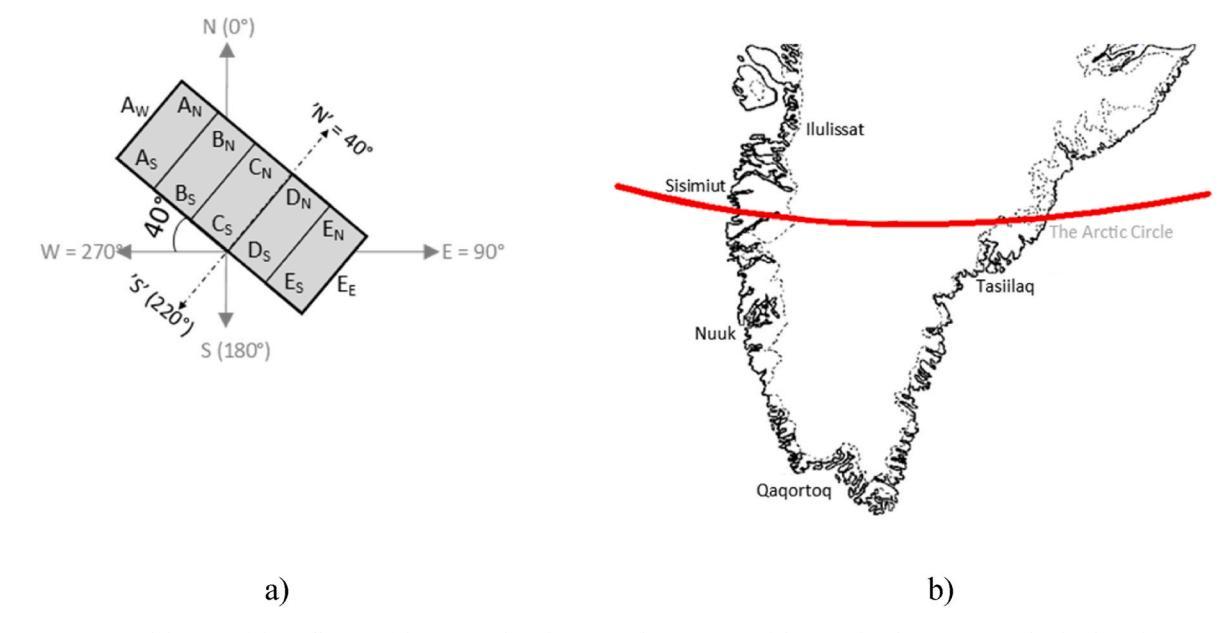
Fig. 2. a) Orientation and division of the wall units of the test pavilion. b) Geographic overview of the considered cities in Greenland (adapted from BR2006 [23]).

consisted of five differently designed façade elements, which for the remainder of this paper are referred to as "units". The orientation of the pavilion and the placement of the five different units (A-E) are shown in Fig. 2. All units were produced in two or three replicates, with the individual units facing different directions. The gables were constructed using units A and E. Data from the roof and floor units were also logged, although this article only focuses on the wall constructions. The pavilion was oriented at an angle of 40° from north (see Fig. 2). This means that what is referred to as the "northern side" in this study is actually offset 5° from north-east. The entrance door was placed in the western gable, A_W.

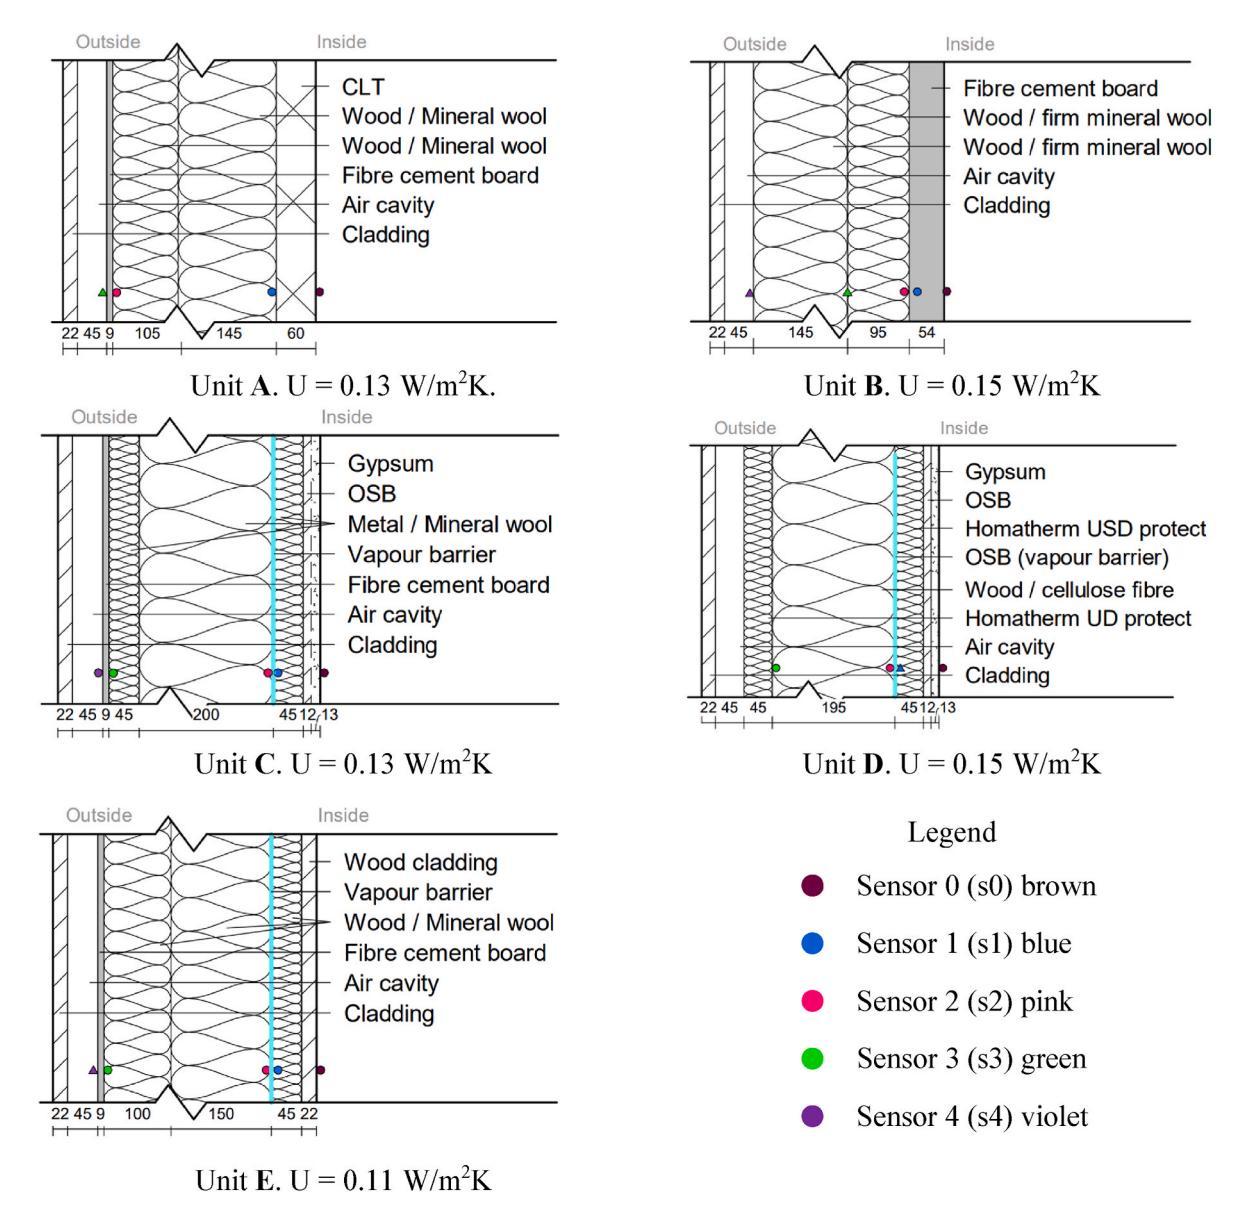
Fig. 3. Details of the construction of each unit and placement of the sensors. Sensor locations are either represented as dots (multiple orientations) or triangles (single orientation). The sensor colour corresponds to the lines in the graphs in Section 3. The sensors are named s0 to s4, starting from the interior side of the wall. (For interpretation of the references to colour in this figure legend, the reader is referred to the Web version of this article.)

As presented in Fig. 3, not all units had a sensor in the ventilated air cavity, but still, there was at least one representative sensor for all orientations. To identify how the orientation affected the hygrothermal conditions in the air cavity, the measurements in the ventilated air cavities are compared in Fig. 5.

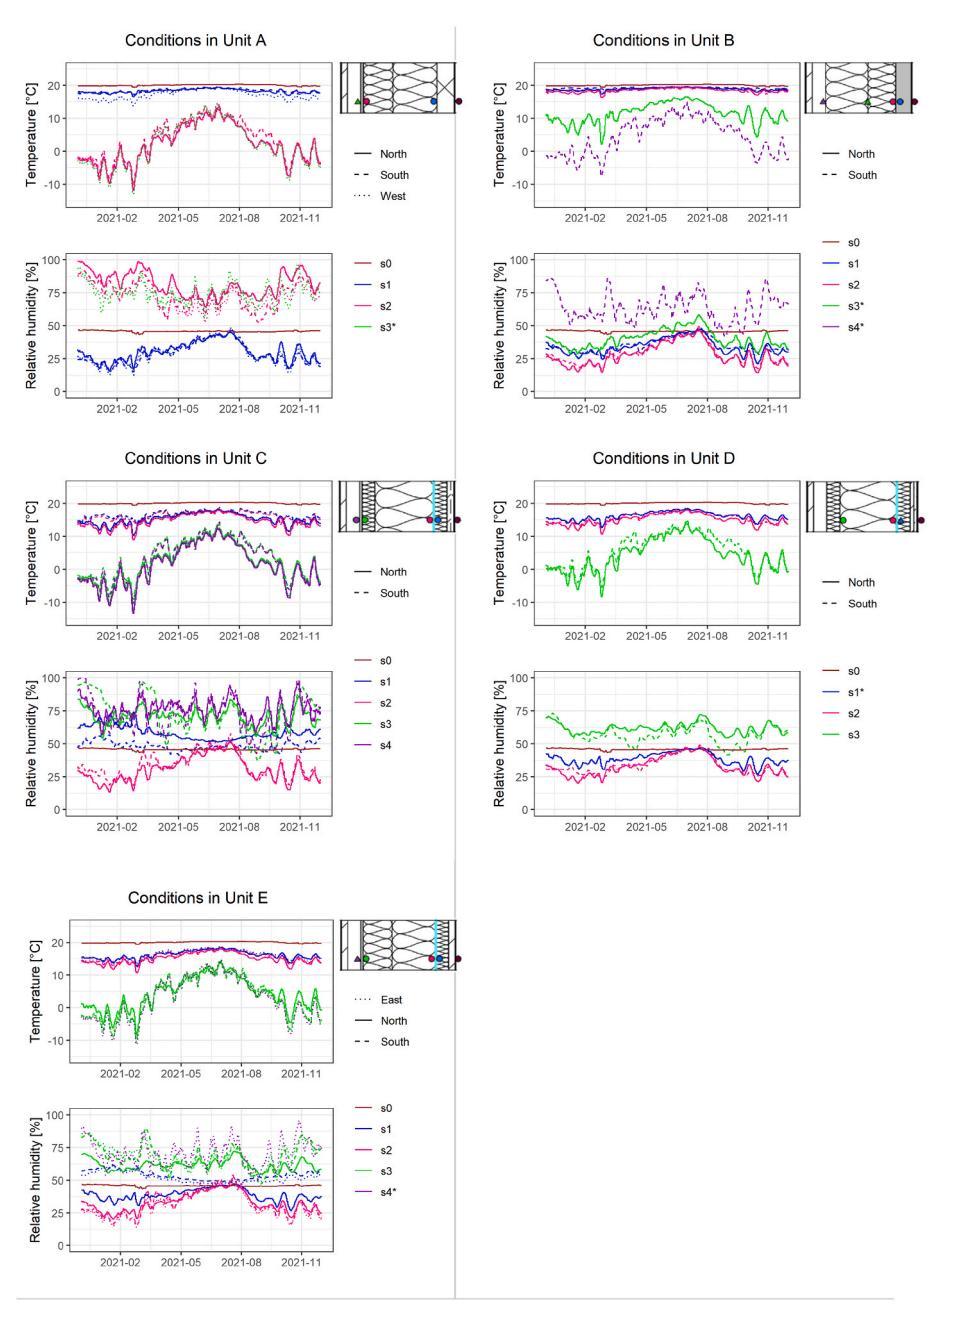
Fig. 4. Hygrothermal conditions in Units A – E (seven-day moving mean). The asterisks (*) indicate that the measurement point was only found in one direction of the unit (equal to a triangle in Fig. 3).

All available data from 2020-09-29 to 2022-10-20 are shown in Fig. 4, including interpolated values. The graphs had two purposes. First, to visually check for any remarkable changes in the measurements over time, which could indicate sensor drift. Second, to illustrate the differences between the units and the orientations. Noticeably, there was a decrease in the interior relative humidity during spring 2022, which did not seem to be caused by temperature changes. Plausible explanations could be that the humidifier, controlling the indoor relative humidity, stopped working or that the water tank connected to the humidifier was empty. Besides this, small deviances in the interior climate were noticeable, caused by maintenance activities in the pavilion, such as filling the humidifier tank and ensuring continuous data logging. From Fig. 4, it can also be seen that the temperatures in the exterior layers were highest in the south-oriented directions, lowest for the northern orientation, and in between for east and west orientations. A plausible explanation of these differences is heat contribution from direct solar irradiation. This could be seen for all units except B, as the sensors were placed differently in the north and south direction. Another general observation was that none of the constructions was exposed to 100% relative humidity for longer periods of time.

Based on s1 in Unit A, it is noticeable that the temperature was lower in the western orientation than in the north and south. As there were no visible differences between the orientations in the exterior layers, this temperature difference might have been caused by improper assembly of the entrance door, which could result in thermal bridges or wind flow in the construction. Given that the relative humidity was also lower in the western orientation, this may very well be the case. The relative humidity in s1 in Unit C stands out, as it was very different for the two orientations. The relative humidity was highest for the north orientation and never overlapped with the measurements for the south orientation. The temperature was also slightly lower in the north than in the south. In Unit E_{N} , there was a peak in temperature in March 2021. The peak in temperature occurred throughout all the northern units.

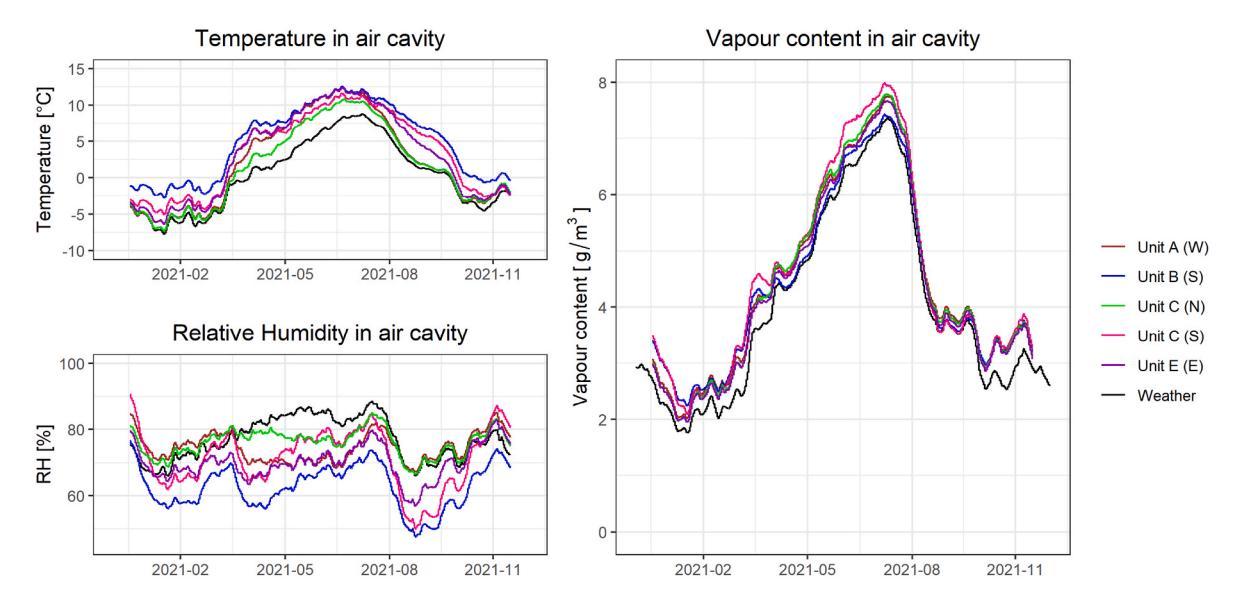
Fig. 5. Graphs for temperature, relative humidity, and vapour content in the air cavity in the year 2021. The graphs display the 30-day moving means to visualise the long-term trends.

The lowest temperatures were found in the northern-oriented Unit C, which can be explained by the fact that this orientation received the least amount of solar irradiation. Some of the highest relative humidity conditions were also detected in this unit. The vapour content in Unit A_W

and Unit C_N were similar, but in A_{W_j} the temperatures were higher, and in the summer months, the RH was lower. It was expected that in each direction, the conditions in the air cavity would be very similar. However, this was not the case, as Unit B_S had higher temperatures and lower RH than Unit C_S . It did not seem to be caused by drifting of the sensors, as they were not displaced equally during the year. The temperature difference between B_S and C_S could be caused by B_S having a higher Uvalue (U = 0.15 W/m^2K) than C_S (U = 0.13 W/m^2K), which allowed a higher heat loss through the surface.

It was found that the vapour moisture content exceeded 10 g/m³ at sensor point s2 for all elements with fibre cement board as the wind barrier. The vapour moisture content also exceeded 15 g/m³ for all units except the ones facing north.

Another uncertainty was caused by the air change rate, ACH, in the ventilated air cavity surrounding the test pavilion. As shown in Fig. 5, the hygrothermal conditions varied, even on the same side of the pavilion. If another facility like this should be planned or if this one was to be improved, it would be beneficial to install sensors to measure the wind speed inside the cavity; however, measuring the airflow is a

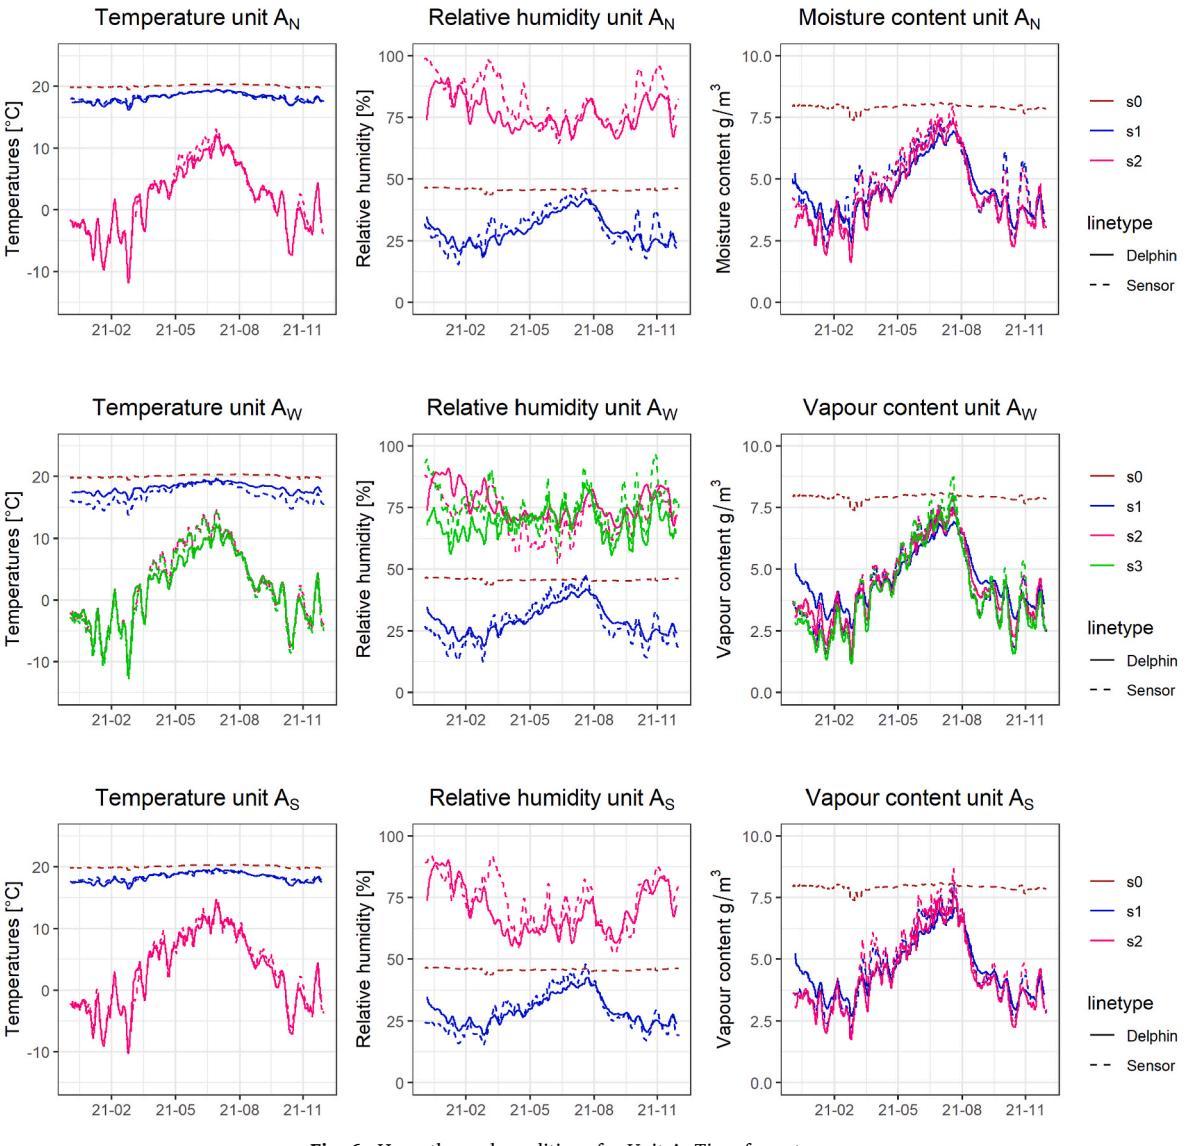
Fig. 6. Hygrothermal conditions for Unit A. Time format yy-mm.

- The simulation of A_W generally performed worse than A_N and A_S . Unit A_W is the gable with the entrance door, which might affect the hygrothermal performance of the unit. Fig. 5 shows that the RH in the air cavity was high in this orientation compared to the other orientations, which is also shown in Fig. 6, where the RH in d₃ was lower than m₃.
- In Unit B_s , the simulated relative humidity (d₄) was higher than the measured (m₄) (see Fig. 7). As for Unit A_W, this could be traced back to the hygrothermal conditions in the air cavity, where m₄ for B_s had the lowest relative humidity.

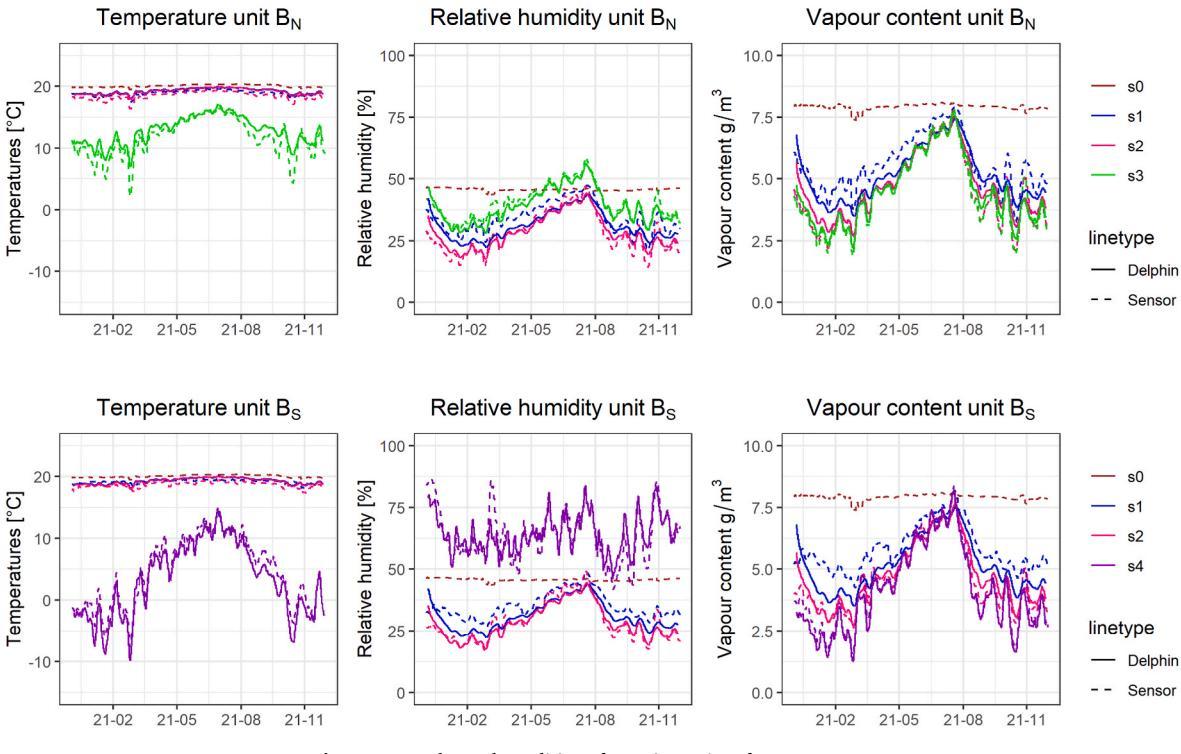
Fig. 7. Hygrothermal conditions for Unit B. Time format yy-mm.

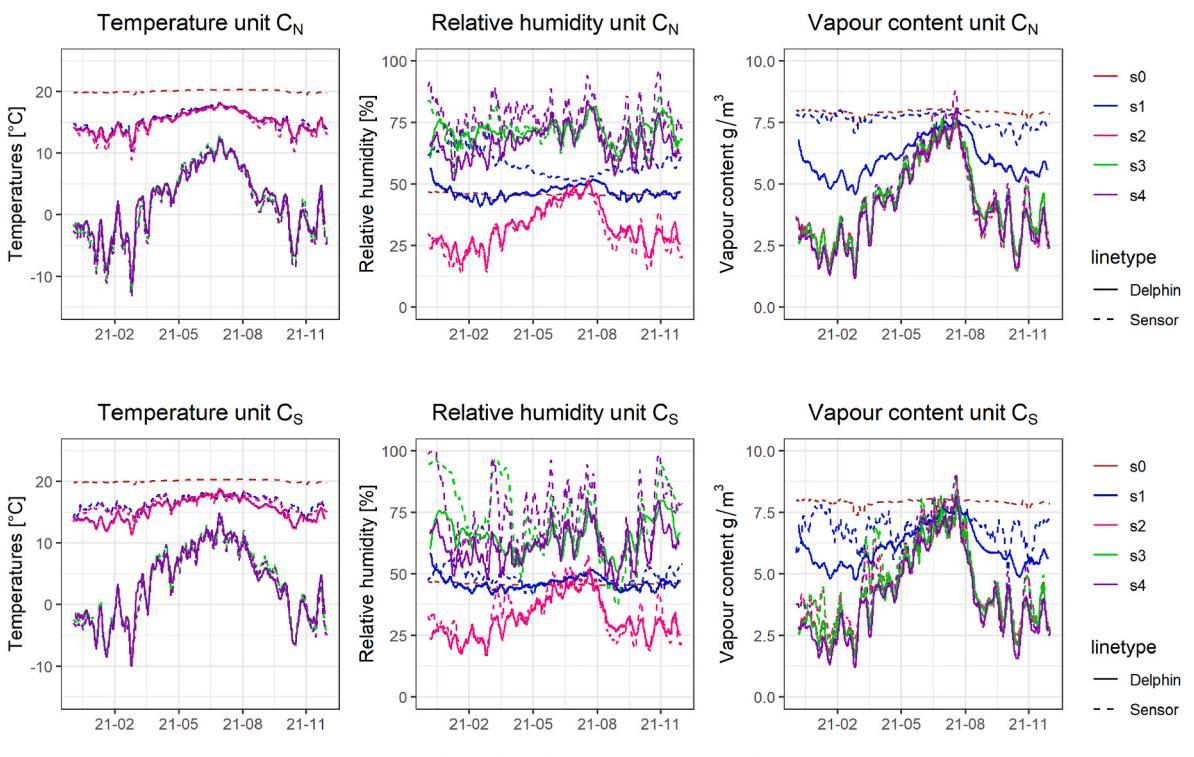
Fig. 8. Hygrothermal conditions for Unit C. Time format yy-mm.

- Both C_N and C_S had sensor points with high RMSE, even for the moving mean of RH. The measured values were very different at s1 compared to s2 and s3, e.g., the peaks were much higher in the southern direction (see Fig. 8). This difference challenged the model fitting in Delphin, as solar irradiation seemed to have a bigger impact on the orientation in the measured data than in Delphin. The high RH in m_1 in the north end (see Fig. 8) does not indicate a perforated vapour barrier, as that would cause the humidity level to align closer with the interior climate. In theory, the difference can be caused by poor sensor calibration, but as described in Section 3.1, Fig. 4 does not indicate such a situation.

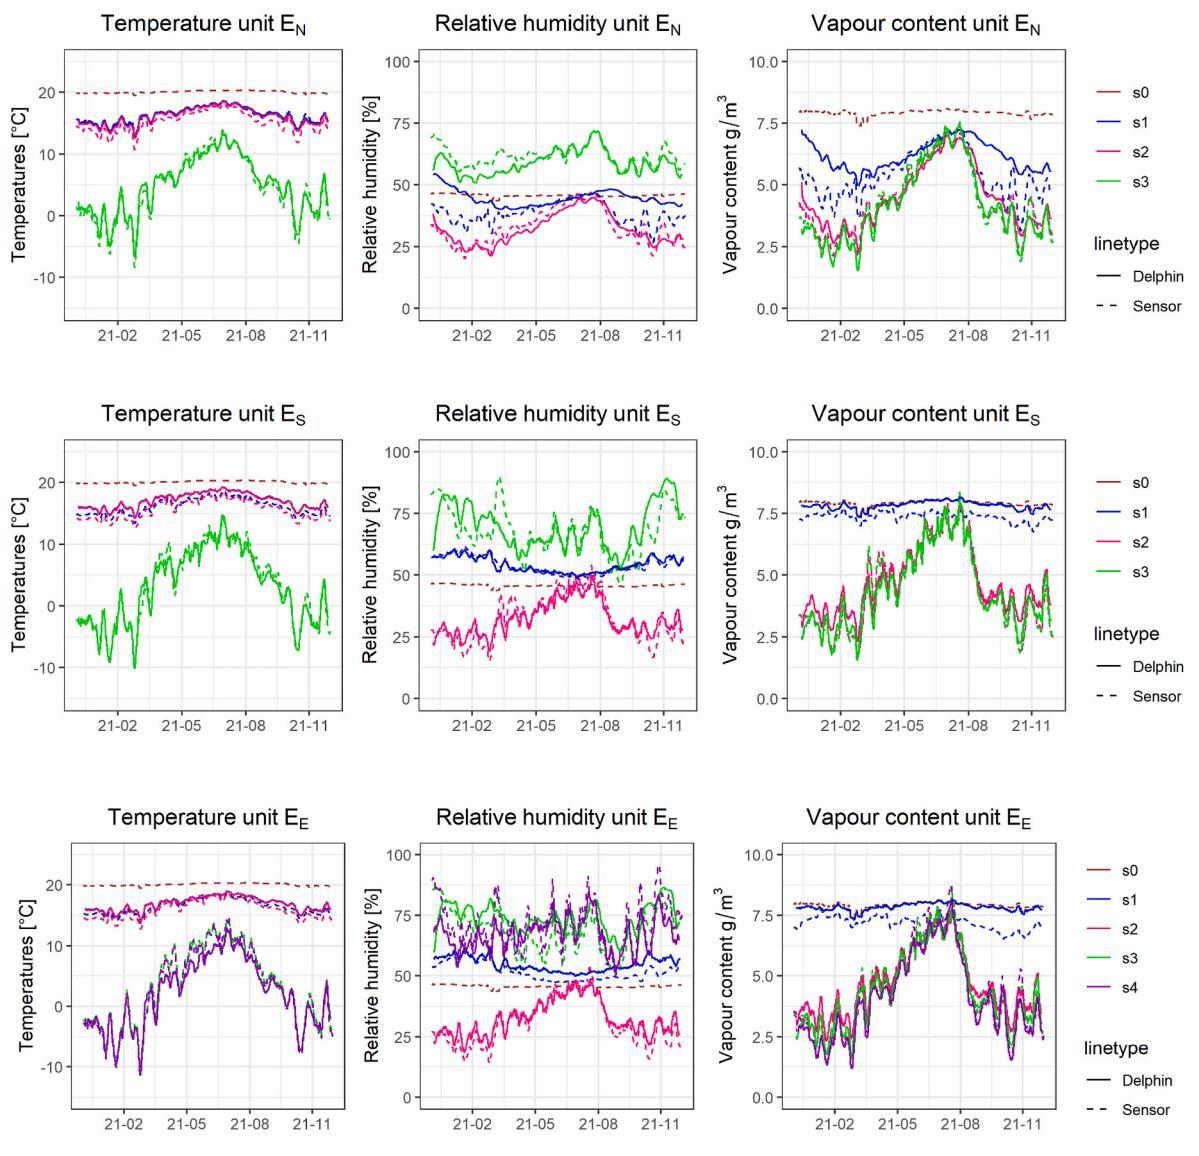
Fig. 10. Hygrothermal conditions for Unit E. Time format yy-mm.

- All orientations for Unit E had high RMSE for relative humidity at sensor point s2. According to the low RMSE for the moving mean values, the error occurred due to short-term spikes in the data. The RMSE for s3 in E_S was also high, where the modelled parameters from Delphin were higher than the measured (m₃). In the gable, E_E , d₄ had smaller peaks than m₄ (see Fig. 10).

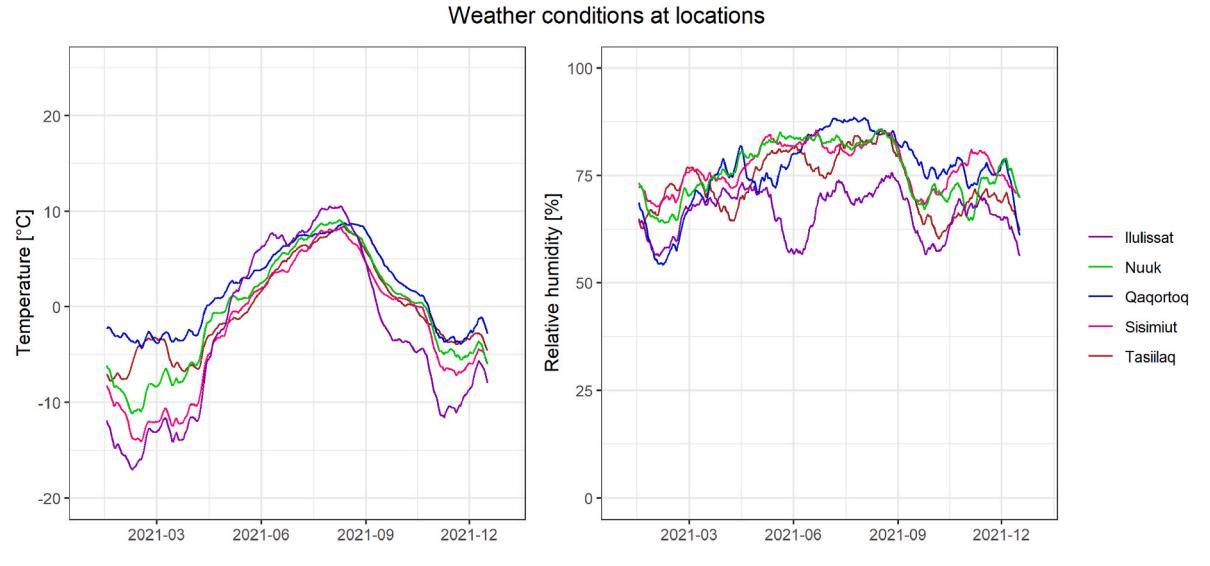
Fig. 11. Weather conditions at the five locations in 2021 (seven-day moving mean).

The temperature and relative humidity from the ERA5 reanalysis dataset for the five locations is presented in Fig. 11.

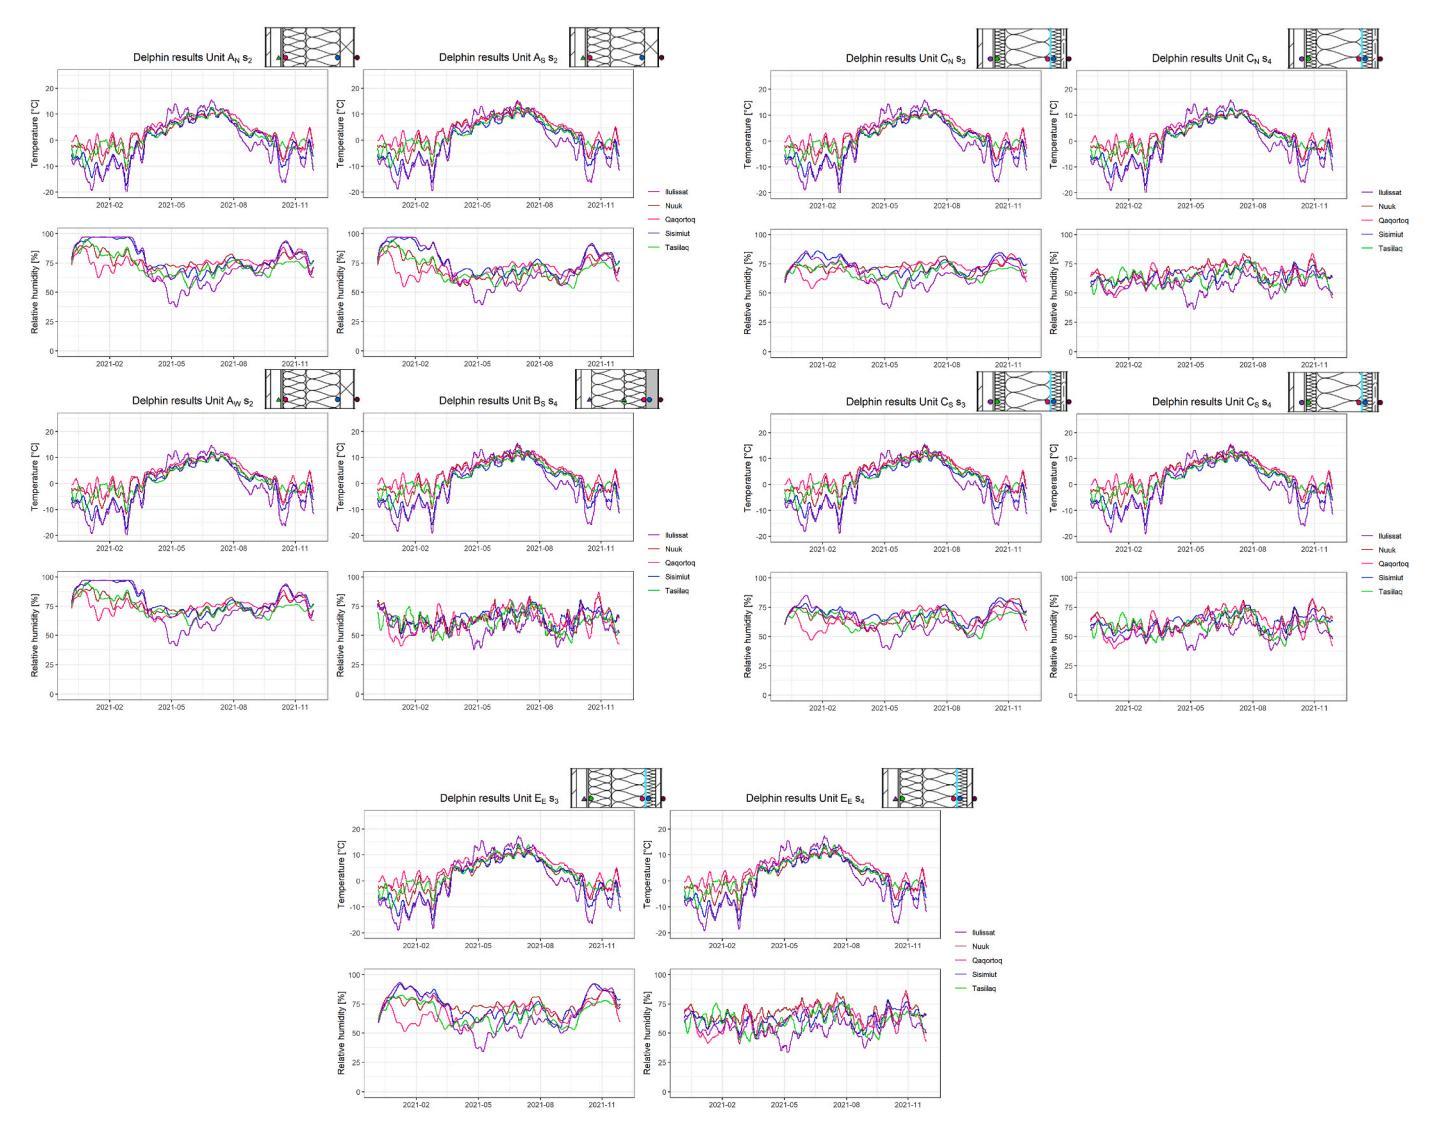
Fig. 12. Comparison of results for multiple Greenlandic locations.

The graphs in Fig. 12 were made using a seven-day moving mean and show the hygrothermal conditions at each sensor point for all considered locations. When evaluating the results, it must be considered that the ERA5 weather data are modelled and not measured. The location had almost no influence on the temperature and minimal impact on the relative humidity at the inner layers (sensor points s1 and s2). Therefore, these are not included in Fig. 12. Neither are the graphs representing humidity levels below 75%. The absent graphs can be found in the repository [49]. At the other sensor points (s3 to s4), the highest relative humidity appears in Ilulissat and Sisimiut, followed by Nuuk.

The constructions and locations at the highest risk of mould growth are identified from the graphs in Fig. 12. The analysis in WUFI VTT is based on the Viitanen model [48] and is made for both measured and simulated values. For all assessments, the material was defined as pine sapwood, which is very sensitive and thus represents a worst-case scenario. The upper part of Table 4 presents the results for the included sensor points analysed with the measured interior conditions from the test pavilion (constant interior conditions of approximately 50% RH and 20 °C). Because of the controlled indoor climate, an additional analysis was made to see the impact of the potentially inappropriate use of a residential building causing high indoor relative humidity. The indoor temperatures were still taken from the measured values from the pavilion, but the RH was changed to 70% and 80%. The calculated mould indexes are presented in Table 4. The mould index ranges from 0 to 6 [50], and according to Ojanen et al. [50], the infestation level is considered acceptable when the index is 2 or less for surfaces inside a construction. The mould index itself is less important as it is based on a relatively short period, but it illustrates the differences and sensitivity for different conditions.

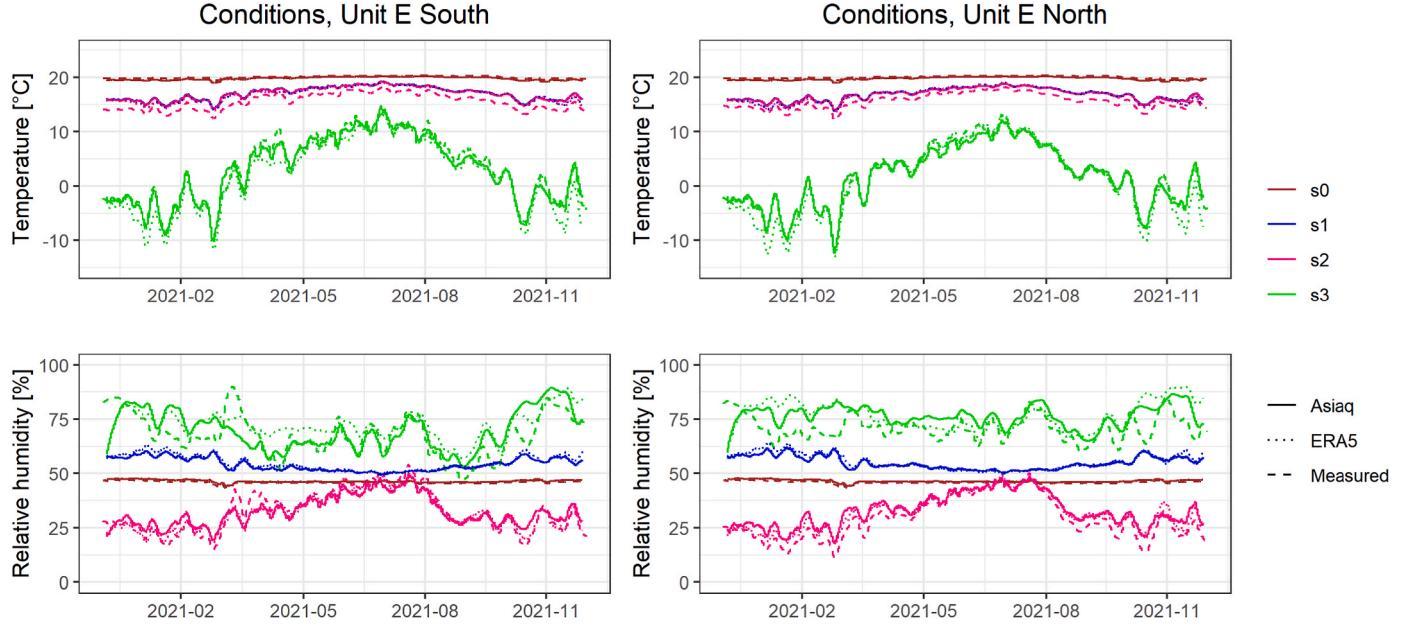
Fig. 13. Simulated and measured conditions in Unit E for different weather data sources for Nuuk.

conditions for a specific time, although they are not measured by rather derived from a weather model. It is relevant to evaluate how it affects the simulation quality by comparing the simulation results made with ERA5 and measured data from Asiaq. This is shown in Fig. 13, along with the data from the sensors. The results are shown for Unit E as it is representative of all units. The rest of the graphs can be found in the repository [49].

The results from Delphin generated using measured weather data (Asiaq) for Nuuk in 2021 are very similar to the results obtained with the modelled weather data (ERA5). The maximum change of RMSE for the temperatures was 0.65 °C, and for RH, it was 6.84% (41 of 48 RMSE-values are below 2.13%). This indicates that the reanalysis weather data can be used as an alternative to measured weather data for studies investigating the impact of different locations. Coincidentally, it can be observed that the modelled weather results in a better fit for RH than the measured weather.
