Published in: COLD CLIMATE HVAC 2009

# Performance of the Low-energy House in Sisimiut

# SUMMARY

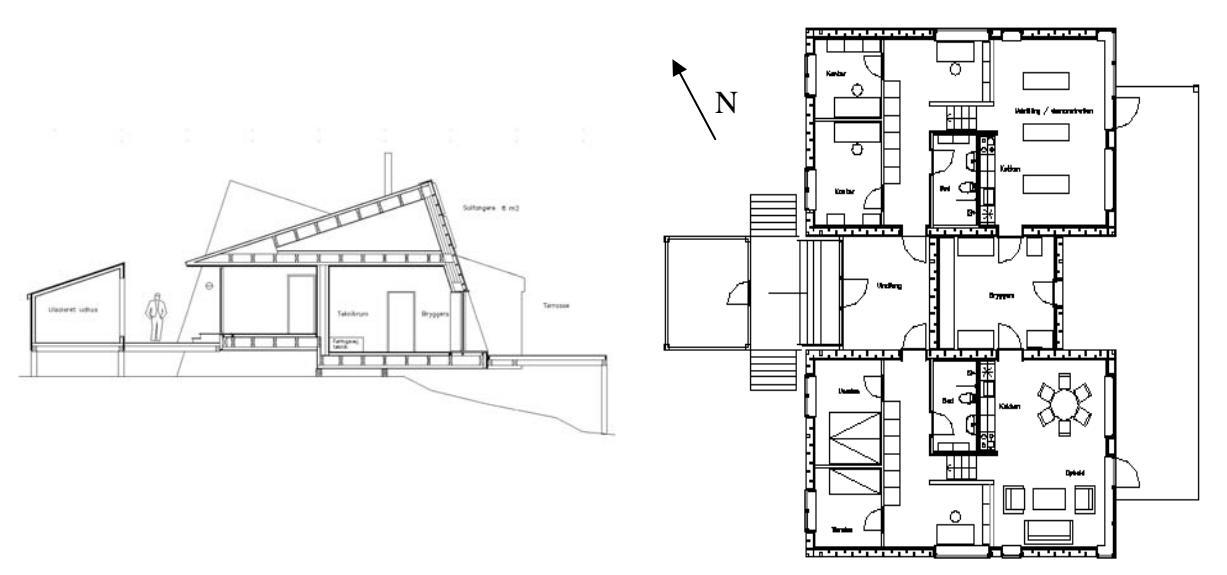
Figure 1. Cross section and floor plan of the low-energy house. The house is built as a double house with common scullery/boiler room and entrance hall.

The low-energy house is made as a double-house with a floor area of 197 m<sup>2</sup>, where the two living areas are built on each side of the boiler room and an entrance hall. Figure 1 shows a cross section and floor plan of the house. One of the two apartments serves as home for a family, while the other is used as an exhibition, and also occasionally functions as a guest house for visitors. Some descriptions of the building are given below, but more can be found in the proceedings of the inauguration symposium (Artek, 2005).

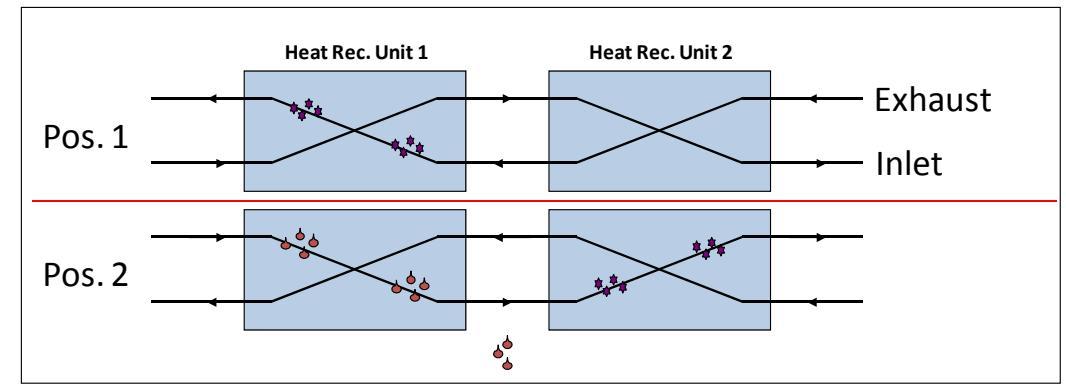
Figure 2. Diagram of the heat recovery unit with two heat exchangers.

A new heat recovery unit was developed for the low-energy house in Sisimiut in cooperation between EXHAUSTO A/S and the Technical University of Denmark. The dimensions of the unit are: Length 1,760 mm, width 930 mm and height 660 mm. The unit consists of two highly efficient aluminium counter flow heat exchangers coupled in a serial connection. A valve is able to switch the air flow direction through the units. When ice formation starts to reduce the airflow in the coldest exchanger the air flow direction is switched. The exchangers, valve and filters are mounted in a cabinet with 50 mm insulation, although the unit is recommended to be placed in a heated place to minimize risks of frost damages from the condensing water. The theoretical temperature efficiency of the heat recovery unit is approximately 90 %. A diagram of the system is shown in Figure 2.

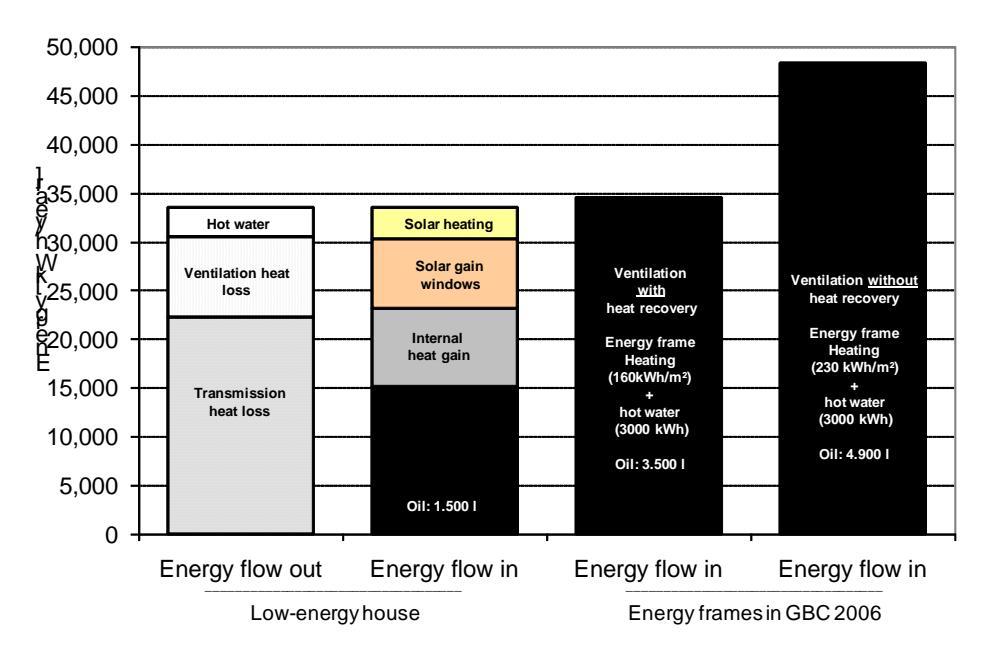
Figure 3. Energy balance of the 197 m<sup>2</sup> low-energy house compared with the demands of the Greenlandic building code.

The results are compared with the expected energy frame demands in the building code of Greenland. For a house with a mechanical ventilation system with or without heat recovery the energy frame demands are set to 160 and 230 kWh/m<sup>2</sup> respectively. It is seen that the energy consumption is simulated to be approximately 1,500 litres of oil per year. Compared with the energy frames of the building code it is seen that more than 3,000 litres of oil are saved every year. The simulation results show that the annual energy consumption of the low-energy house is below the target of 80 kWh/m<sup>2</sup> (Kragh et al., 2005).

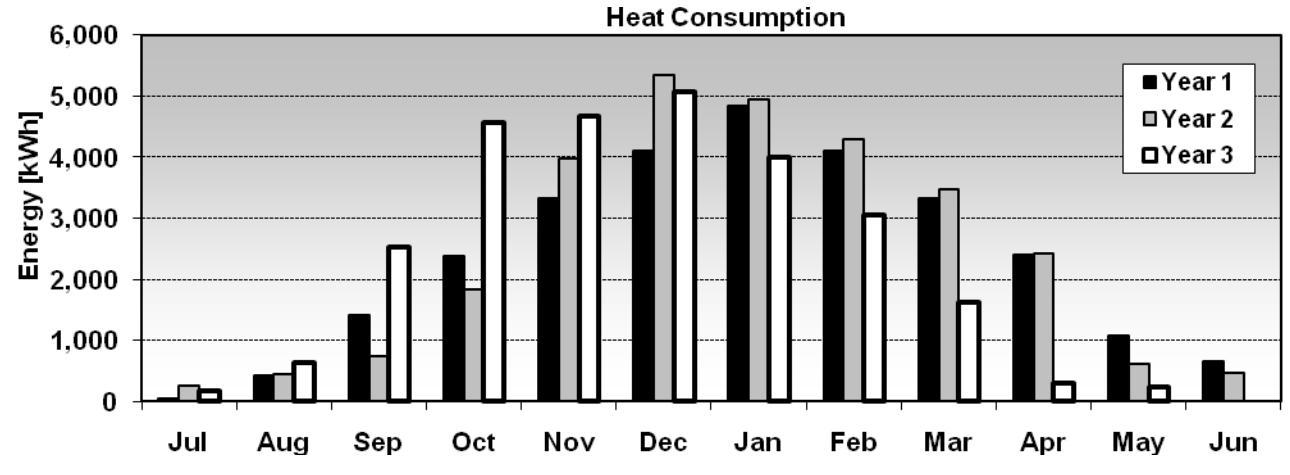
Figure 4. Heat consumption during the months of the first three full years of operation.

Figure 4 shows the monthly energy consumption for heating (exclusive of domestic hot water), where year 1 is for the period July 2005 – June 2006. The house has not been inhabited during the period July 2007 – April 2008 during which period the house underwent some renovation activities: A separation wall was erected in the boiler room, and the wooden floor of the living rooms was changed because of a failure with the first delivered floor. The house was heated during the construction period, although in a somewhat unusual pattern.

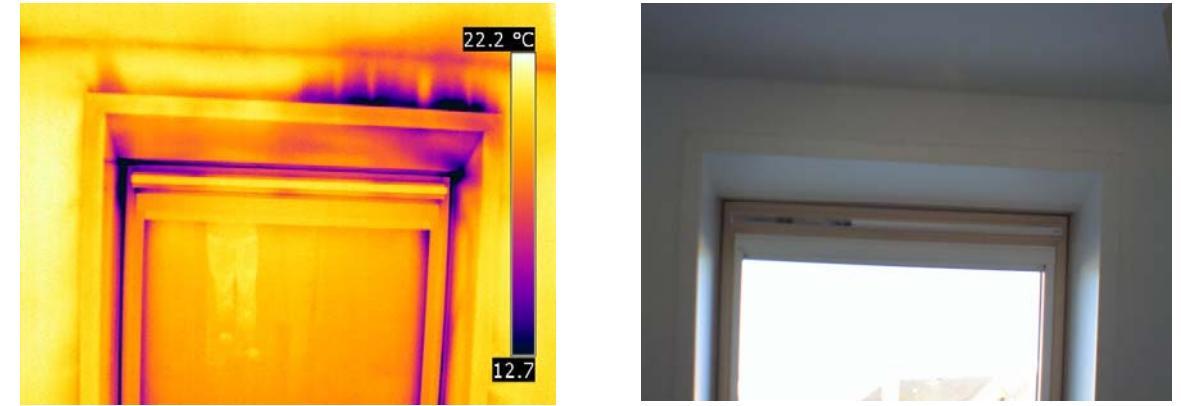
Figure 5. Infrared and normal picture of north-west facing window taken during blower door test.

A so-called blower door test has been carried out on February 7, 2009. The test showed an average leakage of  $3.2 \text{ h}^{-1}$  measured at 50 Pa over- and under-pressure. While this air leakage is not too high compared to the Greenlandic Building Code, since there are no requirements, it is significantly above the requirement imposed since 2006 in the Danish Building Code, that the air change must not exceed  $1.5 \text{ h}^{-1}$  when measured at 50 Pa pressure difference. Problem areas were identified around windows, at floor joints, at electrical outlets, and possibly under the floor (see Figure 5).
