Effect of ionic contamination on climatic reliability of printed circuit board assemblies

Published in: Proceedings of the European Corrosion Congress 2012

Effect of Ionic Contamination on Corrosion Reliability of Printed Circuit Board Assemblies

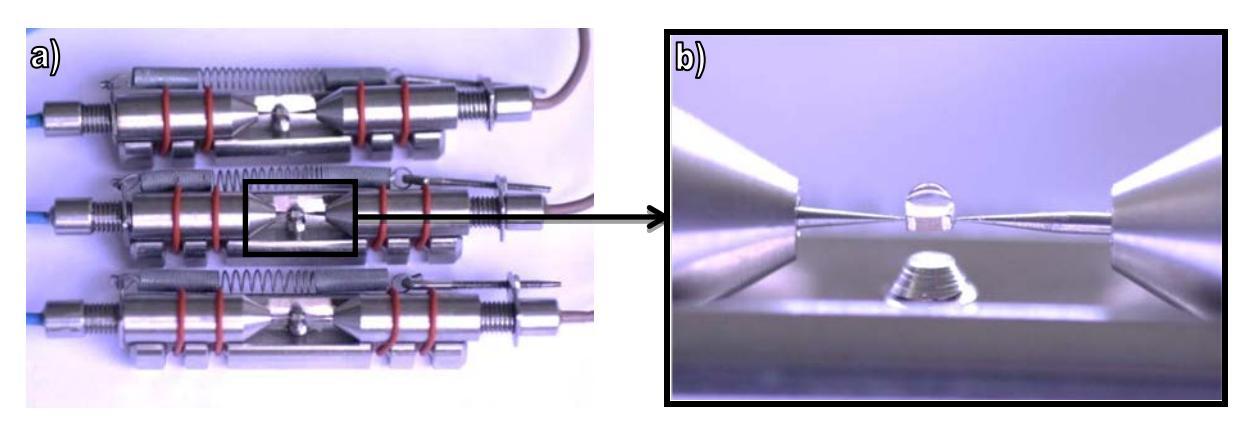
Single component electrochemical migration tests have been conducted using a special setup described by Minzari et al. [10,11]. The single component electrochemical migration (SCECM) setup consists of a sample holder having two small adjustable probes, which act as connectors to each end of the surface mount components (SMC) – in this case ceramic chip capacitors. The entire SCECM setup consists of three separate pairs of metal probes and enables the experiments to be conducted with three chip capacitors at a time, as shown in **Figure 1 (a)**.

Figure 1: Single component electrochemical migration setup

The ECM probability testing on the single components was done by placing a micro droplet of electrolyte at a desirable concentration on top of the surface mount components. The current was measured between the terminals of the components which are bridged via the droplet of electrolyte solution and biased at DC voltage in the range of 1 V - 25 V using an in-house built multi-channel multiplexer unit called "CELCORR test PCB set up", described elsewhere [12]. The leak current followed by the current increase due to ECM (electric short due to dendrite formation) was measured with a 1 µA resolution ammeter connected in the circuit via a two switch system. The sampling rate for the leakage current reading was set to 1 s. The experiments were carried out under ambient conditions: temperature 23.5°C – 24.5°C, relative humidity 30% – 40%.

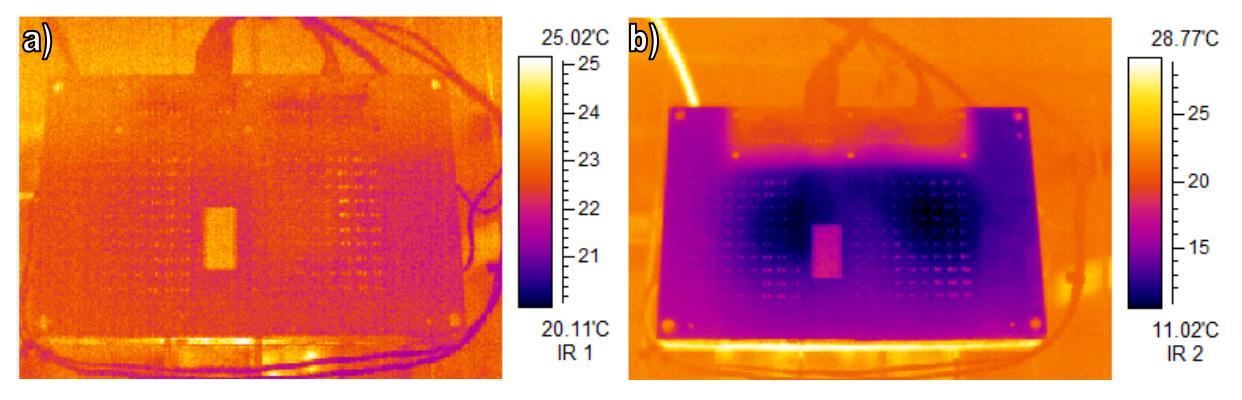
The temperature of the PCB was controlled by mounting the PCB on an aluminum block with embedded Peltier elements. The heat from the hot side of the Peltier elements was removed using a coolant passing through the hollow aluminum block. A DC power source (EA-PSI 6032-06 32V/6A) was used for applying potential to the Peltier elements. The surface temperature of the PCB mounted on the aluminum block was measured with two platinum Resistance Temperature Detectors (PT1000 class A) connected in a *2-wire* circuit. DaqLink data logger "Fourier Systems DBSA720" was used to log the temperature/voltage readings on the surface of PCB throughout the duration of the experiment. The cooling effect on PCBs placed on the aluminum block is presented in **Figure 2**.

Figure 2: Temperature profiles of test PCB fixed on aluminum block with embedded Peltier elements taken at ambient temperature of 25° C: (a) – without cooling; (b) – 4V DC is applied on Peltier elements

The whole test was performed inside the climatic chamber under constant humidity (60% RH), while the temperature of the PCB was changed as described above. Insitu monitoring of the water layer formation and condensation was carried out using the video camera installed inside the climatic chamber. This allowed in-situ observation of water layer formation and corrosion failures on the PCB.

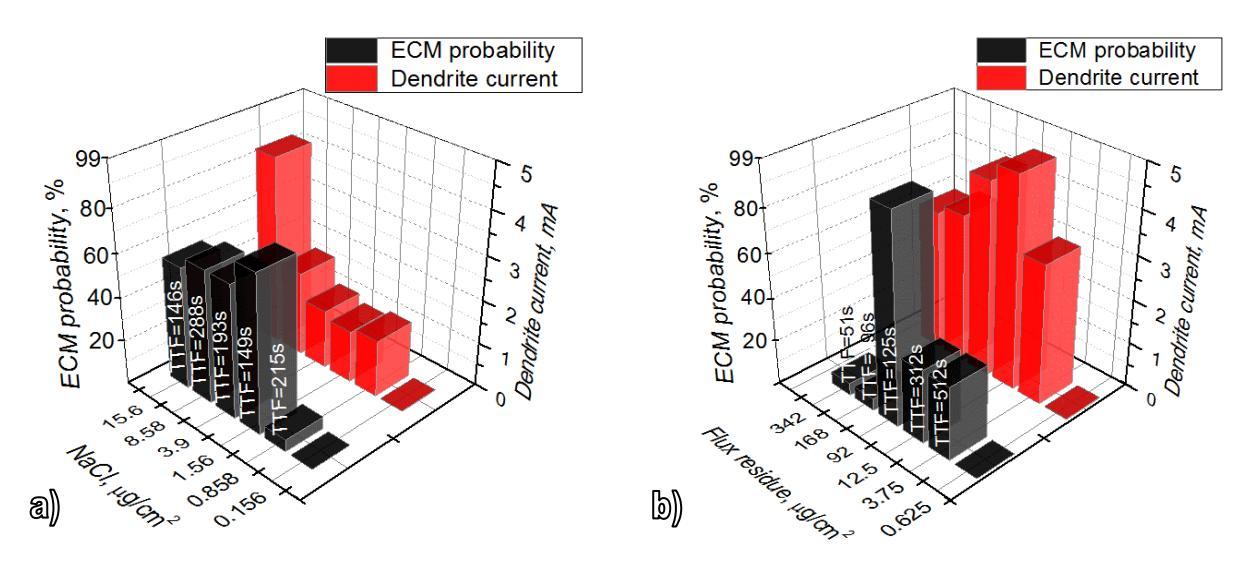
Figure 3 shows the probability of migration (number of capacitors which showed ECM out of 18 experiments in each category expressed as a percentage) and the average dendrite current for NaCl and flux residue as a function of concentration. The average time to dendrite growth initiation marked as time to failure (TTF) corresponding to each set of experiments is shown on the bar.

Figure 3: ECM probability and dendrite current as a function of concentration: (a) NaCl and (b) flux residue

Further increase in flux residue concentrations caused only a low probability of migration (Figure 3 (b)), while the component shown in Figure 5 shows heavy corrosion of the anode terminal, but no dendrites or precipitation of tin hydroxides as was seen in the case of NaCl. This appearance might indicate that the pH level of solution was moved towards the acidic area due to the high levels of weak organic acids in the flux residue and therefore the precipitation of tin hydroxides was

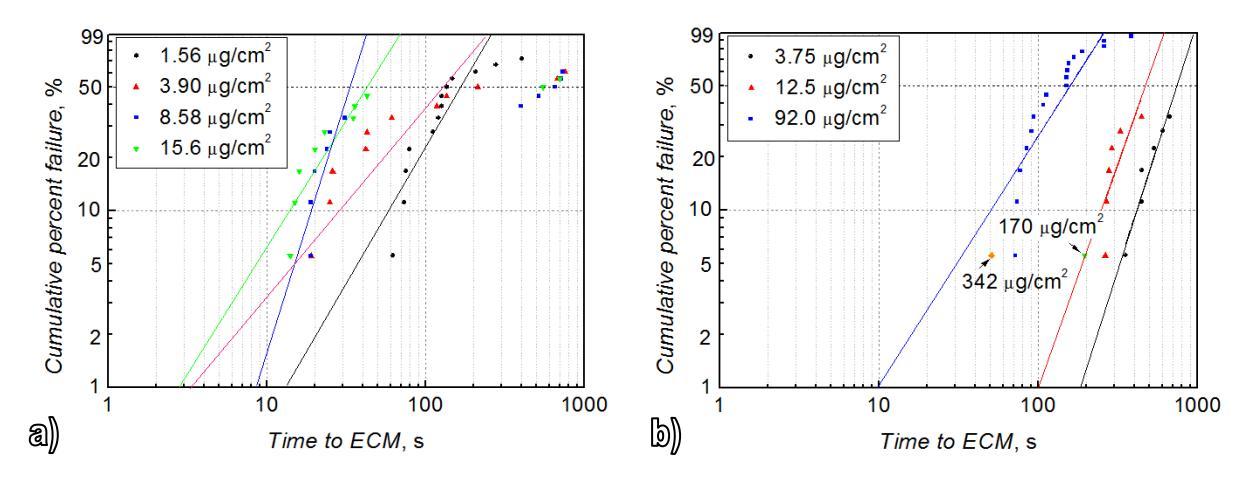
The level and the type of ionic contamination showed an influence on the probability of an ECM event and also the time of ECM initiation. The following effects are shown in the cumulative percent of ECM versus time graphs for NaCl and solder flux residues in **Figure 4**.

Figure 4: Cumulative failure dependence of time for (a) - NaCl and (b) - solder flux residue

As is seen from the graphs in **Figure 4**, increasing concentration shortens the time to an ECM event. This fact is also clear from the comparison of the time needed for 50 % of capacitors to show ECM as well as from the time to the first failure. In the case of NaCl, the increase of concentration from 1.56 μ g/cm² to 15.6 μ g/cm² reduces the time to first failure accordingly: 62s, 25s, 19s and 14s. The presence of flux residues reduces the time to the first ECM event from 354s to 72s with increase of concentration from 3.75 μ g/cm² to 92 μ g/cm².

The results revealed contamination levels below which the probability of dendrite growth is very low. This empirically found limit for NaCl is in the range between 1.56 μ g/cm² and 0.858 μ g/cm², whereas for "no-clean" solder flux residues investigated in this work, this limit is much more broad where it starts at 3.75 μ g/cm² until it peaks around 92 μ g/cm². In general a decrease of TTF and to some extent an increase of cumulative percent failure was observed with increasing level of contamination (**Figure 4**). However a considerable reduction of ECM probability at very high

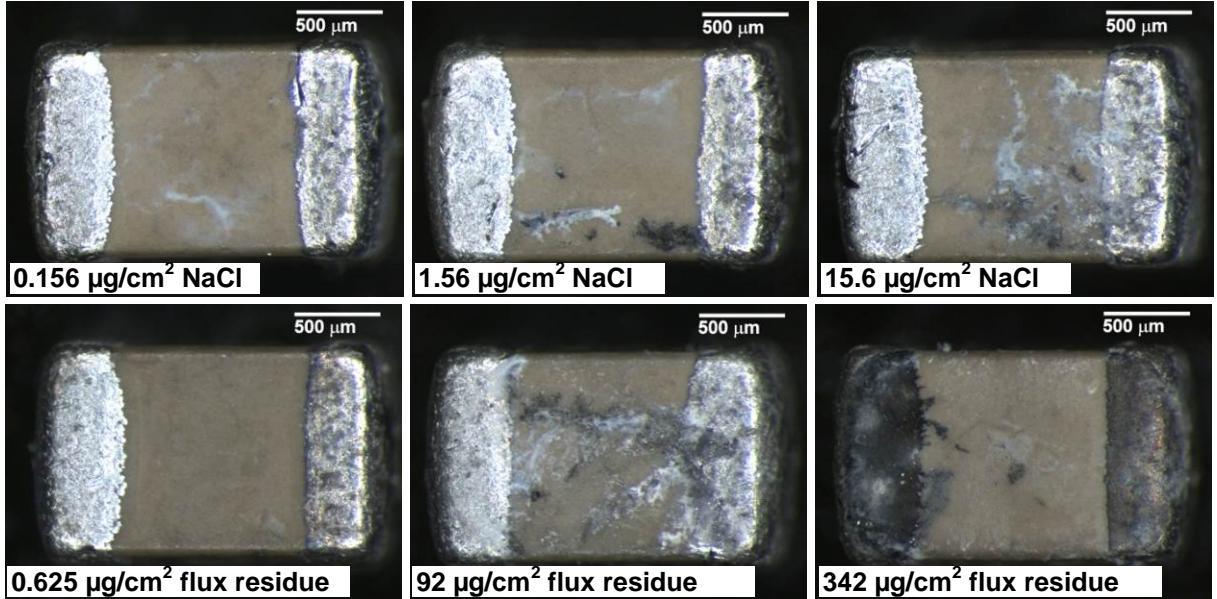
Figure 5 shows the morphology of the dendrite after migration for NaCl and flux residue as a function of concentration. For NaCl, the probability of dendrite growth increases rapidly above a concentration of 0.858 μ g/cm². Below this level, the migration probability is low, probably due to the low dissolution of tin. Typical surface morphology of a component at 0.156 μ g/cm² of NaCl shows very few corrosion products (appearing white in the image). However as the concentration of chloride increases, dendrites start appearing, and at very high concentration levels a mixture of dendrites and white precipitate species can be seen. At high chloride levels, the probability of ECM is also slightly reduced due to the large amounts of tin ions in the solution which leads to heavy precipitation, reducing the chance for dendrite growth as reported by Minzari et al. [13]. The precipitate species can be hydroxides of tin namely Sn(OH)₄ and/or Sn(OH)₂, although intermediate hydroxyl chloride species are also possible [14].

Figure 5: Size 0805 capacitors after SCECM testing at 5 V DC; pictures corresponding to NaCl and solder flux residues are shown in the images. Anode terminal is on the right and cathode on the left side

Typical optical micrographs of the tested components with flux residue (**Figure 5**) shows that the level of corrosion is negligible at lower concentrations; however, at 92 μ g/cm², the surface of the component shows a clear dendrite mixed with some hydroxides. The appearance of ECM at flux residue concentrations 3.75 μ g/cm² – 92 μ g/cm² is similar to the appearance of ECM observed with NaCl. Light optical microscope images revealed the dendrites (dark grey color) bridging the terminals and the tin hydroxides (white color).

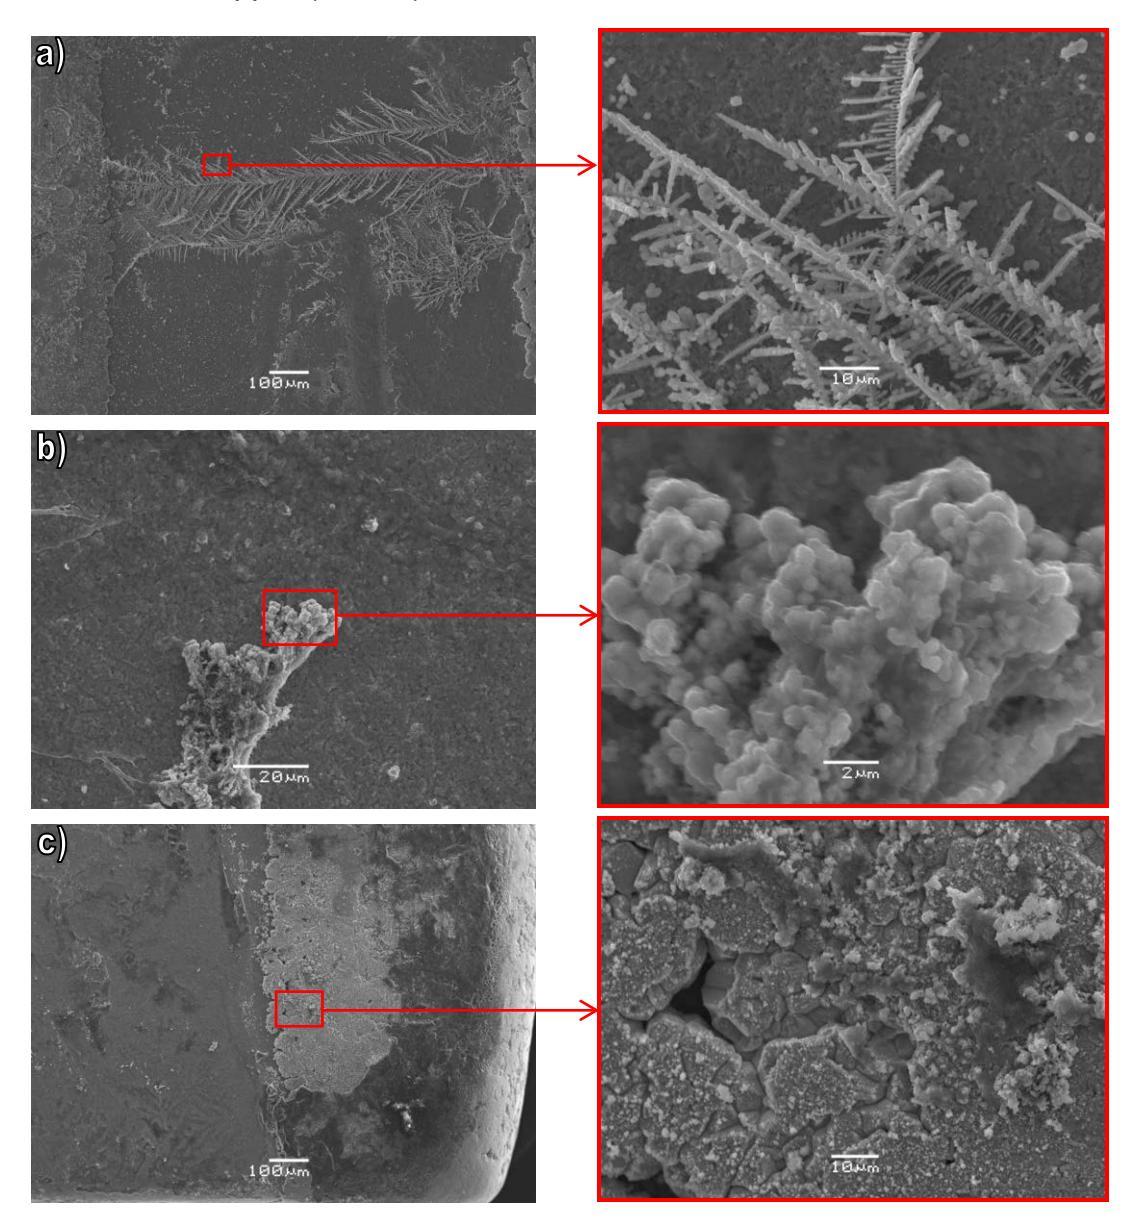
Figure 6: (a) – ECM on the size 0805 capacitors with 92 µg/cm² of flux residue; (b) – deposition of corrosion product (black deposits) nearby cathode terminal with 342 µg/cm² of flux residue and (c) – corrosion of anode terminal with 342 µg/cm² of flux residue

The EDS analysis of corrosion products on the anode terminal (**Figure 6 (c)**) indicated mainly tin (85 wt.%, however some amount of copper (10 wt.%) and small amount of chromium (less than 5 wt.%)) were identified. Both elements are known to be used as termination materials for multilayer chip capacitors [17–19], and indicate a heavy dissolution of electroplated top layer of tin. The copper and chromium were mostly

identified on the very edges of the anode terminal, where the dissolution rate of metal is expected to be the highest.

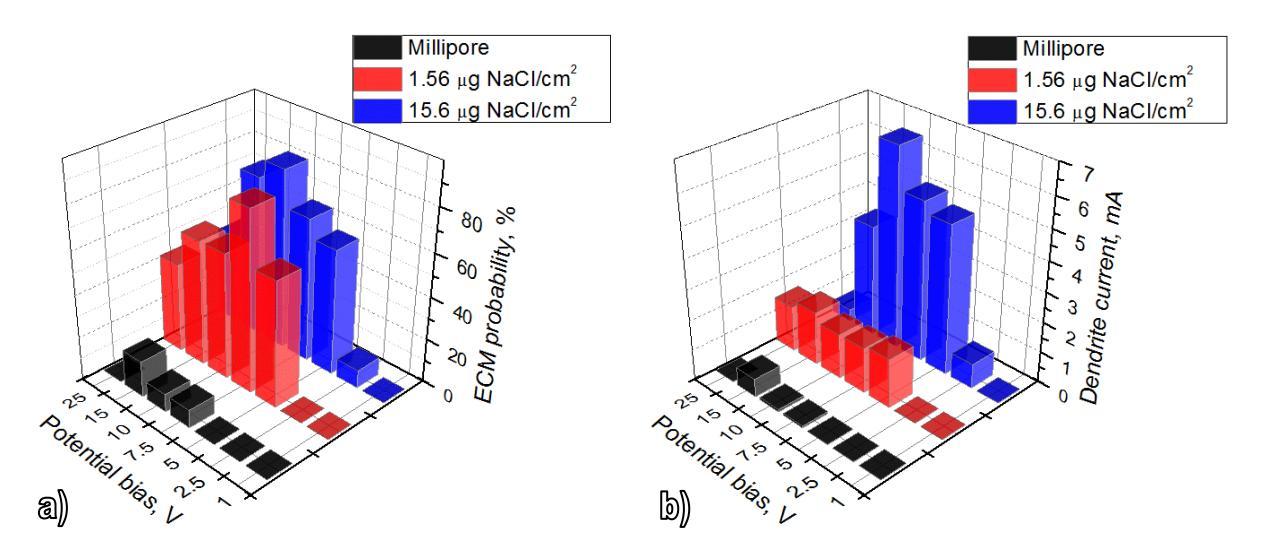
The effect of electric field in the range between 1 mV/µm and 25 mV/µm on ECM probability and dendrite current was investigated at contamination levels 1.56 µg/cm² and 15.6 µg/cm² concentrations of NaCl together with clean components. The graphs representing the results are shown in **Figure 7**. It is seen that the probability of migration initially increases with increasing electric field as the voltage applied on the terminals of capacitor until an intermediate voltage is reached, after which an increase in voltage causes a decrease in the probability of electrochemical migration. The electric field at which maximum probability of migration occurs is a function of NaCl concentration, however it was found to be in the neighborhood of 10 mV/µm – 15 mV/µm (respectively 10 V and 15 V potential bias). Also the probability of migration in general was low at lower potential bias values such as 1 V – 2.5 V above which the probability increases drastically in solutions containing NaCl, while the probability of migration in Millipore water remains low irrespective of the potential bias.

Figure 7: (a) – Comparison of the potential influence on ECM probability and (b) – dendrite current in terms of contamination

In general the probability of migration shows a bell curve with an increasing trend initially followed by a decreasing trend above the maximum, similar to the result found for increase in concentrations of contaminants. However, **Figure 7 (a)** shows

that the effect of contamination is more pronounced, especially from Millipore water to 1.56 μ g/cm² chloride solutions. The dendrite current also shows a similar behavior except for a large increase of dendrite current at 15.6 μ g/cm² conditions. This indicates the formation of thick dendrites, unlike in other cases. It shows that increased contamination increases the dissolution rate of the metal, which consequently forms thicker and more branched dendrites containing more metal and hydroxide precipitation. The high amount of metal content in the dendrites increases the current leaking through. However, as the potential increases, the probability of migration decreases, which also correlates with a decrease in the dendrite current. This is due to the fact that the rate of dissolution of tin increases with an increase in potential bias similar to increase in contamination. This leads to precipitation of the hydroxide species, while the heavy gas evolution at the anode and cathode also inhibit the formation of dendrites. Minzari et al. [11] have reported similar phenomenon with increase in potential bias or contamination level.

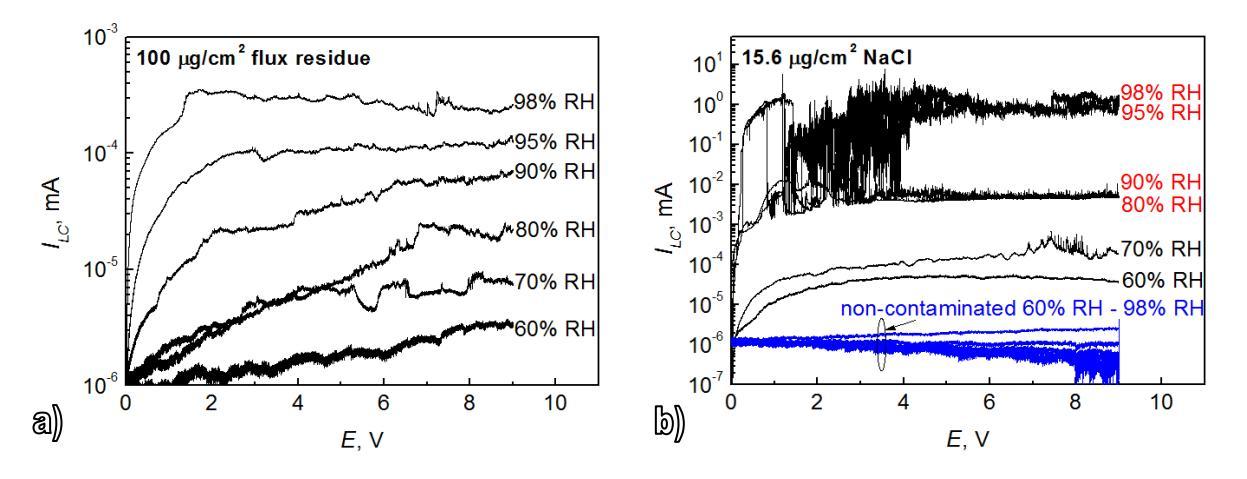
measured in the range from 0 V to 9 V with a sweep rate of 2 mV/s. The measured voltammetry curves as a function of RH are presented in **Figure 8**. The temperature during the experiment was kept constant at 25°C.

Figure 8: Leakage current as a function of applied potential and relative humidity: (a) – solder flux residue and (b) – NaCl and non-contaminated surface

The presence of flux residues (Cobar 390-RX-HT) is less effective in generating leakage current at all humidity levels compared to NaCl. With the increase of relative humidity from 60% to 98%, the leak current measured on the SIR comb pattern precontaminated with the flux residues has increased somewhat more than two orders of magnitude and no ECM initiation has been observed after the testing. Whereas in case on NaCl a more than four orders of magnitude increase in leak current has been observed when the relative humidity exceeded 80 % value. The observation of considerable increase of leak current is assumed to be an indication of NaCl dissolution and water layer formation on the SIR pattern. According to Kohler theory and Pöschl study on sodium chloride interaction with water vapour, the hygroscopic properties of NaCl enables adsorption of water molecules at RH around 75% [22]. The optical inspection of SIR comb pattern after the experiment revealed dendrite growth between the adjacent conductive lines. The increase of leakage current with increase of RH from 60% to 98%, measured on the non-contaminated SIR pattern was in scale of nA and negligible, indicating an importance of PCBA cleanliness for climatic reliability of electronics.

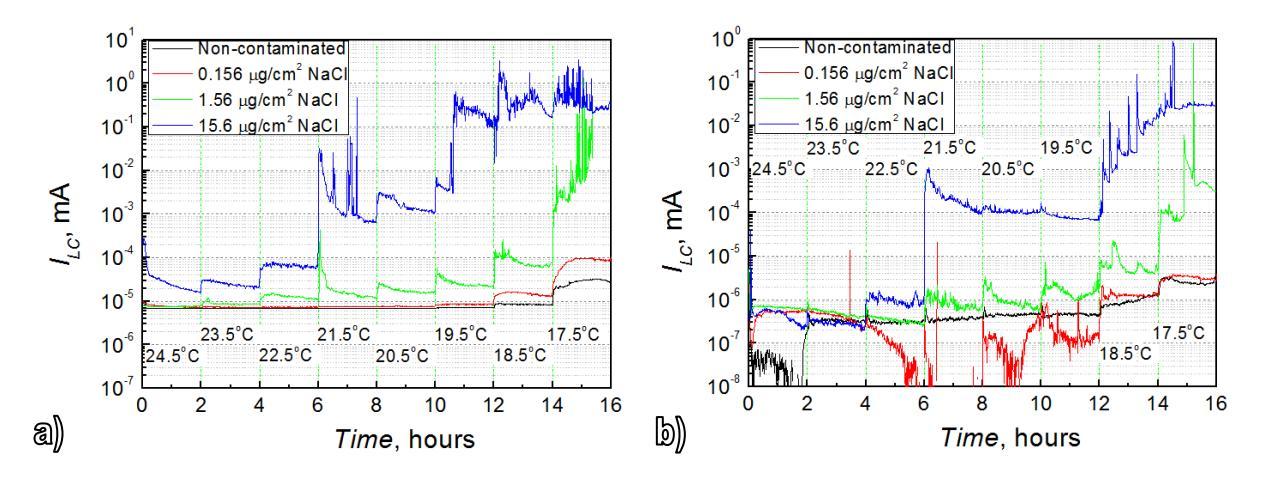
The effect of temperature difference between the PCB surface and surrounding air on the water condensation and leak current was studied on 10 surface mount ceramic chip capacitors connected in parallel and the SIR comb pattern biased at 5 V DC. The temperature of surrounding air has been kept constant at 25 °C. The leak current curves presented in **Figure 9** indicate the increase of current with increased difference in temperature of surrounding air and the surface of the PCB. The temperatures listed on the graphs are the average values of temperatures obtained with two RTD sensors places on the surface of the test PCB.

Figure 9: Leakage current measured on test PCB biased at 5 V DC (a) – SIR comb pattern and (b) – 10 ceramic chip capacitors size 0805 connected in parallel

For the non-contaminated condition, the increase of current is very little and it occurs during the last two steps, when the temperature difference between the surrounding air and PCB is sufficient enough for water condensation to occur. The increase of leakage current at 0.156 μ g/cm² of NaCl occurs at the same steps as it was on a non-contaminated surface, but with slightly higher magnitude of current.

lonic contamination reduces the critical RH value and increases the leakage currents, as was shown by these experiments. A considerable increase of leak current is detected at concentrations starting from 1.56 μ g/cm². A substantial increase of leakage current is observed at complete condensation conditions (very last steps). However at concentrations above 1.56 μ g/cm², the critical RH for condensation is reduced to around 75% for both SIR and capacitors.

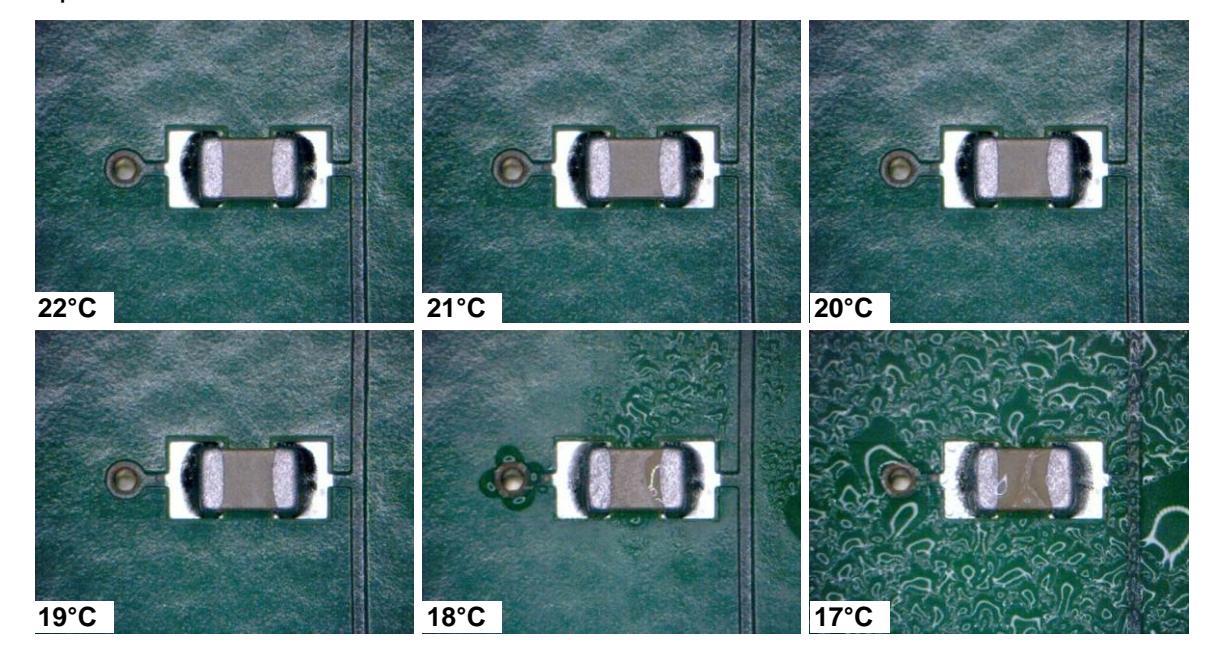
The effect of temperature difference on the condensation is presented in **Figure 10**. The expected error of temperature reading is 1°C. According to the leakage current measurements, the formation of thin water layer starts at 21.5°C, though it is not apparent from the captured images. A further decrease of temperature of the PCB increases the water build up on the surface, which is reflected in the leakage current versus time graphs. The condensation becomes clearly apparent when the temperature on the surface of PCB reaches 18°C.

Figure 10: Water condensation on size 0805 chip capacitors pre-contaminated with 15.6 µg/cm² of NaCl
