In-situ Damage Characterisation of Natural Fibre Composites

In situ Damage Characterisation of Natural Fibre Composites

Presentation at CompTest 2011, Lausanne, EPFL

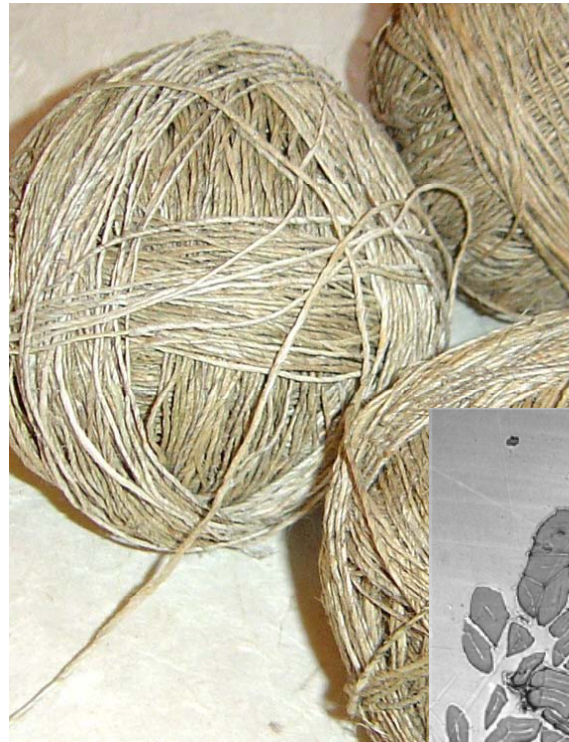
A piece of hemp yarn

- Yarn is spun from a large number of fibres
- Length of fibres
 - 50mm
- Diameter of yarn
 - 200-500 μ m
- Diameter of fiber
 - 5-15 μ m

Short fibres \rightarrow twisting
Fibres can form bundles

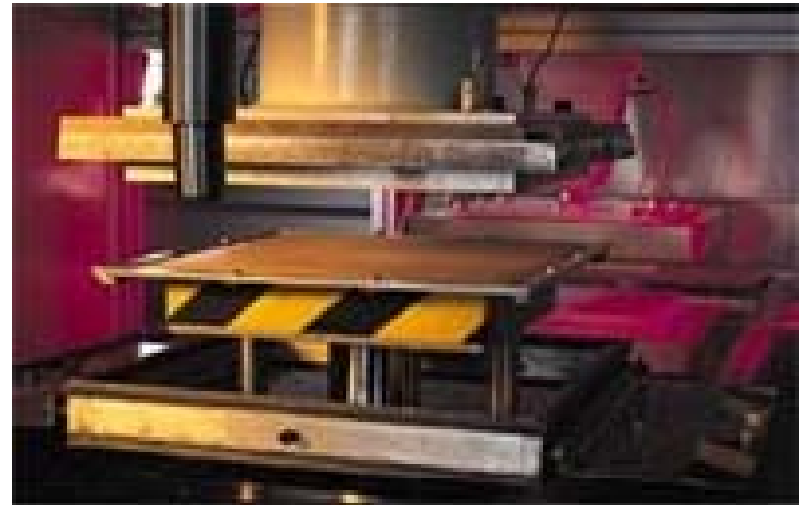
Press consolidation

- Small amount of porosities
- Short consolidation time
