3D X-Ray Computed Tomography (XCT) of Fatigue Damage Evolution in UD Glass Fibre Composite

Kristine Munk Jespersen*, Tristan Lowe, Philip Withers, and Lars Pilgaard Mikkelsen * PhD Student at DTU Wind Energy (kmun@dtu.dk)

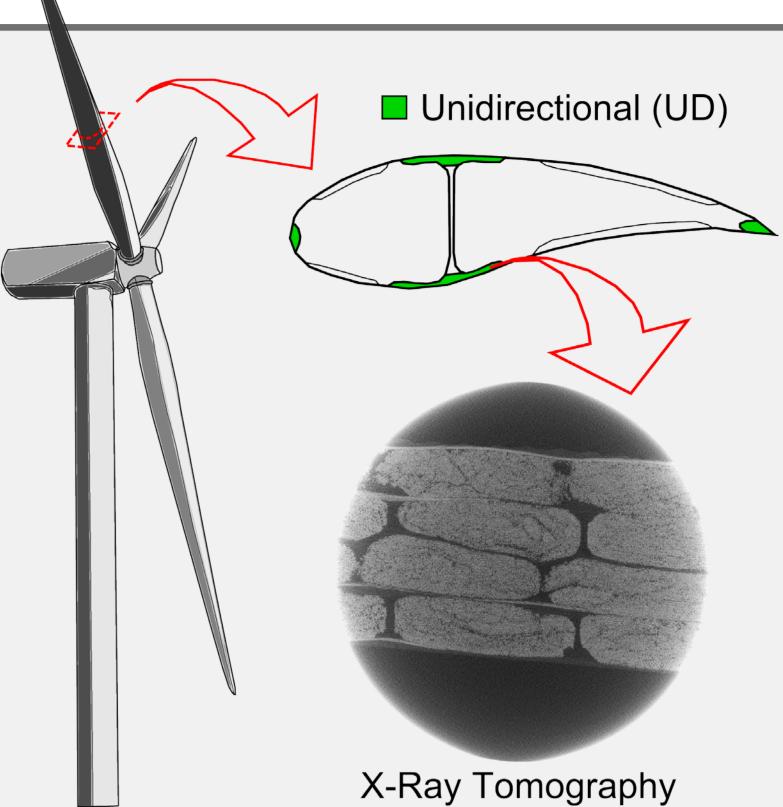
UD glass fibre composite material is used for the load carrying parts of the wind turbine blade considered (marked with green). The glass fibres are gathered in bundles which are held in place by stitching them to a backing layer. The glass fibres are around 16 microns in diameter and are surrounded by a polyester resin.

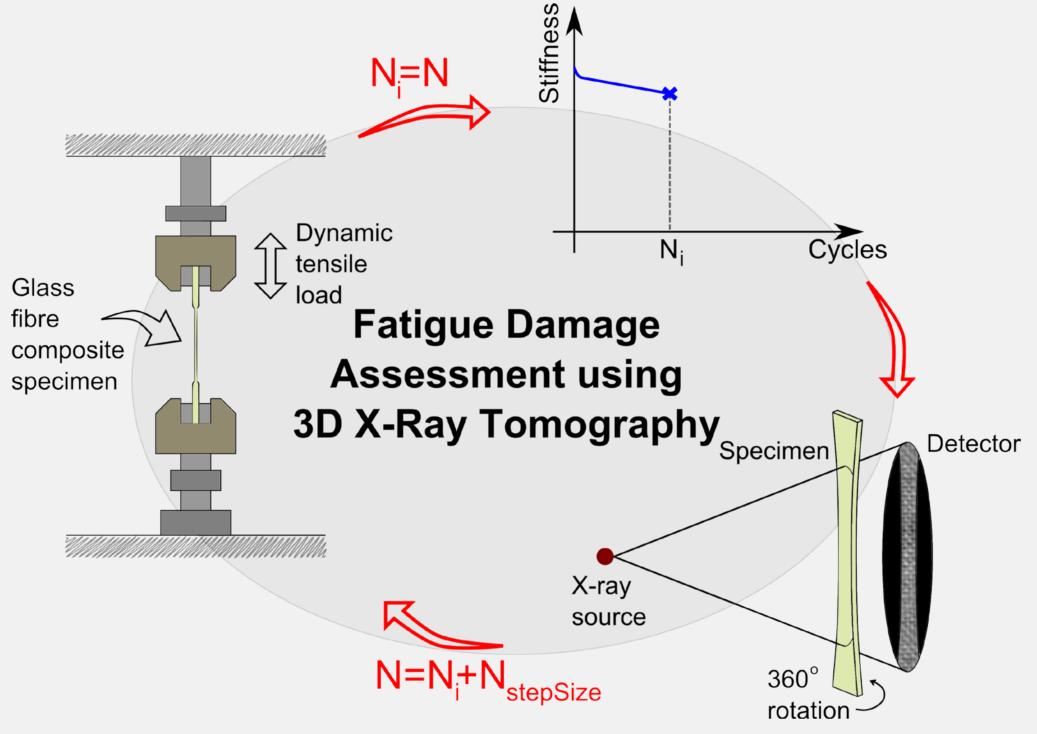
The specimen is subjected to a number of load cycles leading to a stiffness drop. The sample is scanned for quantification of damage. The same sample is then subjected to an additional number of cycles, and this loop is repeated until fracture.

By scanning the glass fibre composite fatigue test specimen at several points during a tension fatigue test, information on the relationship between the microstructure and damage evolution can be extracted.

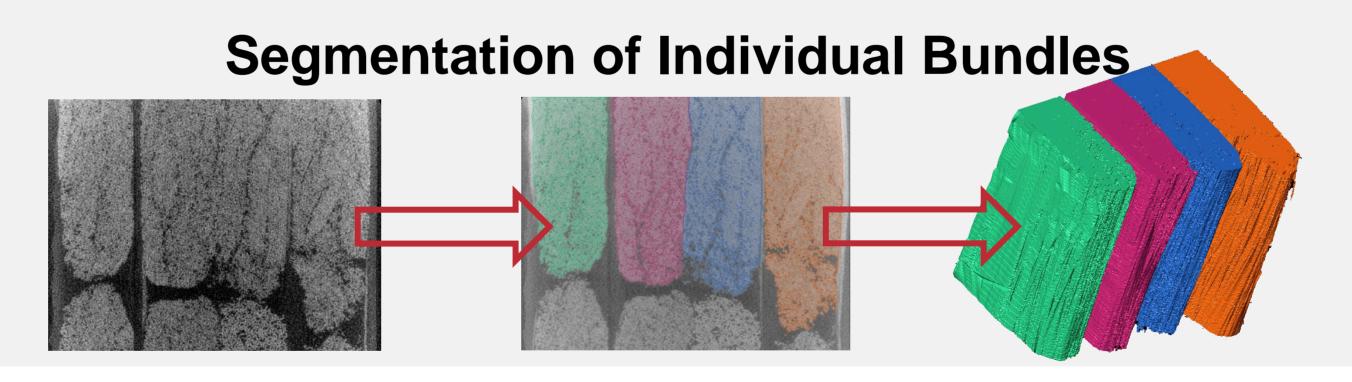
Initial 3D XCT Experiment

The initial experiment was performed with the goal of determining what can be seen when using a Nicon Custom Bay (225/320 kV) scanner. This equipment can scan large specimens but with a maximum resolution of 3 microns (voxel size). A full size fatigue specimen was scanned with a small field of view to obtain the best resolution. Segmentation and visualization was done using the commercial software Avizo.

- Possible to segment bundles at this resolution with Avizo, however some manual work is necessary especially when the bundles are in contact.
- Possible to visually follow the position of most of the fibres at this resolution, however it becomes difficult when fibres are close to each other.
- Not possible to see any cracks with this setup!
- Not possible to determine fibre radii with this setup!

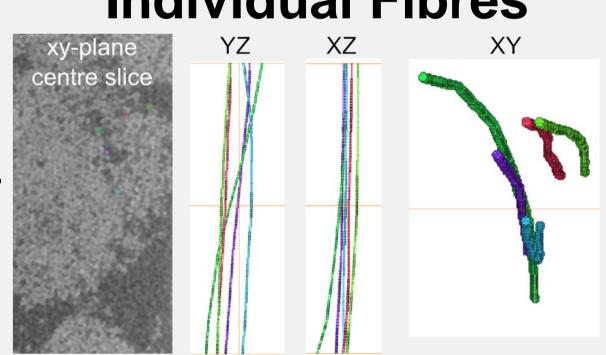
Following Individual Fibres

Avizo was used to follow some fibres along the length, however this was done manually. The fibres were difficult to distinguish from each other with the resolution obtained.
