Contamination profile of Printed Circuit Board Assemblies in relation to soldering types and conformal coating

Published in:
Proceedings of EuroCorr 2014

*Hélène Conseil, Morten S. Jellesen, Rajan Ambat
Materials and Surface Engineering, Department of Mechanical Engineering,
Technical University of Denmark, Hélène Conseil
Building 425, Kongens Lyngby, Denmark, helco@mek.dtu.dk*

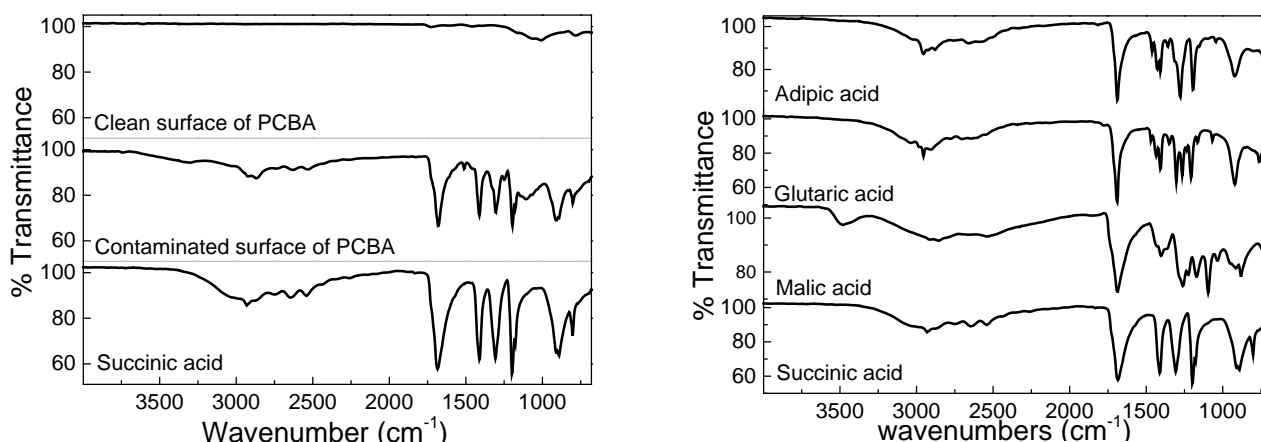
In order to confirm that the contamination revealed by the residue RAT gel corresponds to flux residue, FTIR analysis were performed directly at the contaminated area on the PCBA surface, using a microscopic IR spectrophotometer with ATR. Typical spectra shown in Fig. 5a, clearly show that the chemistry of the contaminated area of the PCBA of the Fig. 3. a. corresponds to weak organic acid (succinic acid in this case), the active part of the flux systems. Similar evaluations of PCBAs showed such acids (Fig.5b).

Figure 5: FTIR spectra on the surface a) of wave soldered PCBA and b) of typical contamination found on the surfaces of WOAs
