Ranking of Cylinder Liner Materials in Two Stroke Marine Diesel Engines

Pedersen, Michael Torben; Imran, Tajammal; Klit, Peder; Felter, Christian; Vølund, Anders

Published in:
Proceedings of the International Conference BALTTTRIB'2009

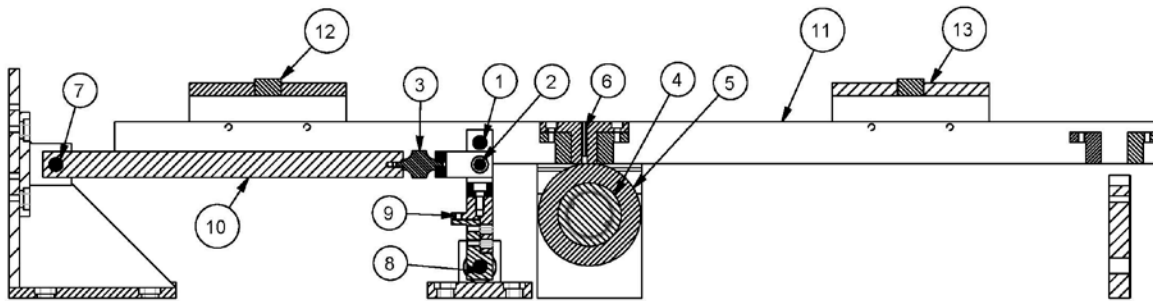
Figure 1. Shows a cross section of the test apparatus. The illustration is taken from the CAD files composed during the development process.

Figure 1. Schematic of the test apparatus. It is seen from the side and as a cross section.

Table 1. Description of the test apparatus as shown in figure 3.

Table 1 gives a schematic description of the test apparatus. Only the main components of the test apparatus are shown here. Whereas, other features and capabilities are as follows. The generated friction from the contact between the piston ring block and cylinder liner ring is measured with a force transducer. The oil film thickness is measured with two inductive sensors. The temperature in the contact line/oil temperature is measured with a thermocouple mounted in the bracket for mounting the piston ring block. All signals are collected with a NI-9219 card mounted in a NI-cDAQ 9172 chassis which is connected to a PC by a USB wire. The motor's speed in rpm is measured direct from the motor through a RS232 connection to a PC. The system is sampling synchronous from all channels.

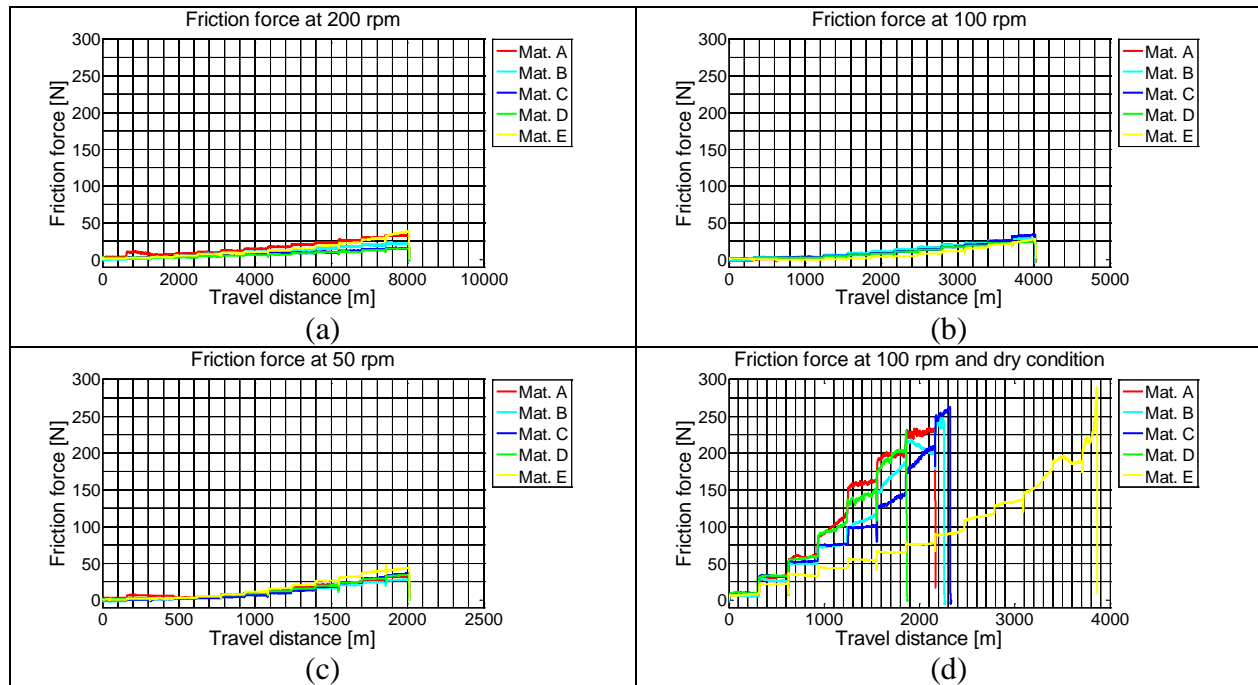
Figure 2. Friction forces measured at 200 rpm (a), 100 rpm (b), 50 rpm (c) and 100 rpm dry contact (d) with ground specimens.

Figure 2. (a), (b) and (c) presents the friction forces obtained at 200, 100 and 50 rpm and oil added for the five materials. No discrepancy between the friction forces measured at the different speeds or materials is clear. The friction forces at the end of the experiments are all in the interval 30 to 40 N which is considered to be the same due to uncertainties.

By evaluating the graphs in figure 2 (d) showing the friction forces measured with dry contact it is clear that material E is fundamentally different from the four other materials¹. The friction force measured with material E is from the travel distance 0 to 500 meters around the same as for material A to D, but from 500 meters and onwards material E starts to deviate significantly from the other materials. Material E runs for a longer distance (roughly computed 1.75 times longer) than the others. This means, that seizure does not occur with material E in the same scale as with material A to D. Material B and C stand out from material A and D. Material A and D are running for a longer distance and achieving lower friction forces for the same load steps. Material D exhibits the worst behaviour of all the tested materials. Material D runs for only 1.875 meters which indicates that this material is more exposed to seizure when running under dry condition compared to the other materials.

By comparing figure 2(a), (b) and (c), with ground/burnished surfaces, with figure 5 (a), (b) and (c), with rough surfaces, a significant difference in measured friction forces is observed. With the ground/burnished surfaces the friction forces are in the interval 30 to 40 N and with rough surfaces the friction forces are fluctuating around 125 N. This is an increase in the friction forces of a factor of 3 to 5 from ground/burnished surfaces to rough surfaces. This clearly stresses the importance of the surfaces topology. It also stresses the importance of having similarly manufactured components when the materials are ranked with the method developed.

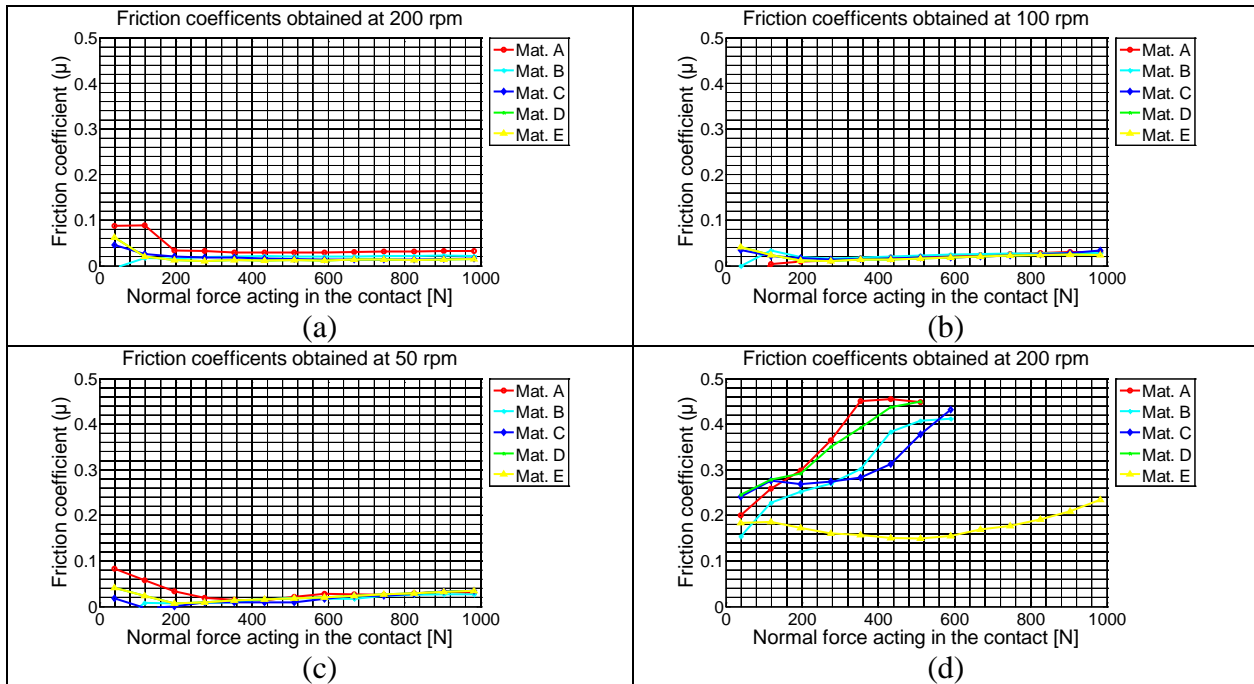
Figure 3. Graphs representing the friction coefficients obtained at 200 rpm (a), 100 rpm (b), 50 rpm (c) and 100 rpm dry contact (d).

In figure 3, the graphs are representing the calculated friction coefficients for the experiments run with ground/burnished cylinder liners ring and piston ring segment. The first three points (interval from 40 to 200N) in figure 3(a), (b) and (c) have to be discarded due to the uncertainties in the measurement. From 200N and onwards the graphs are correct. When figures 3(a), (b) and (c) are compared it becomes clear that the friction coefficients at 50rpm increases steadier than those at 200 and 100rpm. This indicates a higher contribution from hard asperity contacts. From 200N and onwards the friction coefficients are in

the interval from 0.01 to 0.03 and these values are considered to be realistic and the five materials are stated to performing equally under lubricated conditions. Presented in figure 3(d) are the graphs for the experiment done at dry running conditions. Under dry conditions the materials differ from each other regarding seizure and thereby friction coefficients which is already established by the explained differences in the measured friction forces. It can be seen in figure 3(d) that material E has a friction coefficient which is up to a factor of 3 lower than for the rest. This is, however, only the case under dry running conditions. When an oil film is present (figure 3. (a), (b) and (c)) the friction coefficients are all the same for the five materials.

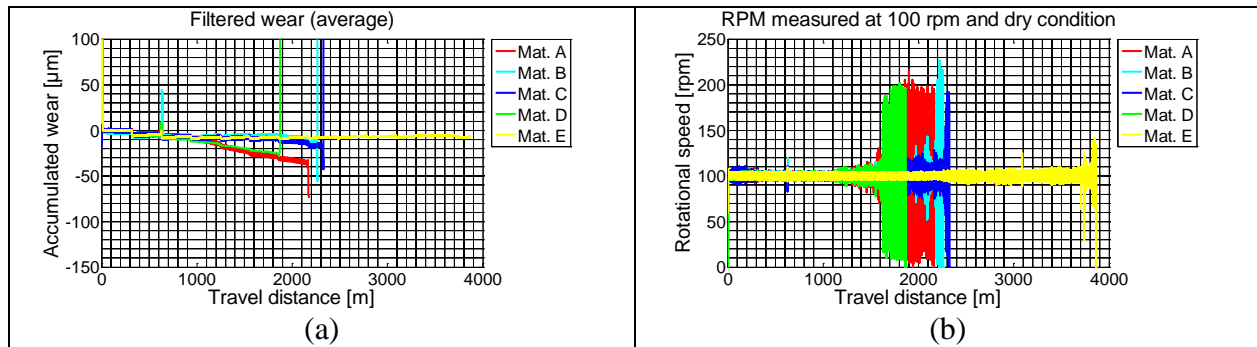
Figure 4. Graphs representing the combined measured wear of the piston ring block and cylinder liner (a) and the rotational speed of the cylinder liner ring (b).

Figure 4(a) shows the graphs drawn on the basis of the measured combined wear² of the cylinder liner ring and piston ring block (the accumulated wear). Again is material E standing out from the other materials with a combined wear of 7.5µm. Upon careful observation of the figure 4(a), it reveals that the wear is decreasing after 1200 m of sliding distance. This is unexpected but can be explained by the thermal expansion of the cylinder liner ring together with the high wear resistance of material E.

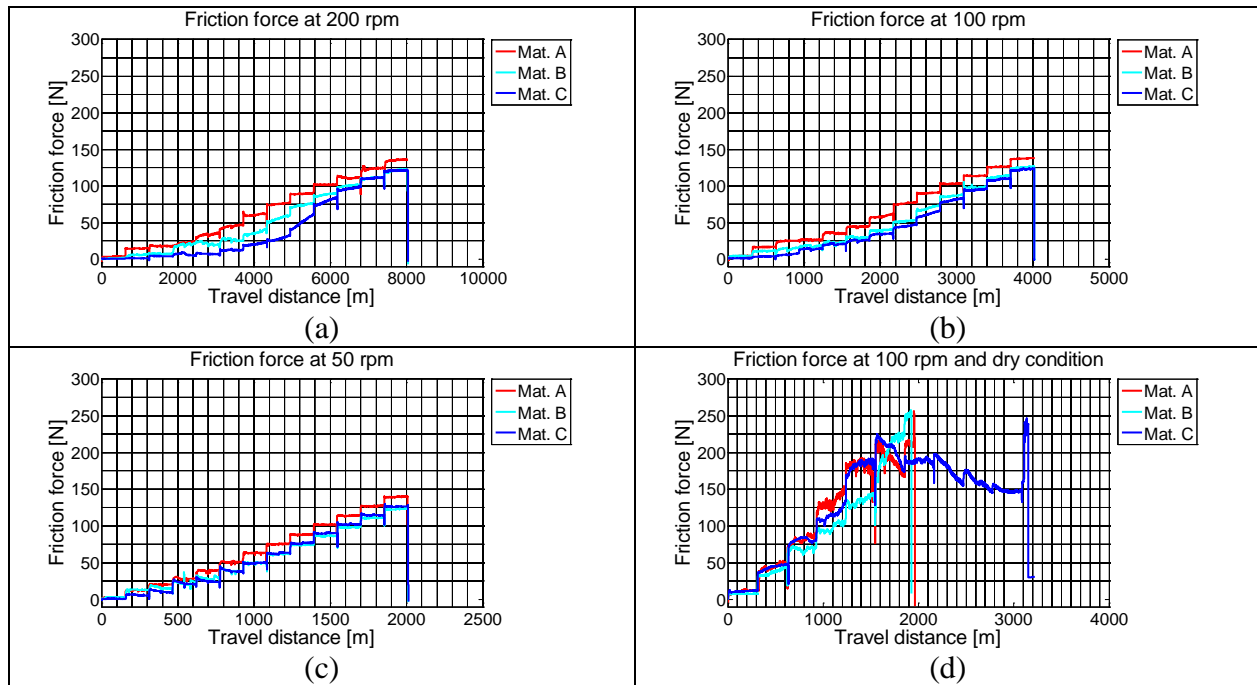
Figure 5 shows the change in the friction forces as the load is increased. Graphs (a), (b) and (c) represent the experiments performed with a lubricated contact between the cylinder liner ring and the piston ring block. There is no significant difference in the three materials performance when oil is present in the contact line and the surfaces are rough. This is equivalent to what was established out from Fig. 2 (a), (b) and (c). The graphs end on approximately 125 N in case (a), (b) and (c). The small deviations between the graphs are ascribed to the variation in amount of oil available in the contact line.

Figure 5. Friction forces measured at 200 rpm (a), 100 rpm (b), 50 rpm (c) and 100 rpm dry contact (d).

The experiments with dry contact between the components are continued until the electrical motor's integrated safety system cuts off the power to the motor due to overload. Figure 5(d) shows the friction forces measured in the case where the components are in dry contact and with rough surfaces. Materials A and C are travelling the same distance. Material C runs for approximately 1.100m more than material A and B. This is due to oil from the construction oozed down on the cylinder ring and thereby destroyed the experiment. The results for material C should therefore be ignored. Probably the pollution started at approximately 1.550m where the curve for the friction force starts to decrease.

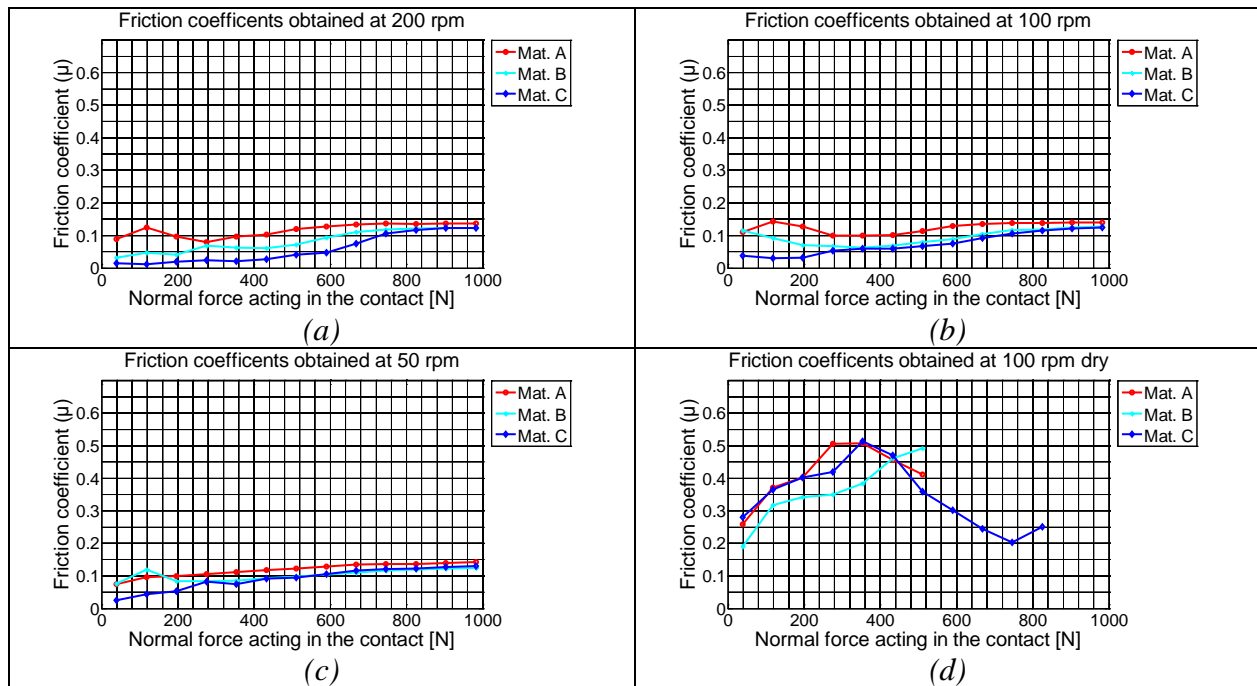
Figure 6 presents the friction coefficients calculated on the basis of the measured friction forces and the load step in question. The graphs a, b and c show that material A has the highest friction coefficient. The graphs also show that the friction coefficients are rising throughout the experiments. This indicates influence from asperity contact which means that the oil film thickness is not sufficient to separate the surfaces. The increase in the friction coefficients is larger than those calculated for the ground/burnished surfaces. Since the roughness is smaller for the ground surfaces the required oil film thickness to separate the surfaces is smaller. The friction coefficients for the three materials are in the interval from 0.05 to 0.15. Figure 6(d) presents the friction coefficients from the experiment run with dry contact between the piston ring block and cylinder liner ring and rough surfaces. This graph clearly shows that material B is performing better than material A. Material C is also performing worse than material B from a normal force of 40 N to 350 N but this observation should be made with care due to the oil pollution of the experiment mentioned earlier. The friction coefficients are in the interval from 0.2 to 0.5. This is equivalent to what was obtained with the ground/burnished surfaces.

Figure 6. Graphs representing the friction coefficients obtained at 200 rpm (a), 100 rpm (b), 50 rpm (c) and 100 rpm dry contact (d).

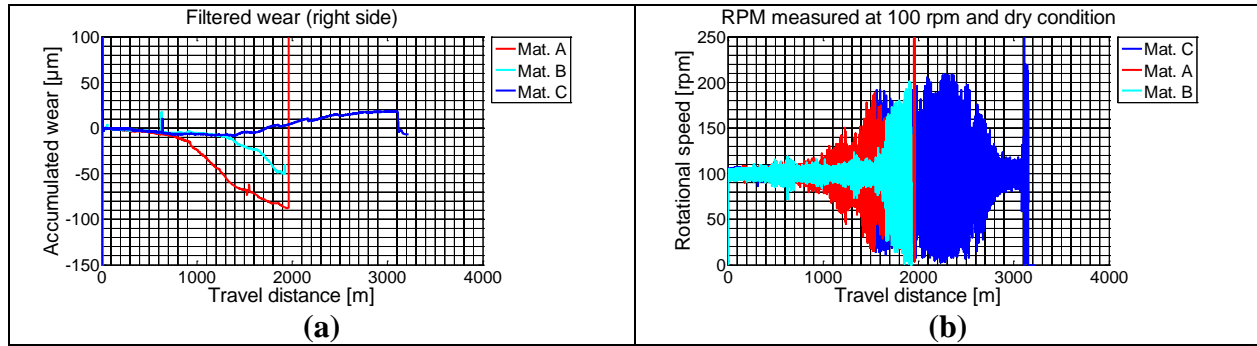
Figure 7(a) shows the accumulated wear measurement. This is a measure of how much both the piston ring block and cylinder liner ring are worn all together. The graphs can be utilized to get information regarding incubation time for the materials. Consistent with what is presented in Table 4 material A is worn the most. The new information is that material A also has the shortest incubation time compared to material B.

Figure 7. Graphs representing the combined measured wear of the piston ring block and cylinder liner (a) and the rotational speed of the cylinder liner ring (b).

Figure 7 (b) shows the rotational speeds of the cylinder liner rings measured during the experiments at 100 rpm and with dry contact between piston ring block and cylinder liner ring. The graph gives information about how seizure evolves. Material A experiences seizure earlier than material B which is consistent with the observation in figure 7(a) where B has a longer incubation time. What also can be observed is that material B has a faster increase of seizure which indicates the material has poor seizure resistance.
