Horns Rev 2 offshore wind farm photo case with wakes observed in 2016

Publication date:
2017

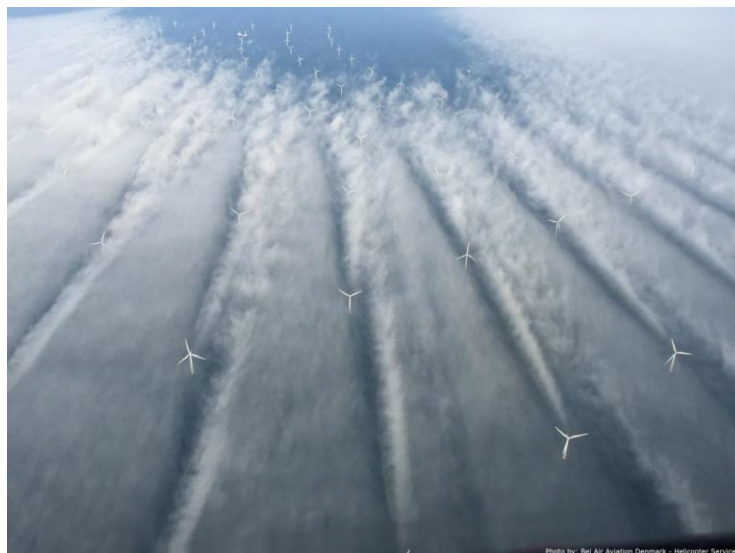
Figure 1: Photograph of the Horns Rev 2 offshore wind farm on 25 January 2016 at 12:45 UTC seen from SSW direction. Photo by Bel Air Aviation Denmark, Helicopter Services. Source: Hasager *et al.* 2017 *Energies* doi:10.3390/en10030317

Offshore wind farm wakes were photographed in foggy conditions at Horns Rev 2 on 25 January 2016 at 12:45 UTC (See¹). The study examines the atmospheric conditions from satellite images, radiosonde, vertical profiling wind lidar located at the transformer platform and SCADA data. Furthermore results from atmospheric WRF meso-scale modelling, Park wake model and large eddy simulation wake model are prepared and analysed. At the time of the photos a humid and warm air mass was advected from the southwest over cold sea. The dew-point temperature was such that cold-water advection fog formed in a shallow layer. Most turbines produced at or near rated power. The wind speed was 13 m/s at hub height and wind direction was from the southwest. The flow was stably stratified. The photo shows long, narrow wakes that persisted several rotor diameters downwind of the wind turbines. The LES model included a temperature scheme, and the results indicate the pattern of fog in the wake. Due to stable stratification the wakes are long and narrow with a smooth appearance. The LES results are novel and for the first time ever compared to visually observed fog cones. In the far-field of the wind farm wake mixing of warm air from aloft dispersed the fog. This is noted in the photos and WRF model results. The physical processes are modelled from WRF without and with a parametrization for the wind farm included. The results indicate a difference in liquid water content showing that a drying effect appear downwind of the wind farms for more than 100 km. Thus the photos confirm this drying process. It is the first time this is visualized and modelled for an offshore wind farm. Interestingly, these new images show highly contrasting conditions regarding the wind speed, turbulence intensity, atmospheric stability, weather conditions and wind farm wake development as compared to the well-known Horns Rev 1 photographs from 12 February 2008.
