## Distribution of *Asellus aquaticus* and microinvertebrates in a non-chlorinated drinking water supply system – Effects of pipe material and sedimentation

*Published in:*  
Water Research

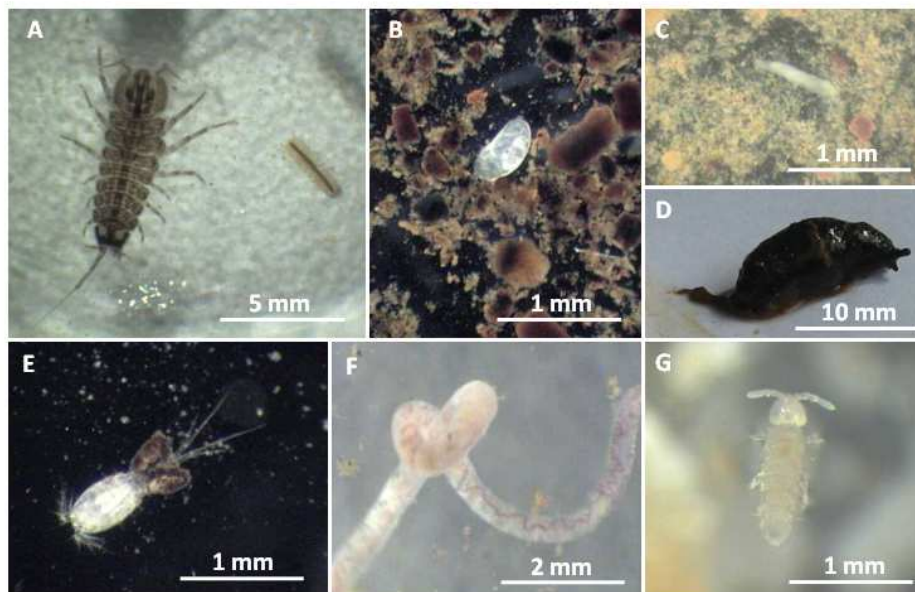
514  
515 **Figure 6. The distribution of samples with living *Asellus aquaticus* and dead *A. aquaticus* from 8 cast iron pipes**  
516 **and 11 plastic pipes from zone 1. *A. aquaticus* was present in a significantly higher number of samples from cast**  
517 **iron pipes than plastic pipes (100 % positive samples versus 45 % positive samples) ( $p = 0.018$ , Fisher's exact**  
518 **probability test for 2x2 tables). There was a significantly higher concentration of *A. aquaticus* in cast iron pipes**  
519 **6.0/m<sup>3</sup> than in plastic pipes 1.6/m<sup>3</sup> ( $p = 0.037$ , Mann-Whitney U-test).**

520 **Replicate samplings are removed. Dead *A. aquaticus* may be present in samples with living *A. aquaticus*.**  
521

331 To investigate the importance of pipe materials we compared samples from cast iron and plastic  
332 pipes in zone 1. Although present in both pipe types significantly more samples from cast iron pipes  
333 than from plastic pipes contained *Asellus aquaticus* (100 % positive samples versus 45 % positive  
334 samples) ( $p = 0.018$ , Fisher's exact probability test for 2x2 tables) (Fig. 6). Five samples were taken  
335 at localities within a 300 m radius with the same source of water supplying all five points. Three of  
336 the sampled pipes were plastic pipes and the remaining two were cast iron pipes. Only the cast iron  
337 pipes contained *A. aquaticus*. This indicates that cast iron pipes provide an environment suitable for  
338 breeding populations of *A. aquaticus* while *A. aquaticus* caught from plastic pipes are mainly single  
339 living specimens or dead specimens, which may have been transported passively through by the

340 water flow. The average concentration of *A. aquaticus* was also higher in cast iron pipes (6  
341 specimens/m<sup>3</sup>) than in plastic pipes (1.6 specimen/m<sup>3</sup>) ( $p = 0.037$ , Mann-Whitney U-test) (Fig. 6).

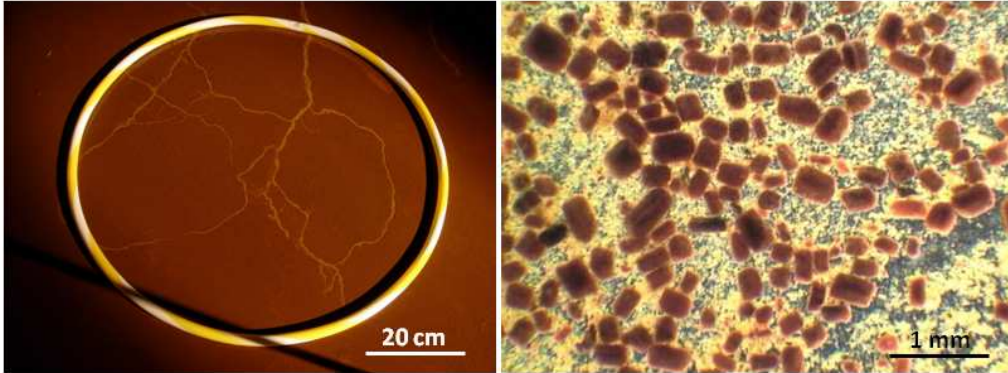
497  
498 **Figure 2. Traces of *Asellus aquaticus*. A) Trails on sediment in empty elevated tank. B) Pellets (faeces). The**  
499 **characteristic transverse fissure is seen on some pellets. Photos: S.C.B. Christensen.**

243 *A. aquaticus* varied in size from 2 to 9 mm, which is small compared to *A. aquaticus*  
244 from fresh water ponds, which can reach 20 mm. *A. aquaticus* sampled in this study were brown  
245 with small eyes (Fig. 1). Characteristic *A. aquaticus* pellets (DVGW 1997, Walker 1983) were  
246 observed in many sediment samples (Fig. 2) and could be used as an indication of the presence of *A.*  
247 *aquaticus* populations.

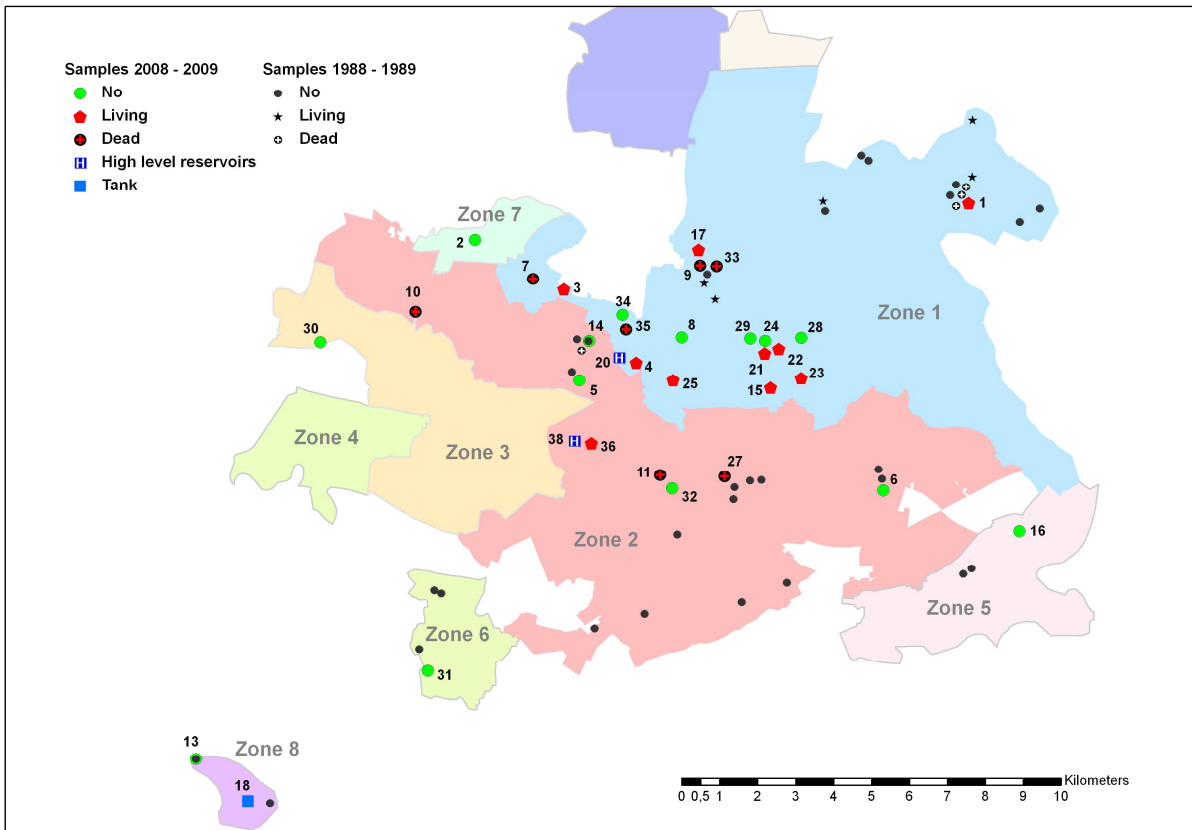
500  
501 **Figure 3. Distribution of *Asellus aquaticus* in pressure zones 1-8. The distribution of living and dead *A. aquaticus***  
502 **in the samples from 2008-09 was consistent with the samples from 1988-89 ( $p = 1.000$ , Fisher's exact probability**  
503 **test for 2x2 tables). The elevated water tanks in zones 1 and 2 contained *A. aquaticus*, while none was observed in**  
504 **the clean water tank in zone 8. Living *A. aquaticus* were observed in zone 1 covering a wide area while living *A.***  
505 ***aquaticus* in zone 2 was found at only one sampling location. No *A. aquaticus* was observed in zones 3-8. Numbers**  
506 **refer to sampling locations.**

269 Pressure zone 1 with the elevated tank 1 contained the majority of the caught *Asellus aquaticus* (68  
270 % positive samples in zone 1, Fig. 3), while microinvertebrates were present in all parts of the  
271 investigated distribution system (94 % positive samples) (Fig. 4). Pressure zone 2 with the elevated

272 tank 2 had a few *A. aquaticus* positive samples, with only one living *A. aquaticus* and only an  
273 average of 1 specimen per positive sample. No *A. aquaticus* were caught in the remaining zones;  
274 zone 3 – zone 8 (Fig. 3).
