Effect of a Damage to Modal Parameters of a Wind Turbine Blade

Proceedings of the 7th European Workshop on Structural Health Monitoring

EFFECT OF A DAMAGE TO MODAL PARAMETERS OF A WIND TURBINE BLADE

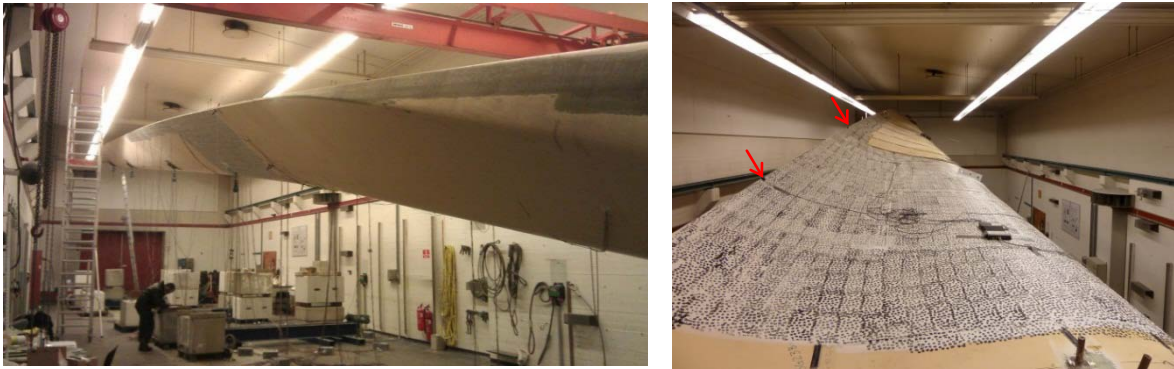
Figure 1: The 34m blade in the experimental Blade Test Facility at DTU Wind Energy. Left: Suction of blade. Right: Upper (pressure) side of blade. Accelerometers is marked with a red arrow

To study and compare the dynamic characteristics of a damaged wind turbine blade and the corresponding undamaged blade, a full-scale 34m blade, manufactured by SSP Technology A/S, was mounted to a test rig under laboratory conditions (cf. Figure 1). The blade was positioned horizontally with the suction side pointing towards the ground.

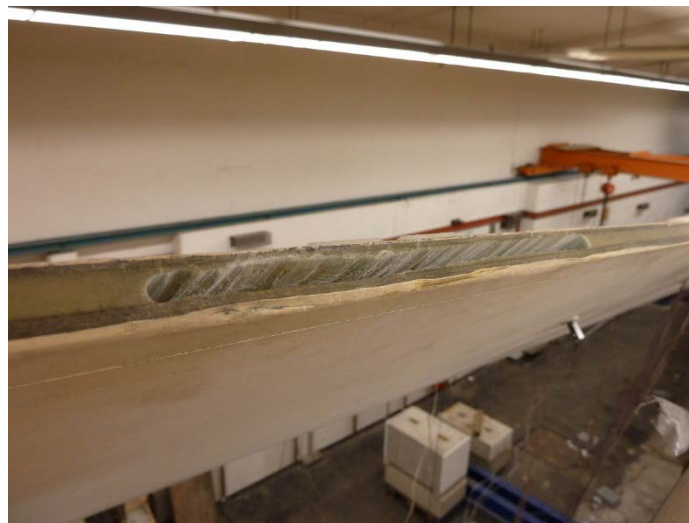
Figure 2: The artificial trailing edge damage introduced in the 34m blade

Several test campaigns were carried out throughout the experiment. The first test was carried out on the undamaged blade. This (reference) test was subsequently followed by tests, where artificial damages were introduced in the trailing edge 18,8m and onwards from the root. In the damaged part of the blade the adhesive between the upper and lower part of the shell was removed to mimic a crack in the trailing edge (cf. Figure 2). The first the damage had a length of 20cm along the blade, and this damage was progressively extended throughout the test campaigns, reaching a length of 120cm in the final test, and thus extending from 18,8m to 20,0m as measured from the blade root. The damaged part of the trailing edge was re-established after tests to enable the blade to be used for other experiments, and the first (reference) tests on the undamaged blade was repeated to investigate whether the re-established trailing edge had affected the dynamic properties of the blade.
