Diagnosis of bearing creep in wind turbine gearboxes

Skrimpas, Georgios Alexandros; Liu, Zhenyan; Hilmisson, Reynir; Sweeney, Christian Walsted; Holbøll, Joachim

Published in:
Third European Conference of the Prognostics and Health Management Society 2016

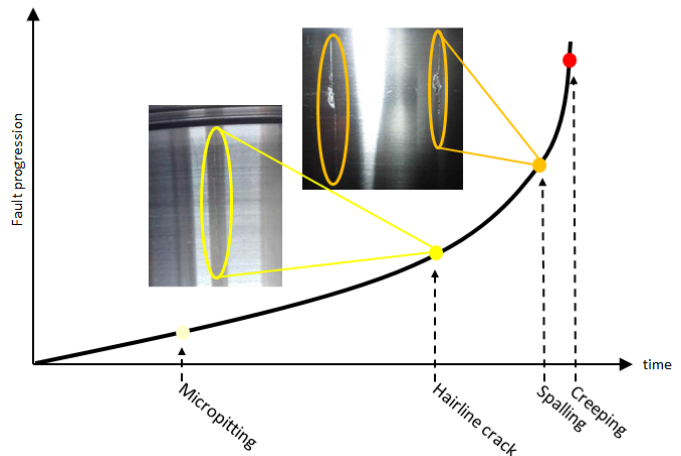
Gearbox bearings suffer from all typical failures, such as inner or outer race defects, where the severity, development rate and frequency depends on various factors, such as applied load, i.e. radial or axial-radial, design of gearbox and position of the bearing. In this work, a special failure mode seen mainly in the inner raceway of roller bearings is investigated and analysed. The fault development is assessed to follow the stages depicted in Figure 1, where it is assumed that it commences in the form of pitting in early stage, al-

though the latter cannot be verified due to lack of inspections at this stage. Typically, this failure mode develops to hair line cracks in mid-early stage, where more than one cracks might be present, and propagates to extensive crack and spalling in mid-late stage. The final stage is a combination of severe bearing damage and rotational looseness, i.e. bearing creep, due to loose fit between the shaft and the inner race. The exact nature of rotational looseness cannot be explicitly verified, i.e. if the relative motion between the shaft and the inner race can be characterized as micro or macro movement. However, based on the extent of wear on the shaft surface, it is believed that it is most likely macro-movement either intermittent or continuous, depending on the applied load. The latter can be confirmed if the data are classified in torque or power bins, as it is shown in latter section.

Figure 1. Stages of the failure mode under investigation.

Figure 5 illustrates the high frequency crest factor trending behavior in high power production extracted from the accelerometer installed adjacent to the intermediate stage (2nd stage). In details, HFCF started increasing in July 2013 and crossed a predefined alert limit after approximately one month, where the defect is assessed to be at early stage. Based on the applied condition monitoring strategy, this is the first generated alarm by the system which requires further evaluation from specialists. It is noted that the lower alert limit, represented by a yellow horizontal coloured line, is configured by the system using basic statistical features, such as mean value and standard deviation, from a predefined time interval where the condition is assessed to be fault free. On the contrary, the red line, referred to as danger line, is fixed for all turbines of the same platform. The HFCF trend continues to progress until October 2014 where it stabilizes at a new level approximately twice the value at the healthy state period. Based in Figure 1, the most likely stage of the defect is between hairline crack and spalling in the inner race.

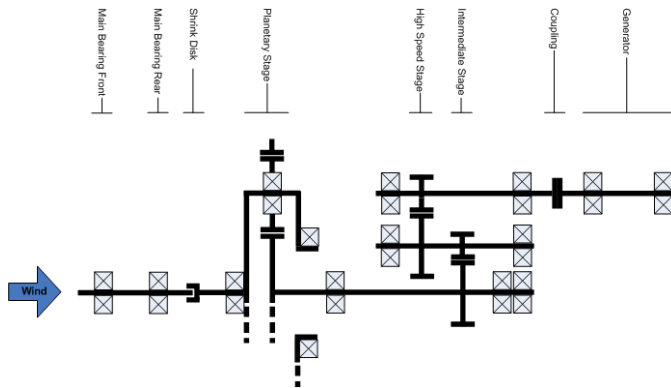
Figure 2 illustrates all bearings and gears of a typical modular drive train configuration. Although it can be encountered in any bearing supporting either the low, intermediate or high speed shafts, it is most commonly seen in roller bearings.

Figure 2. Gear and bearing locations in a three stage (one planetary and two parallel) gearbox, along with two main bearings and generator bearings.

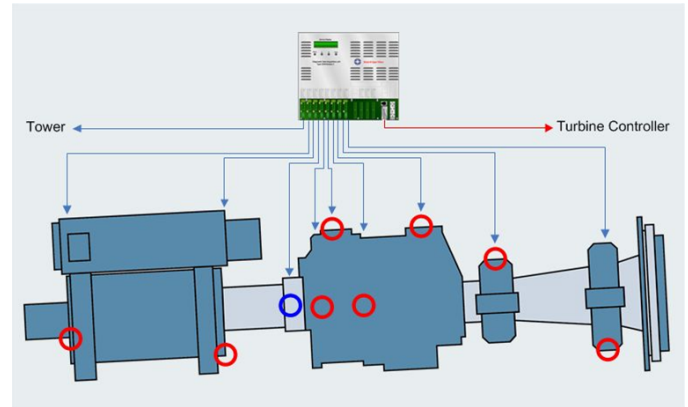
Figure 3 illustrates the positioning of accelerometers across the drive train, marked with red rings. It can be seen that their positioning is selected strategically in order to ensure optimum vibration path between the monitored component and the sensor. Furthermore, speed signal is commonly included in most condition monitoring systems (CMS), providing the reference for speed related measurements. In Figure 3 the tachometer is represented by a blue ring on the gearbox high speed shaft.

Figure 3. Layout of installed sensors, accelerometers in red and tachometer in blue, in a typical wind turbine drive train.

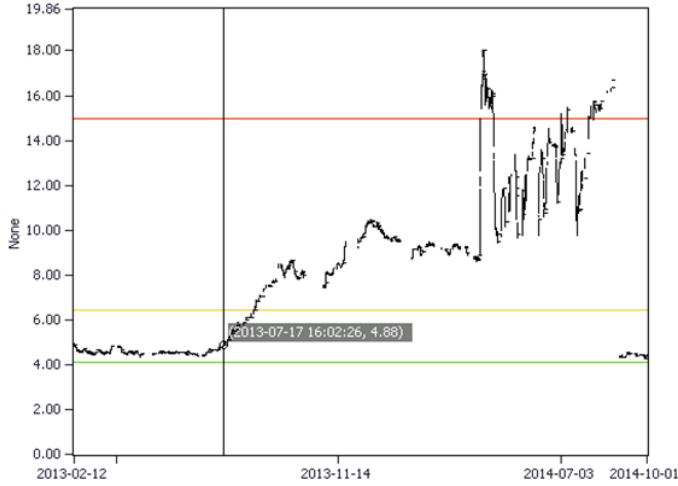
Figure 5. Trending behaviour of HFCF over a period of approximately 18 months in high power production.

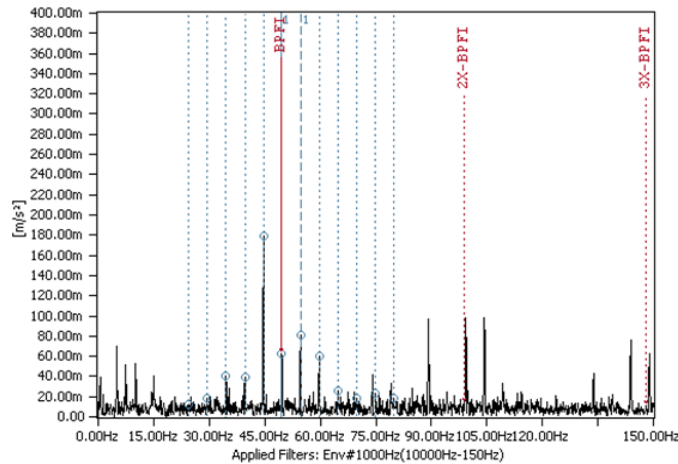
Spectral analysis validates the presence of an inner race defect as displayed in Figure 6, which presents the envelope spectrum from the signal collected by the accelerometer ded-

icated to the intermediate stage of the gearbox. Multiple harmonics of the inner race defect frequency (BPFI - ball pass frequency inner) along with sidebands matching the running speed of the shaft supported by the bearing can be located, pinpointing the defective bearing and the exact location of the fault.

Figure 6. Envelope spectrum after the rise of HFCF, but before RV step change.

acteristic inner race defect frequency and its sidebands are more pronounced compared to Figure 6.

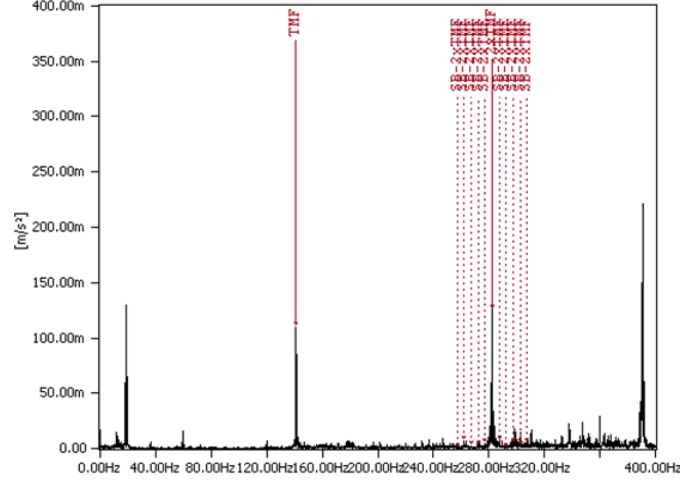
Figure 7 shows the frequency spectrum focusing on the bandwidth close to the first three tooth mesh frequencies of the 2nd stage. Detailed analysis does not reveal any signs of potential faults, such as increased sidebands, hence at this stage the fault is reckoned as early stage and does not influence the meshing of the gears.

Figure 7. Frequency spectrum after the rise of HFCF, but before RV step change.

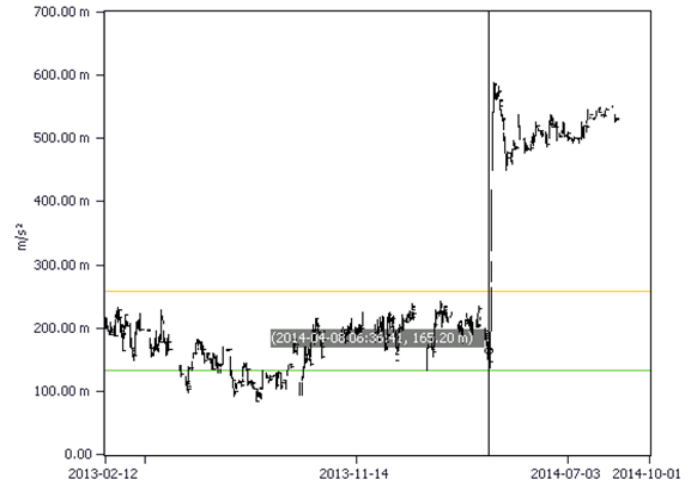
Consistent diagnosis of the final state of the described failure mode, i.e. bearing creep, is achieved effectively by inspecting the RV trends for sudden step changes. It is important to emphasize the fact that by comparing multiple failed bearings,

the authors have verified that RV changes rapidly within a few hours and stabilizes at a new level. This behaviour suggests that the axial crack escalates rapidly to broken inner race or at least to such an extent which allows the bearing to move relative to the shaft due to loss of interference fit.

Figure 8. Trending behaviour of residual value (RV) over a period of approximately 18 months in high power production.

The gearbox was kept in operation for approximately 40 days after the RV sudden increase resulting in extensive damage of the intermediate shaft. It is noted that the present case study is one of the first subjected to this failure analysed by the authors, hence this time interval is not representative for gearboxes suffered from the same fault. However, it can be argued that further running could potentially jeopardise the condition of the gears.

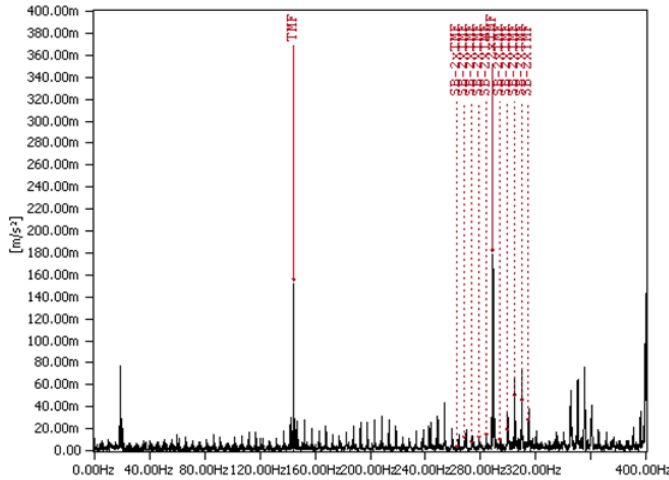
The emerging looseness affects the load on the gears resulting in abnormal meshing. The latter propagates in the frequency spectrum in the form of multiple sidebands around the tooth mesh frequencies matching the running speed of the shaft supported by the failed bearing. Figure 9 illustrates the frequency spectrum of a recorded signal after the RV step change where multiple sidebands are present. Furthermore, a similar step change is observed in the HFCF trends in Figure 5 indicating that the impacts are now higher in amplitude most probably due to a larger crack. This effect can be confirmed in the envelope spectrum in Figure 10 where the char-

Figure 9. Frequency spectrum after the step change of RV.

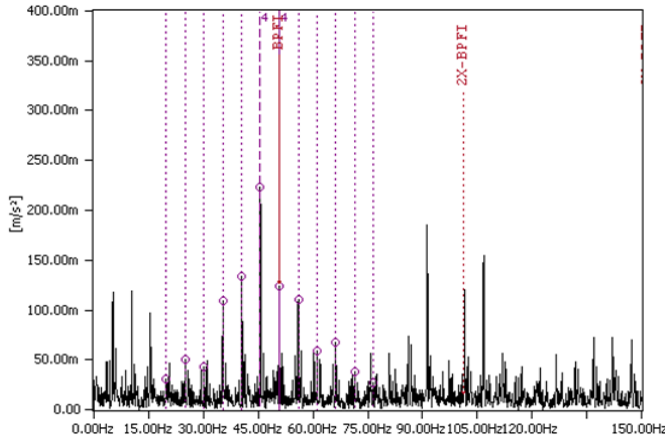
Figure 10. Envelope spectrum after the step change of RV.

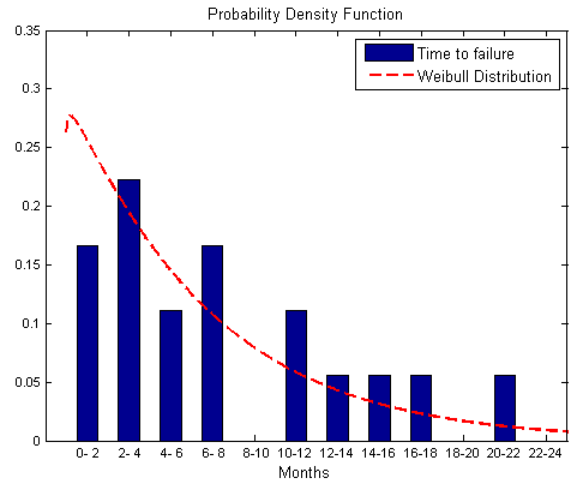
In order to investigate the fault progression rate and the time interval for a defect to escalate from inner race spalling to creep, 18 cases of faults at the same location of the same gearbox type are analysed. Figure 11 shows the probability density function of the faults under consideration, which

ranges from a few days to approximately 20 months. The underlying distribution can be represented by a Weibull distribution shown with red in Figure 11 with $\alpha = 1.013$ and $b = 198.755$, based on Equation 3. Figure 12 displays graphically if the data are originated from Weibull distribution, using the Matlab built-in function *wblplot()*, which is assessed to be valid due to the linear relationship.

Figure 11. Probability density function of remaining useful lifetime for the failure mode of interest.

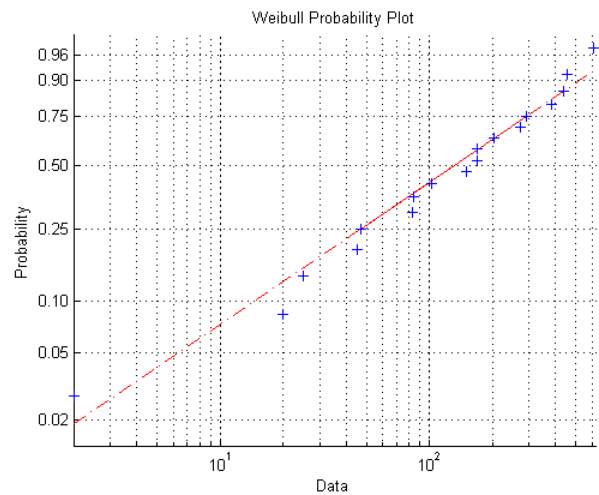
Figure 12. Assessment if data are originated from Weibull distribution.
