Diagnosis of bearing creep in wind turbine gearboxes

Published in:
Third European Conference of the Prognostics and Health Management Society 2016

A defect in one of the intermediate shaft support bearings following the stages of the failure mode of interest, i.e. axial crack, spalling and creeping, is discussed and analysed. The analysis part is based on both scalar values from selected condition indicators, and detailed analysis of high sampled vibration signals recorded by the accelerometer installed adjacent to the intermediate stage (2nd stage). It is important to highlight the fact that all scalar values are classified in five discrete power bins offering enhanced fault detectability capabilities and consistent comparison between different operational states.

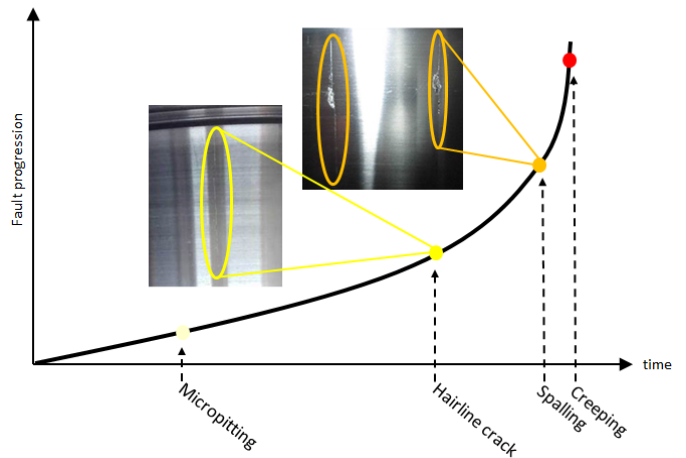
Gearbox bearings suffer from all typical failures, such as inner or outer race defects, where the severity, development rate and frequency depends on various factors, such as applied load, i.e. radial or axial-radial, design of gearbox and position of the bearing. In this work, a special failure mode seen mainly in the inner raceway of roller bearings is investigated and analysed. The fault development is assessed to follow the stages depicted in Figure 1, where it is assumed that it commences in the form of pitting in early stage, al-

though the latter cannot be verified due to lack of inspections at this stage. Typically, this failure mode develops to hair line cracks in mid-early stage, where more than one cracks might be present, and propagates to extensive crack and spalling in mid-late stage. The final stage is a combination of severe bearing damage and rotational looseness, i.e. bearing creep, due to loose fit between the shaft and the inner race. The exact nature of rotational looseness cannot be explicitly verified, i.e. if the relative motion between the shaft and the inner race can be characterized as micro or macro movement. However, based on the extent of wear on the shaft surface, it is believed that it is most likely macro-movement either intermittent or continuous, depending on the applied load. The latter can be confirmed if the data are classified in torque or power bins, as it is shown in latter section.

Figure 1. Stages of the failure mode under investigation.

Spinning of the inner race on the shaft results in extensive shaft wear, which requires replacement of the whole shaft. In addition, the meshing between the gear(s) mounted on the affected shaft and the corresponding gear of the same stage, either pinion or gearwheel, deviates from the normal operational condition due to the developing looseness, jeopardizing the teeth profile and general health of the entire gearbox. If the fault is detected and troubleshot in early-mid stage, the faulty condition can be handled successfully by replacing solely the bearing, minimizing the down time and cost of repair.
