Thermo Active Building Systems(TABS) - Performance in practice and possibilities for optimization

Thermo Active Building Systems (TABS) - Performance in practice and possibilities for optimization

DTU Byg-Sagsrapport SR-16-04 (DK)
Marts 2016

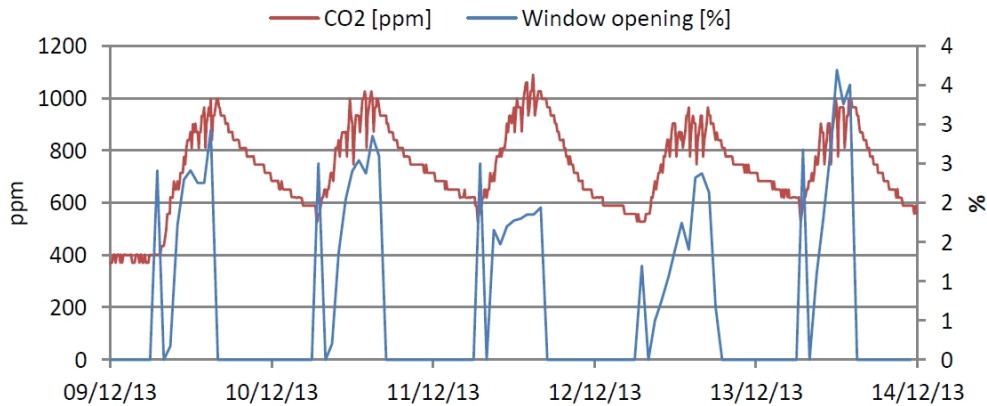
Figure 2 – The natural ventilation strategy in Viborg Town Hall and corresponding CO₂ concentration – south west open plan office on the 2nd floor

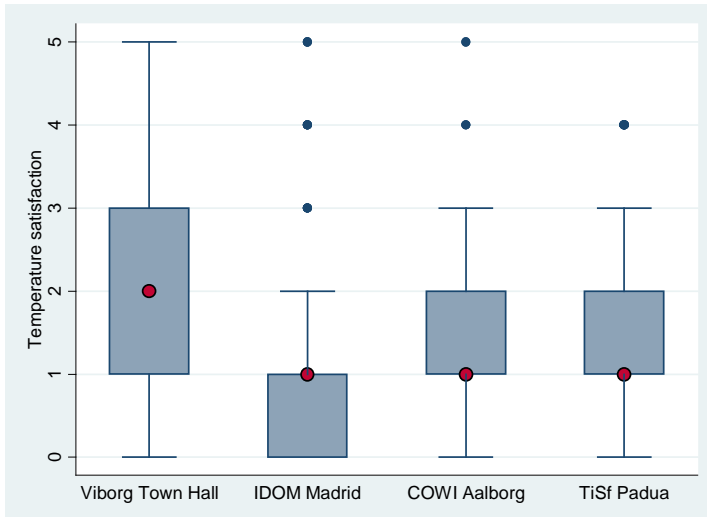
Figure 3 – Box plot of temperature satisfaction for all surveyed buildings (on vertical axis: 0 = "Clearly satisfied", 1 = "Satisfied", 2 = "Just satisfied", 3 = "Just dissatisfied", 4 = "Dissatisfied", 5 = "Clearly dissatisfied")

Figure 3 shows a box plot of temperature satisfaction from all surveyed buildings. Median temperature satisfaction was in the range of the scale expressing satisfaction with the conditions. When considering whole interquartile range, the highest satisfaction was expressed by respondents in IDOM building in Madrid. Viborg Town hall had the lowest satisfaction rate with median of 2 and interquartile range of (1, 3) on the satisfaction scale. This corresponds well with results of physical measurements.

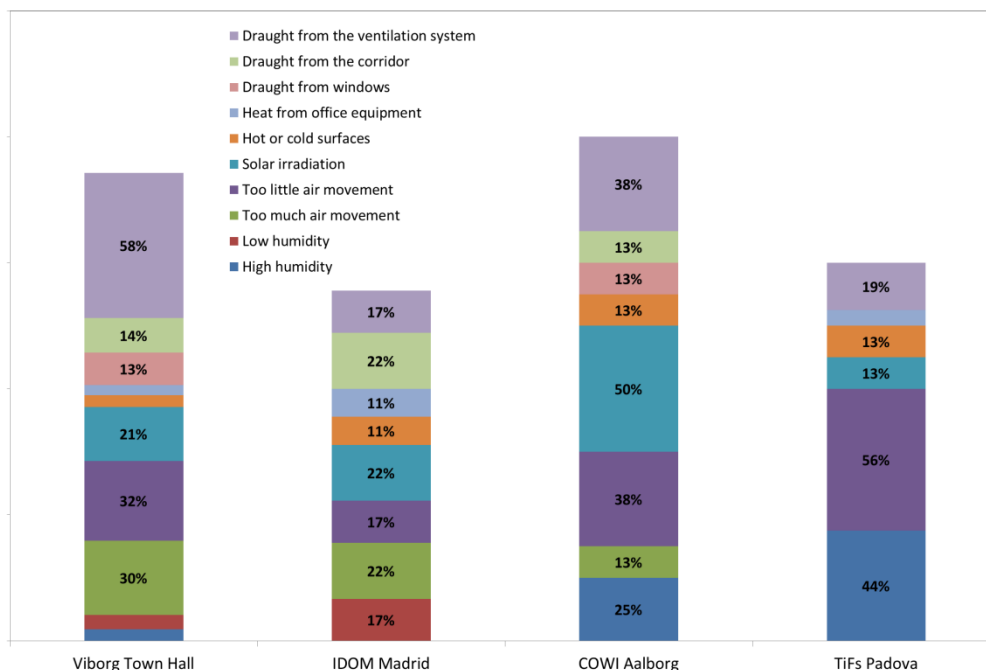
Figure 4 – Sources of thermal discomfort in surveyed buildings – value labels indicate percentage of respondents dissatisfied with thermal conditions that indicated particular source of discomfort

Figure 4 illustrates distribution of sources of discomfort in surveyed buildings. The percentage in the figure represents percentage of respondents that were dissatisfied with thermal conditions in the particular building.

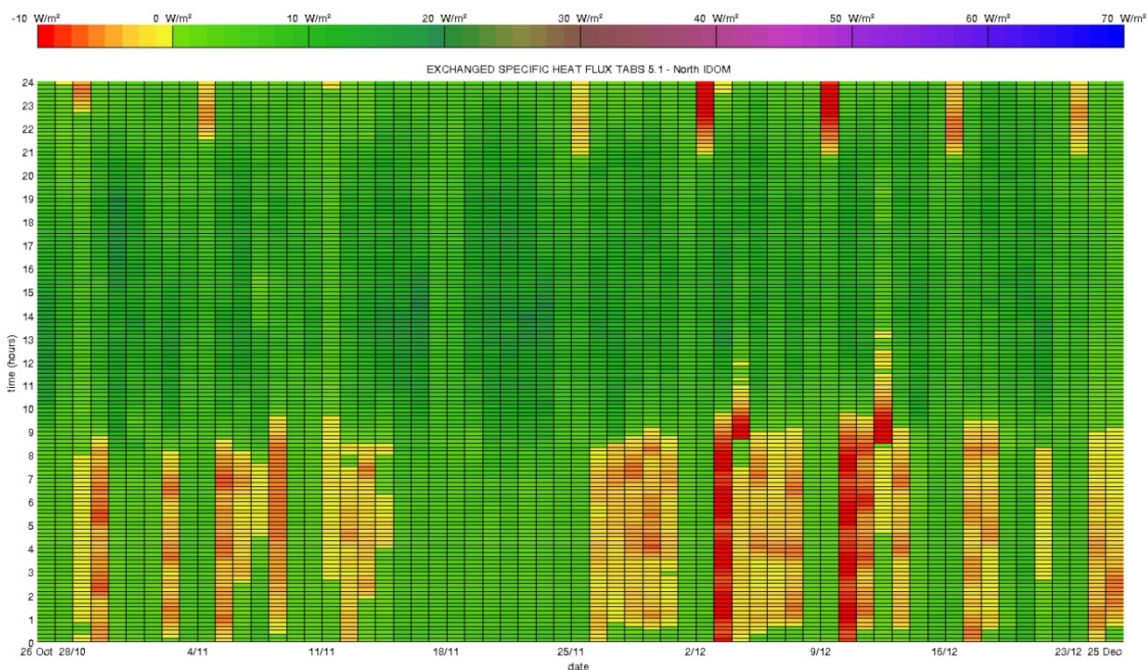
Figure 5 - Exchanged specific heat flux by TABS (W/m^2) in northern office space in IDOM Madrid during winter; positive values indicate cooling and negative values heating of the space

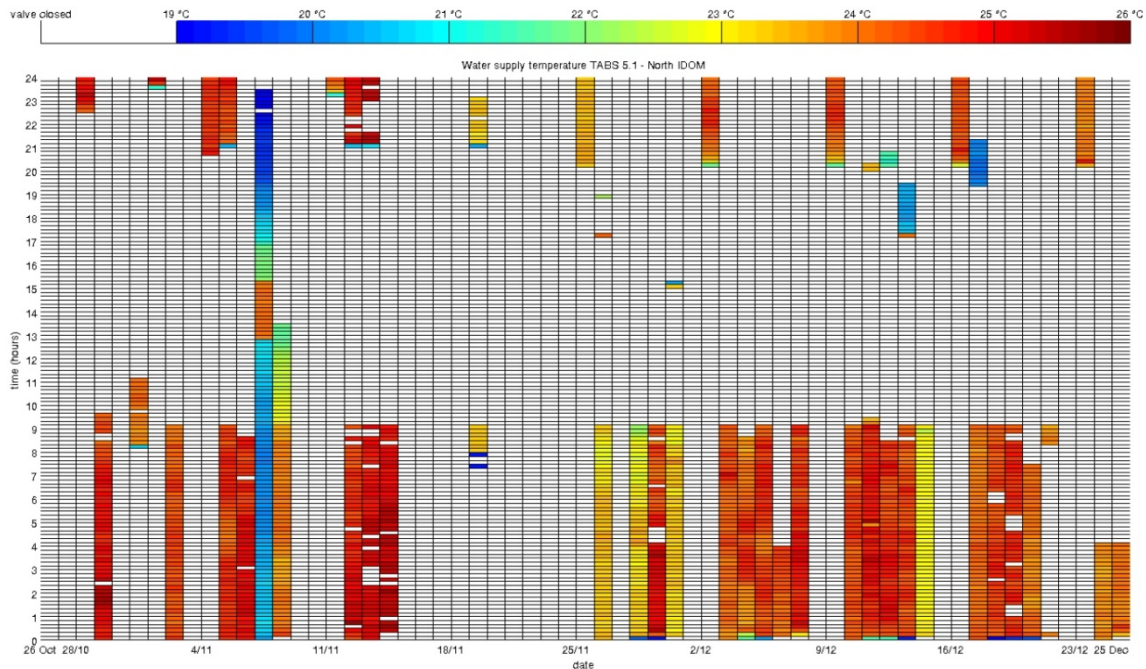
Figure 6 – TABS supply water temperature (°C) in northern office space in IDOM Madrid during winter; white areas indicate periods with no water circulation through the TABS in the zone

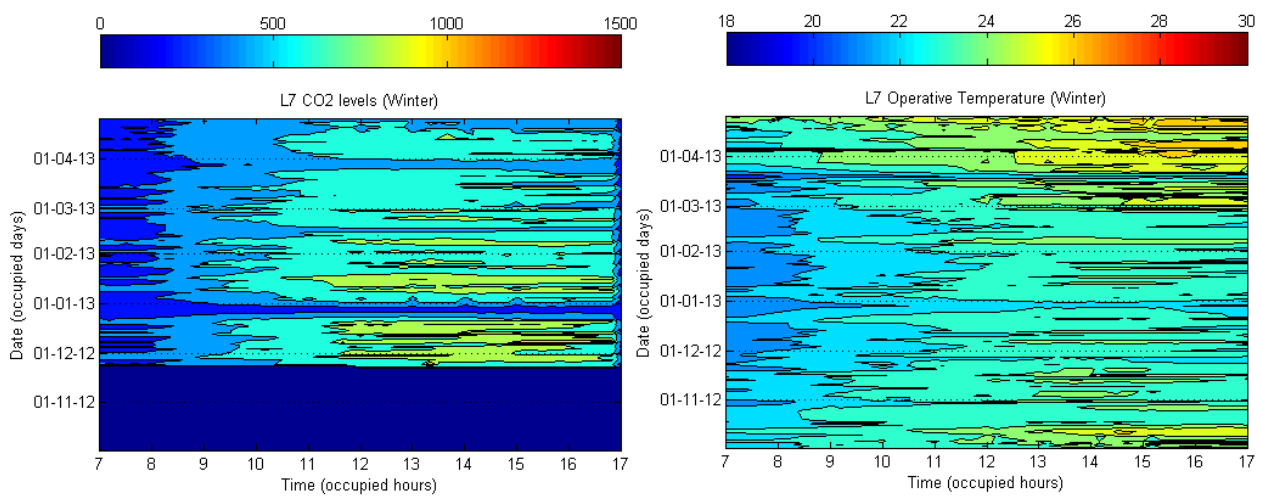
Figure 7 – Left: CO₂ concentration (ppm) and Right: operative temperature (°C) in south-west open plan office space in Viborg Town Hall during occupied hours

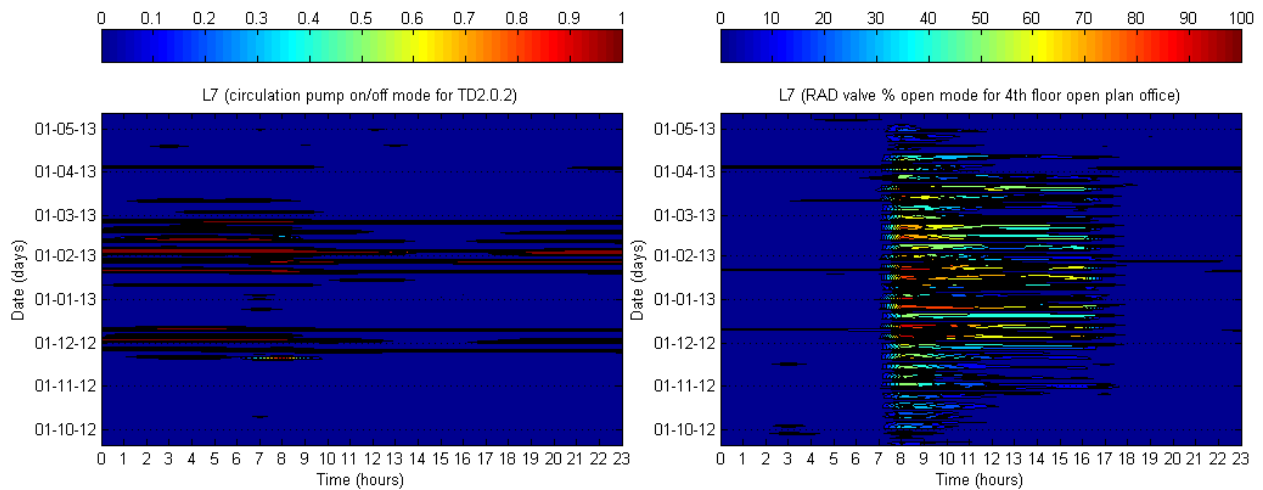
Figure 8 – Left: TABS circulation pump operation and Right: operation mode of the motorized valve on convectors under windows in south-west open plan office space in Viborg Town Hall

Above mentioned results, together with results from the occupancy survey, which showed large percentage of respondents dissatisfied with draught caused by ventilation, indicate that control strategy for thermal environment in the building deserved some optimization.

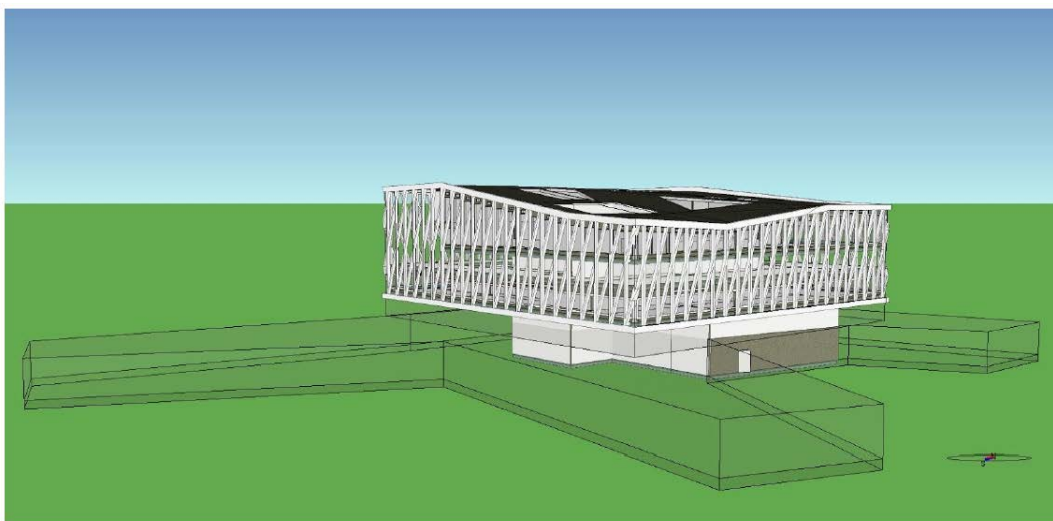
Figure 9 – Model of Viborg Town Hall in building performance simulation tool IDA ICE

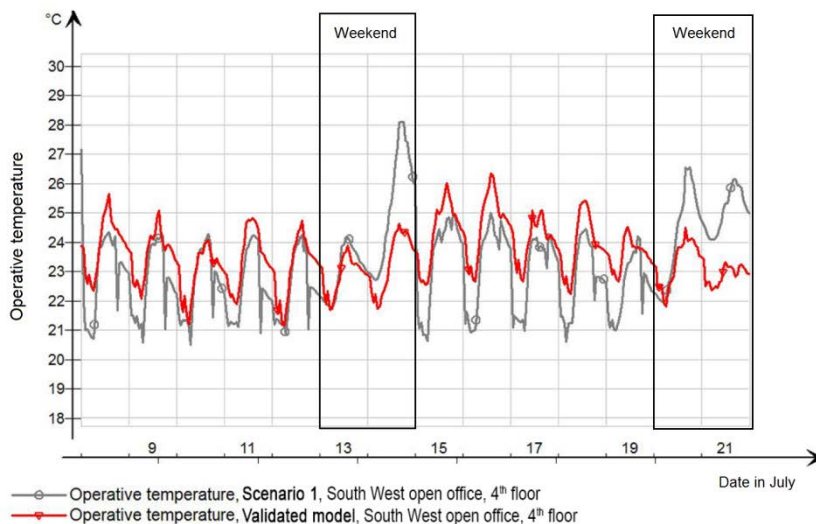
Figure 10 - Comparison of operative temperatures in validated model (reference) and optimization Scenario 1 at open plan office at 4th floor oriented towards south west (14 days from 8 July till 21 July)

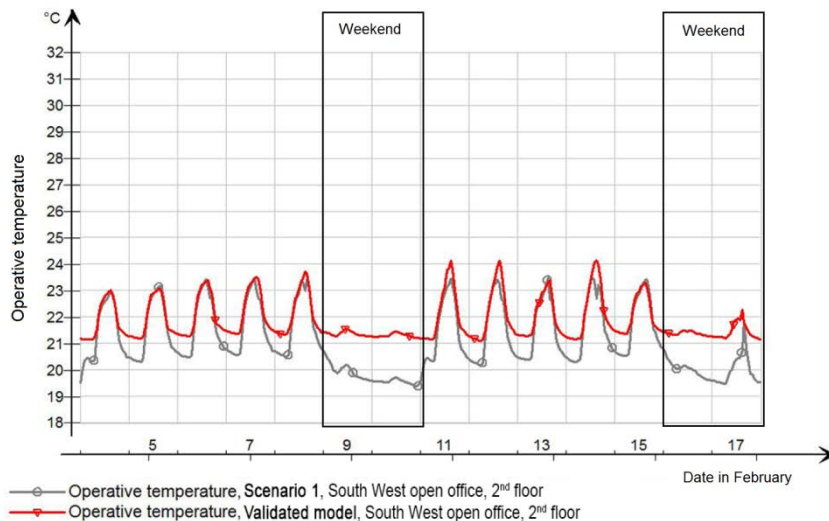
Figure 11 - Comparison of operative temperatures in validated model (reference) and optimization Scenario 1 at open plan office at 2nd floor oriented towards south west (14 days from 4 Feb. till 17 Feb.)

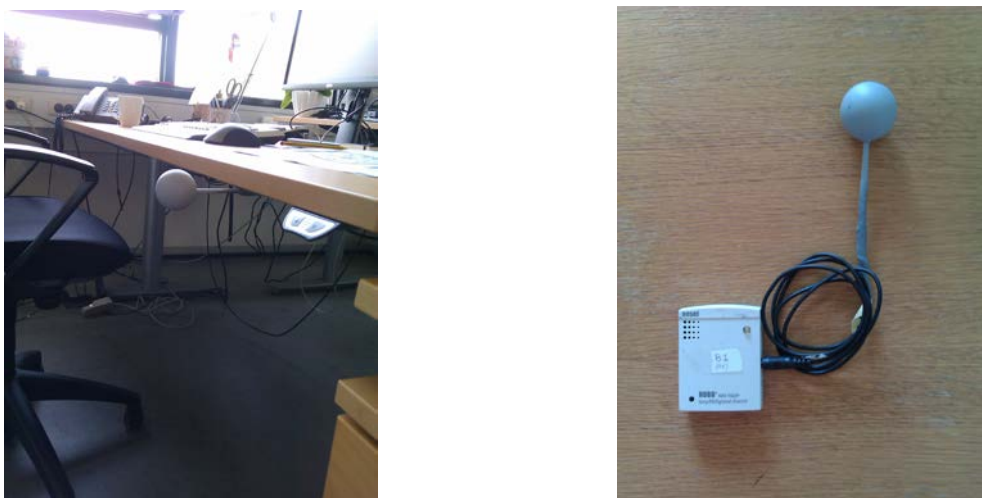
Figure 1. (Left) Placement of the operative temperature sensor at workplace, (Right) A set of grey sphere-shaped sensor and data logger

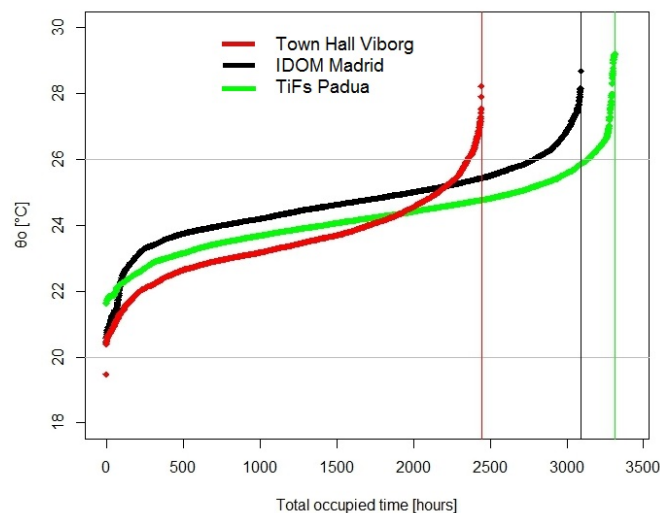
Figure 1. Duration curves for hourly mean operative temperatures (θ_o) measured in southern spaces of the investigated buildings; amount of hours in the data-set was not equal for all buildings – end of the data-set for particular building is indicated by a vertical line at corresponding colour.

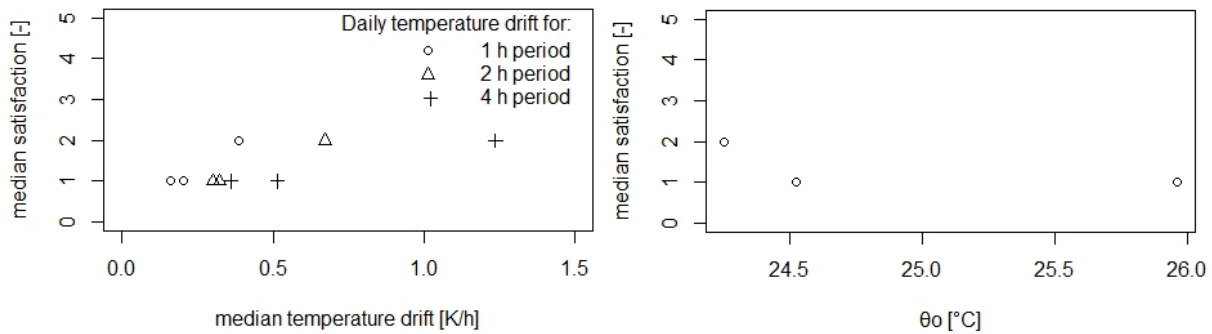
Figure 3. (Left) Relation between daily temperature drift and temperature satisfaction from all investigated buildings, (Right) Relation between daily mean operative temperature and temperature satisfaction from all investigated buildings

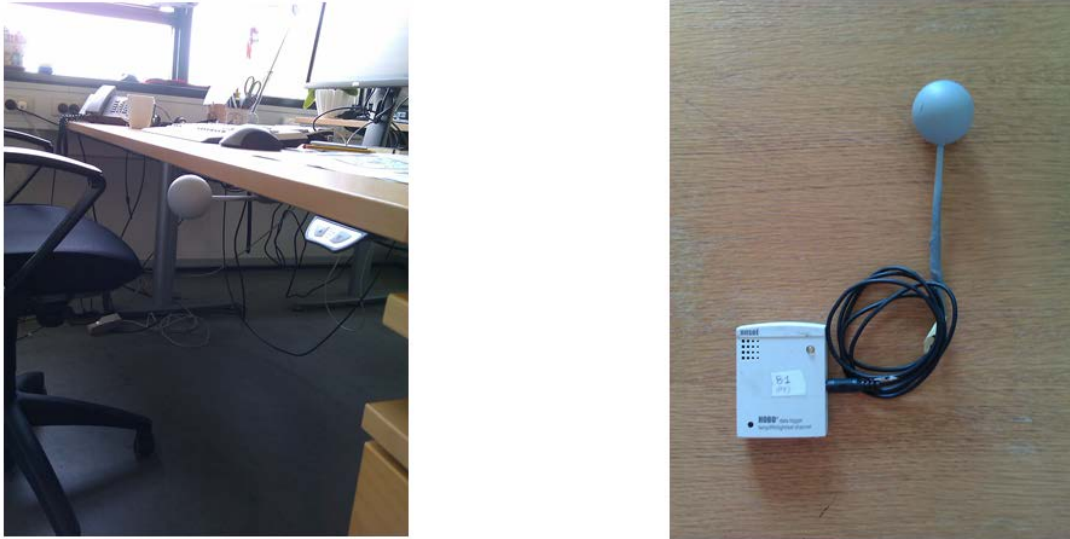
Figure 1 - (Left) Illustrative placement of an operative temperature sensor at a workplace, (Right) A set of grey sphere-shaped sensor and data logger

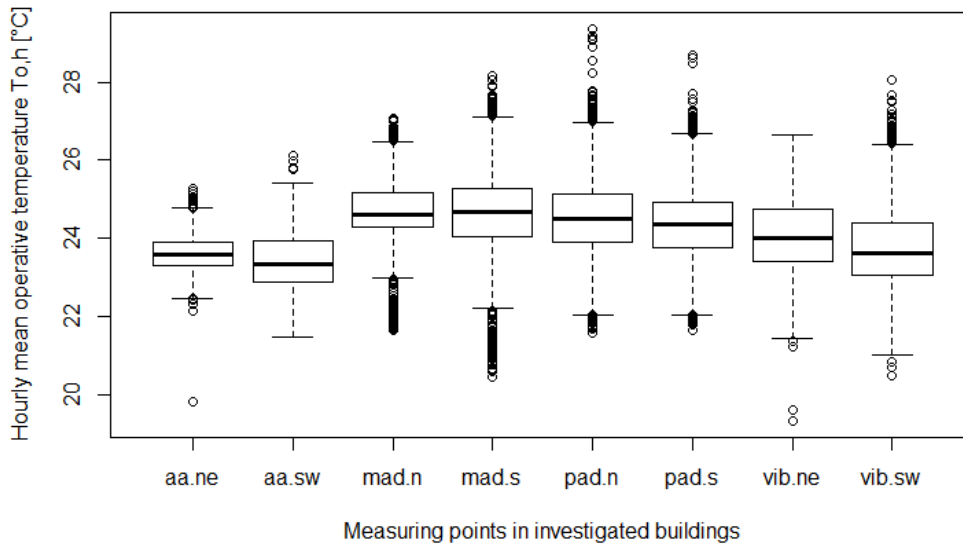
Figure 2 – Measured mean operative temperatures in investigated buildings, measuring points are abbreviated as follows: first two letters – building: aa – COWI Aalborg, mad – IDOM Madrid, pad – TiSF Padua, vib – Town Hall Viborg; second two letters – orientation: n – North, ne – North-east, s – South, sw – South-west
