MAGNESIUM-OXIDE BOARDS CAUSE MOISTURE DAMAGE INSIDE FACADES IN NEW DANISH BUILDINGS

Kurt Kielsgaard Hansen ⁽¹⁾, Tommy Bunch-Nielsen ⁽²⁾, Bent Grelk ⁽¹⁾, Carsten Rode ⁽¹⁾

Abstract

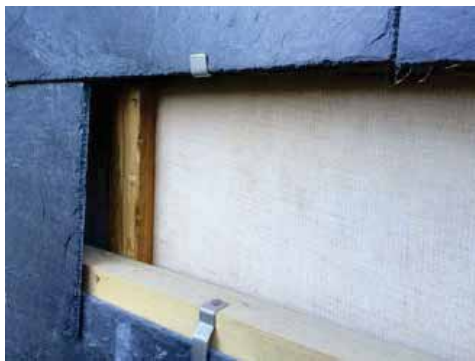
Figure 3: The MgO-board is placed facing the air gap, which is behind the siding boards made of natural slates.

In winter 2014/15, many moisture damages were observed inside ventilated facades of new or newly renovated Danish buildings. The moisture damaged facades were constructed with sheathing made of magnesium oxide boards (MgO-boards) facing the air gap behind the material used for exterior siding. MgO-boards have often been used as sheathing behind a ventilated air gap as shown in Figure 1 and Figure 3. A photo of a MgO-board is shown in Figure 2.

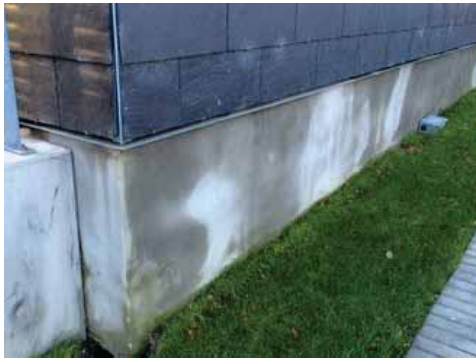
The observed damages were caused by the fact that MgO-boards absorb moisture from outside air. Water drops containing chloride ions appear on the outside of the boards – often so many that they run down the vertical boards and out via the air gap behind the siding boards (see Figures 4 and 5). The metal mountings for the MgO-boards can corrode heavily within a few years, cf. Figure 6.

Figure 5: The water drops containing chloride ions run down the vertical MgO-boards and drain out of the wall from behind the wall's siding boards.

For this reason, it can be stated that MgO-boards are not suited as sheathing in exterior facades or any other application where the boards are in contact with a moist climate. At RH above approximately 84% RH the MgO-boards will form drops of salty water on the surfaces, and this water will be absorbed in wooden structures in connection with boards and water absorption will increase and can lead to mould growth on wood. The MgO-board itself is also

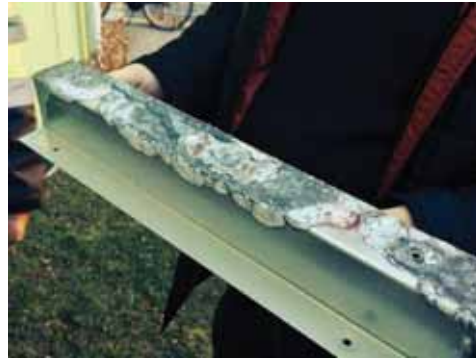
Figure 6: The zinc covering of the steel profile is corroded as a result of direct contact with salty sweat or 'tear' drops from the adjacent MgO-board.

sensitive to mould growth due to the content of organic material. Furthermore, the MgO board will itself also be disintegrated over time when it is exposed to high humidity due to the dissolution of the salts it consists of. If metal parts, such as galvanized steel, fasteners and flashings are in contact with MgO-boards, they will start to corrode within short time, leading to safety problems in the structure. Sheathing with MgO-boards are now being replaced by other types of materials in a great number of buildings in Denmark.

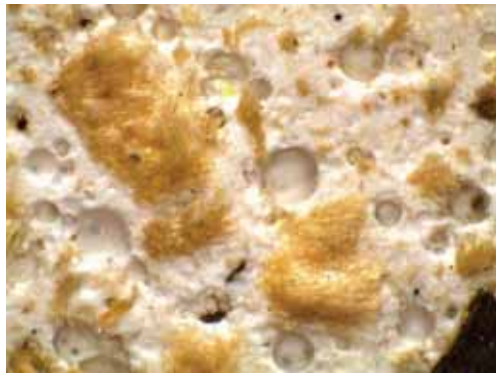
amount of very porous organic material and the many fine spherical air pores. All investigated MgO-boards have some type of fibrous reinforcement (glass fibre mesh) on the faces.

Figure 7: Cut of a MgO-board investigated in a stereo microscope at 10 times magnification.

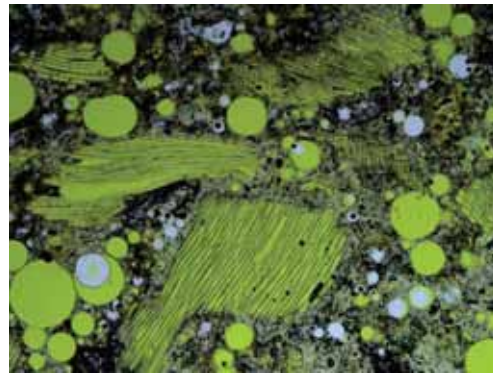
The hydrated product is hard and strong but the product decomposes over time by contact with water or air at high relative humidity (RH). The durability problems with this material are reason that the material has so to speak been forgotten in the following years. However, within the last 10 years a relatively high number of so-called MgO products (MgO-boards) have been put on the market within the building industry. MgO-boards have a composition, which is very similar to hydrated Sorel cement but has both organic additions, such as sawdust (wood flour), and inorganic filler additions such as sand, lime or volcanic ash – even though it may not be stated in the data sheets for MgO-boards. Figure 7 shows a cut of an MgO-board analysed in a stereo microscope at 10 times magnification. The analysis shows that the investigated MgO-board contains a high amount of organic material such as wood fibres or sawdust, and a high number of fine spherical air pores. Figure 8 is a micro analysis of a thin section of a specimen at 50 times magnification that verified both the considerable

Figure 8: Micro analysis of a thin section of a specimen at 50 times magnification.

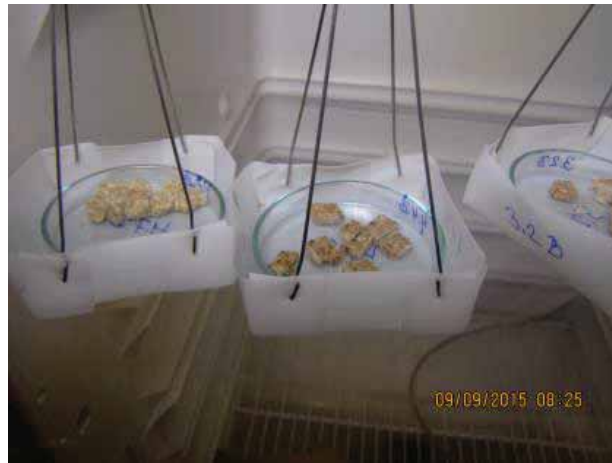
The initial moisture absorption in MgO-boards from the surrounding air was measured at three different levels of relative humidity at 23 °C: 35% RH, 80% RH and 95% RH. Before start of the moisture exposure, samples of size 5 x 4 x 3 mm were dried at 105 °C for 4 days, and cooled to room temperature. MgO-samples with a total weight of about 2 g were placed

in a petri glass dish, which was placed inside a basket made of Teflon. Weighing of the baskets were performed without opening the front doors of the climate chambers, as the baskets were hung up one by one below the balance by means of a steel string. Figure 9 shows the climate chamber where the actual RH is created by mixing flow of dry air with flow of saturated air. Based on a calibrated RH-sensor the connected PID-system regulates the dry airflow and the saturated air flow for obtaining the wanted RH. In this way, the RH is created in wanted steps. Figure 10 shows the specimens in the petri glass dishes placed in the baskets. The measurements were performed after 0, 1, 2, 3, 4, 5, 7 days and after 2 and 4 weeks. The results are presented in Figures 11, 12 and 13. Indication of mould growth on specimen 4.4C was seen after 30 days of exposure to 95% RH, cf. Figure 14.

Figure 10: Specimens in the petri glass dishes placed in baskets.

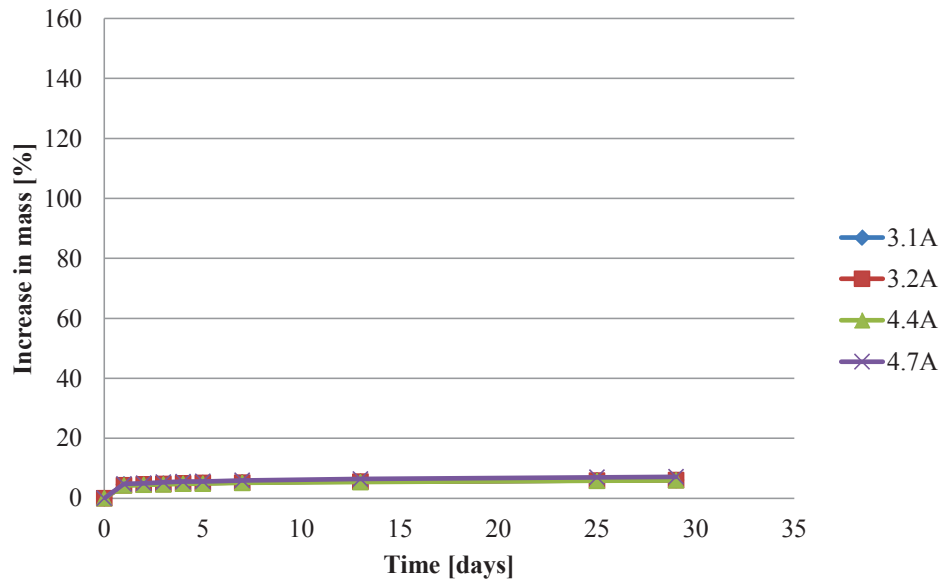
Figure 11: Course of the moisture retention at 35% RH.

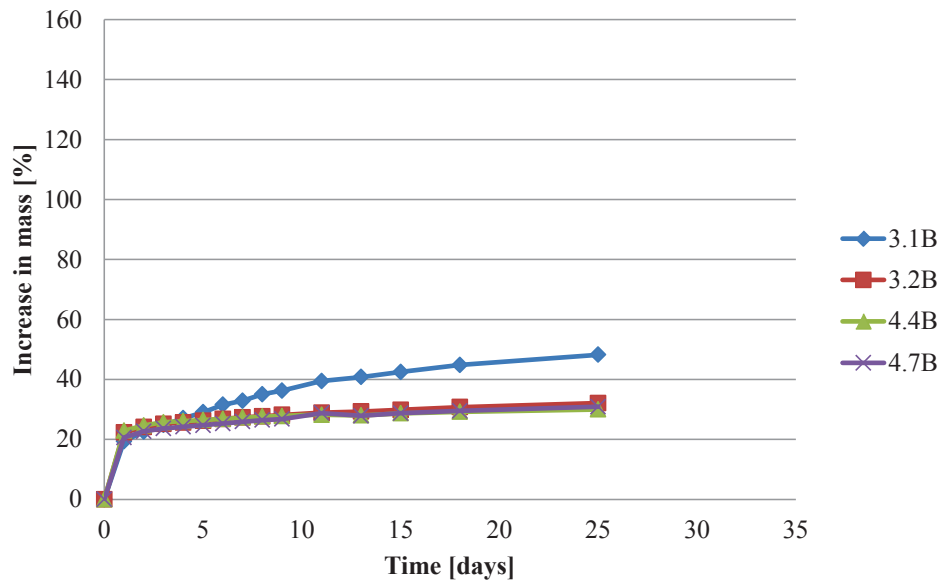
Figure 12: Course of the moisture retention at 80% RH.

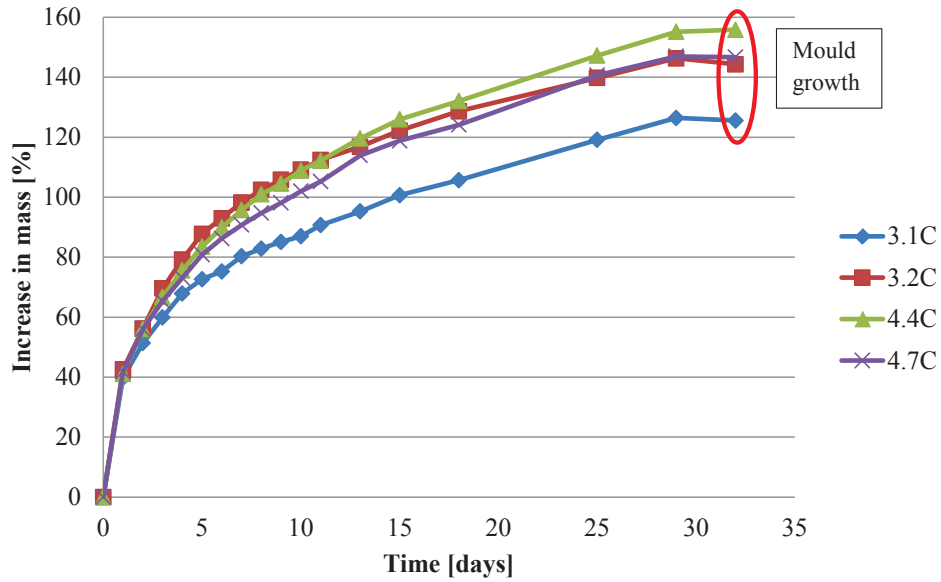
Figure 13: Course of the moisture retention at 95% RH.

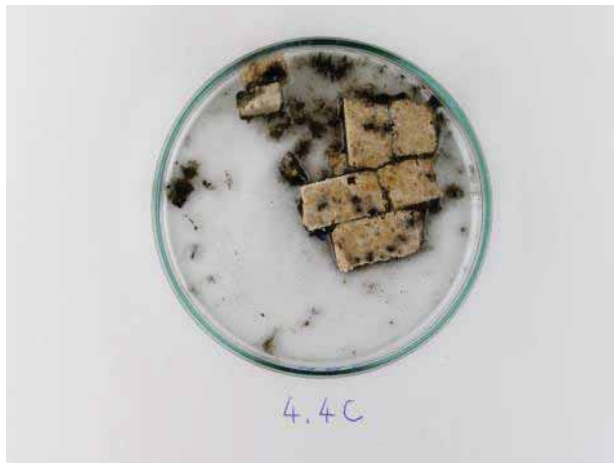
Figure 14: Indication of mould growth on specimen 4.4C after 30 days of exposure to 95% RH.

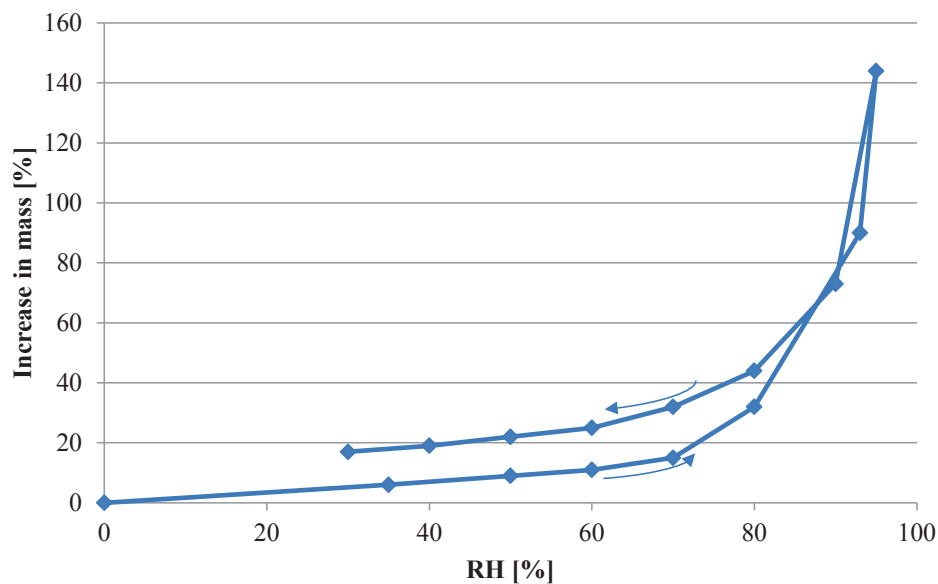
Absorption was measured for specimens that were originally used for initial moisture absorption at 35% RH. The absorption points were measured from 35% RH and up to 92% RH. An example of the results of the absorption and desorption measurements is shown in Figure 15.

Figure 15: The results of the absorption and desorption measurements for specimen 3.2.
