International RILEM Conference on Materials, Systems and Structures in Civil Engineering 2016

## **MAGNESIUM-OXIDE BOARDS CAUSE MOISTURE DAMAGE INSIDE FACADES IN NEW DANISH BUILDINGS**

### **Abstract**

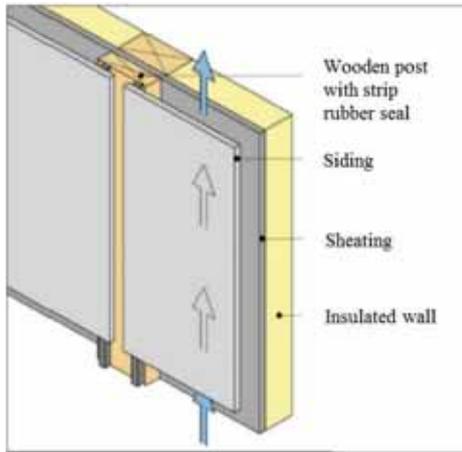
Figure 1: Sketch of a typical façade construction where a sheathing board is used as wind barrier. Adapted from [1].

In winter 2014/15, many moisture damages were observed inside ventilated facades of new or newly renovated Danish buildings. The moisture damaged facades were constructed with sheathing made of magnesium oxide boards (MgO-boards) facing the air gap behind the material used for exterior siding. MgO-boards have often been used as sheathing behind a ventilated air gap as shown in Figure 1 and Figure 3. A photo of a MgO-board is shown in Figure 2.

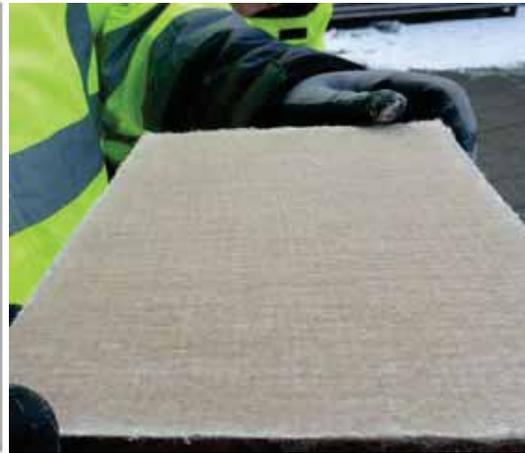
Figure 2: Photo of 8 mm thick MgO-board with a glass fibre mesh on both surfaces.

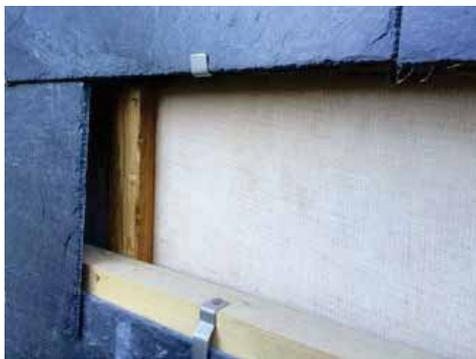
Figure 3: The MgO-board is placed facing the air gap, which is behind the siding boards made of natural slates.

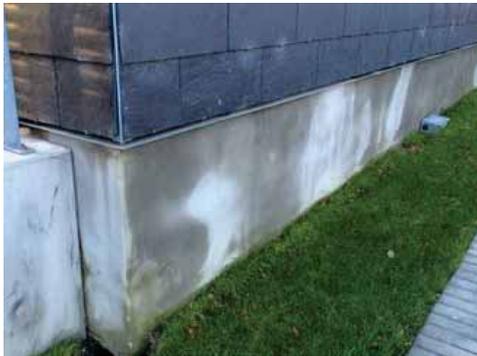
Figure 5: The water drops containing chloride ions run down the vertical MgO-boards and drain out of the wall from behind the wall's siding boards.

The observed damages were caused by the fact that MgO-boards absorb moisture from outside air. Water drops containing chloride ions appear on the outside of the boards – often so many that they run down the vertical boards and out via the air gap behind the siding boards (see Figures 4 and 5). The metal mountings for the MgO-boards can corrode heavily within a few years, cf. Figure 6.

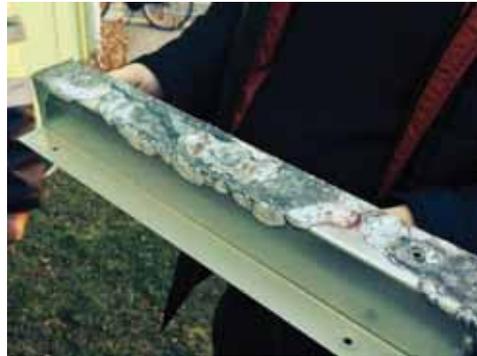
Figure 6: The zinc covering of the steel profile is corroded as a result of direct contact with salty sweat or 'tear' drops from the adjacent MgO-board.

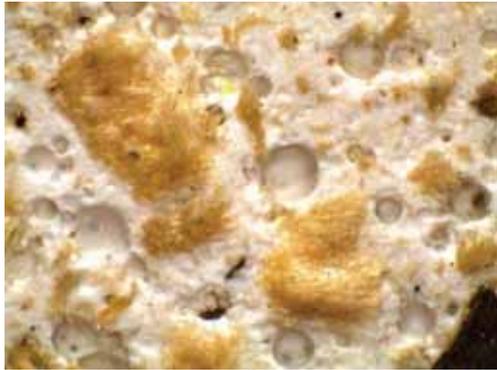
Figure 7: Cut of a MgO-board investigated in a stereo microscope at 10 times magnification.

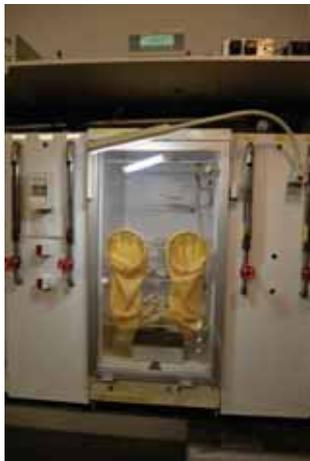
Figure 9: The climate chamber.

in a petri glass dish, which was placed inside a basket made of Teflon. Weighing of the baskets were performed without opening the front doors of the climate chambers, as the baskets were hung up one by one below the balance by means of a steel string. Figure 9 shows the climate chamber where the actual RH is created by mixing flow of dry air with flow of saturated air. Based on a calibrated RH-sensor the connected PID-system regulates the dry airflow and the saturated air flow for obtaining the wanted RH. In this way, the RH is created in wanted steps. Figure 10 shows the specimens in the petri glass dishes placed in the baskets. The measurements were performed after 0, 1, 2, 3, 4, 5, 7 days and after 2 and 4 weeks. The results are presented in Figures 11, 12 and 13. Indication of mould growth on specimen 4.4C was seen after 30 days of exposure to 95% RH, cf. Figure 14.

Subsequent measurements of absorption and desorption were performed for the same four specimens that were analysed for initial moisture absorption at 35% RH and 80% RH, i.e. the initial dry masses were known. The climate chamber used is shown in Figure 9. Desorption was measured for specimens 3.1B, 3.2B, 4.4B and 4.7B, which originally were used for determination of initial moisture absorption at 80% RH. Before starting the desorption runs, the humidity of the climate chamber was increased from 80% RH to 92% RH in steps of 2% RH with the purpose of finding the level of RH at which the specimens began to form drops (i.e. sweating or 'crying') on the surface. We knew from the first part of the tests (at 95% RH) that specimens showed severe sweating starting after one week, while boards at 80% RH apparently did not sweat after 80 days of exposure. In view of the risk of mould growth at RH higher than 92% RH, desorption was started at this RH. Desorption points were measured from 92% RH and below.

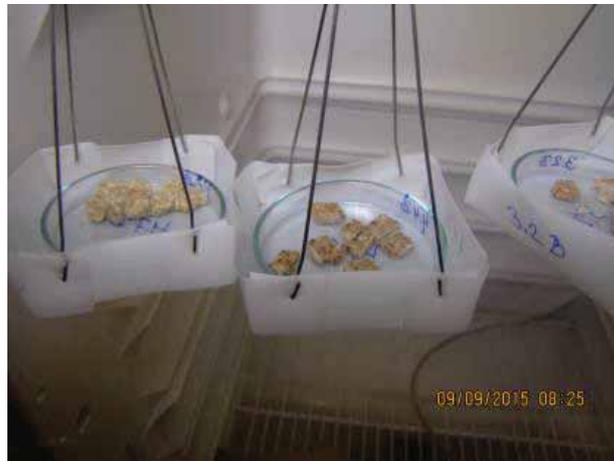
Figure 10: Specimens in the petri glass dishes placed in baskets.

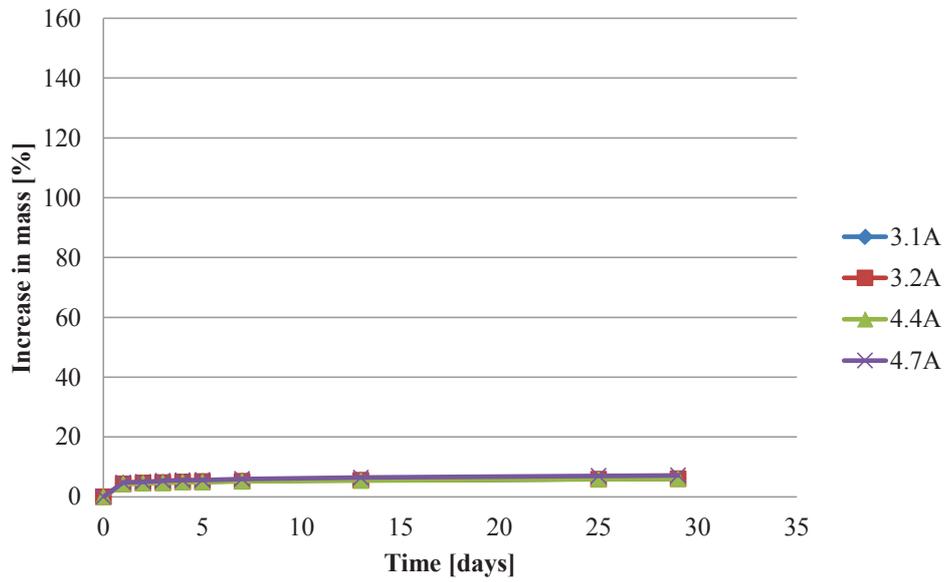
Figure 11: Course of the moisture retention at 35% RH.

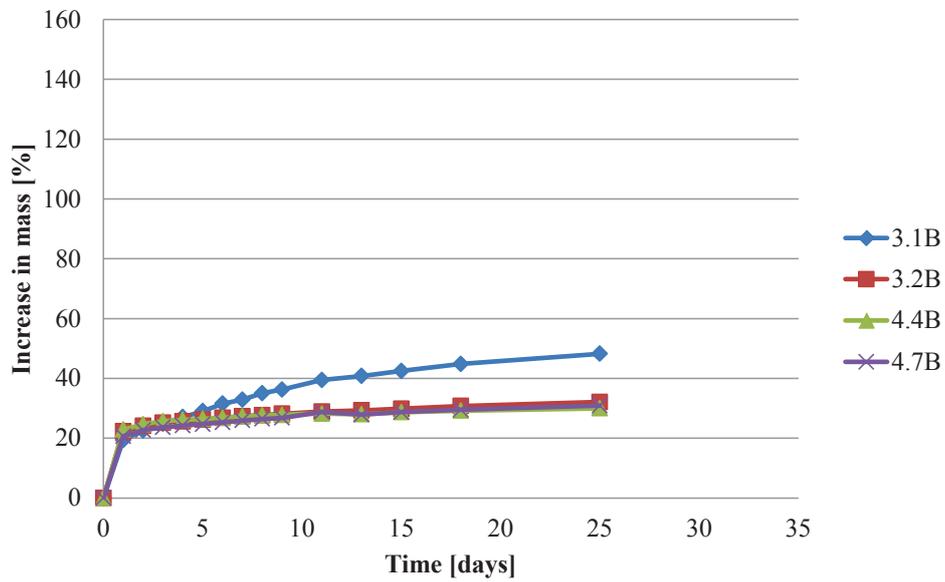
Figure 12: Course of the moisture retention at 80% RH.

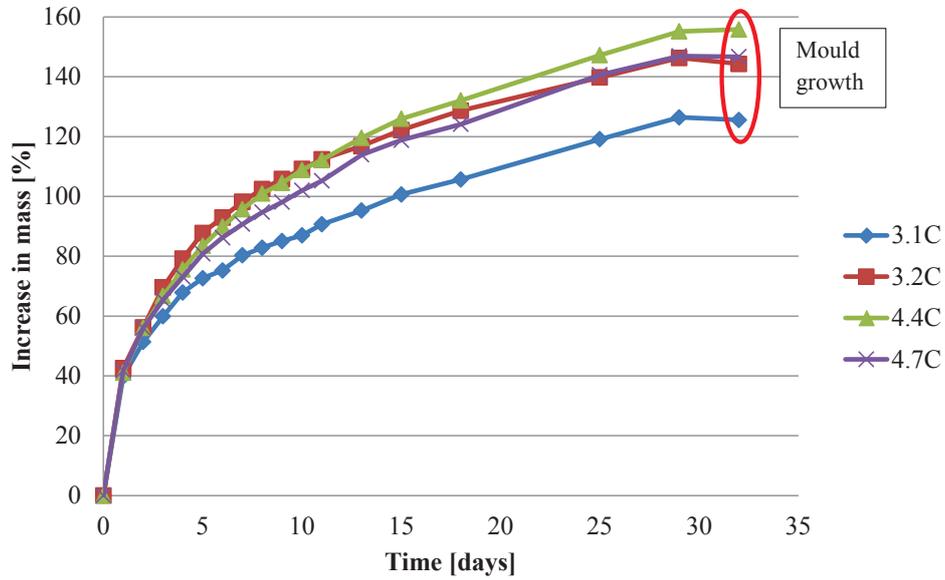
Figure 13: Course of the moisture retention at 95% RH.

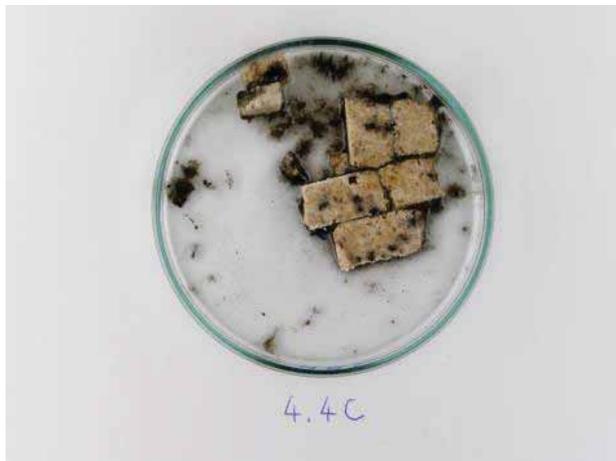
Figure 14: Indication of mould growth on specimen 4.4C after 30 days of exposure to 95% RH.

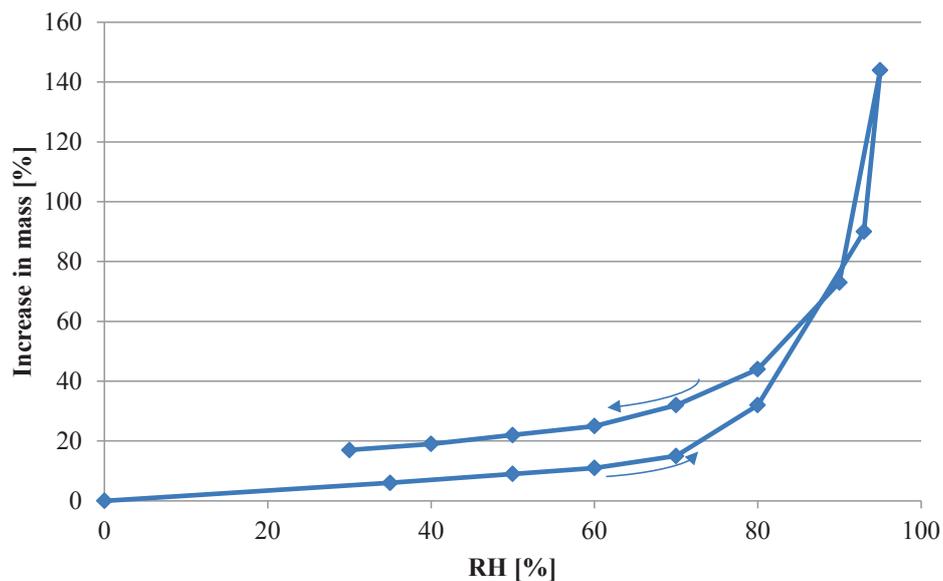
Figure 15: The results of the absorption and desorption measurements for specimen 3.2.

Absorption was measured for specimens that were originally used for initial moisture absorption at 35% RH. The absorption points were measured from 35% RH and up to 92% RH. An example of the results of the absorption and desorption measurements is shown in Figure 15.

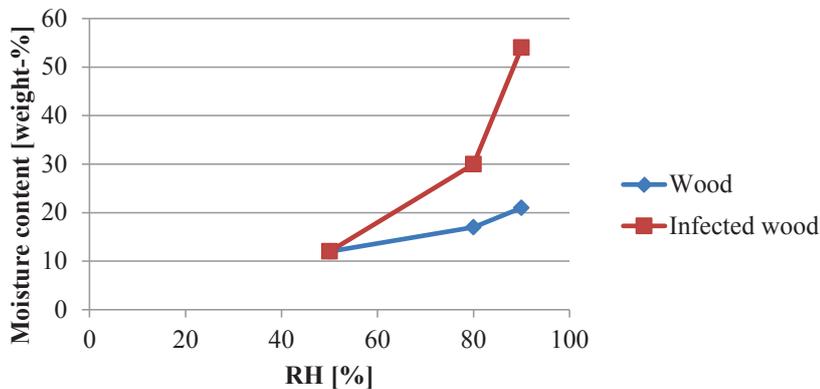
Figure 16: The absorption curves for the infected wood and the non-infected wood.

The pine wood posts supporting the adjacent MgO-boards inside the façade construction absorb the water drops ('tear' drops) from the MgO-boards. The 'tear' drops contain relatively high amounts of chloride ions. Infected wood from a post from a house, as well as non-infected wood, have been used for absorption measurements as follows: First, the infected wood and the non-infected wood pieces were conditioned to attain equilibrium at 50% RH. They were then conditioned to equilibrium at 80% RH, and finally to equilibrium at 90% RH. The absorption curves for the infected wood and the non-infected wood are shown in Figure 16.
