International RILEM Conference on Materials, Systems and Structures in Civil Engineering 2016

## **MAGNESIUM-OXIDE BOARDS CAUSE MOISTURE DAMAGE INSIDE FACADES IN NEW DANISH BUILDINGS**

### **Abstract**

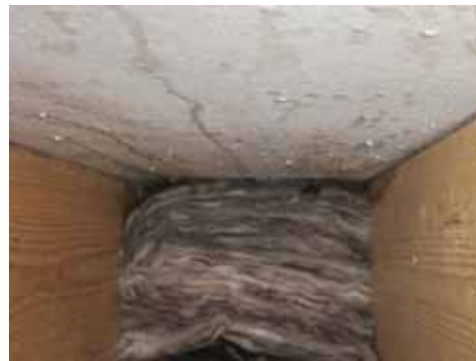
Figure 4: Salty water drops on a vertical MgO-board on the side that faces the insulation filled cavity inside the wall.

The observed damages were caused by the fact that MgO-boards absorb moisture from outside air. Water drops containing chloride ions appear on the outside of the boards – often so many that they run down the vertical boards and out via the air gap behind the siding boards (see Figures 4 and 5). The metal mountings for the MgO-boards can corrode heavily within a few years, cf. Figure 6.

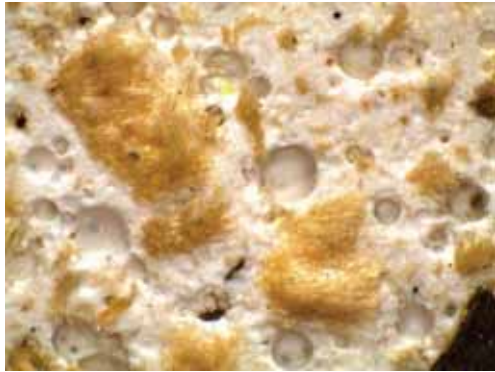
Figure 7: Cut of a MgO-board investigated in a stereo microscope at 10 times magnification.

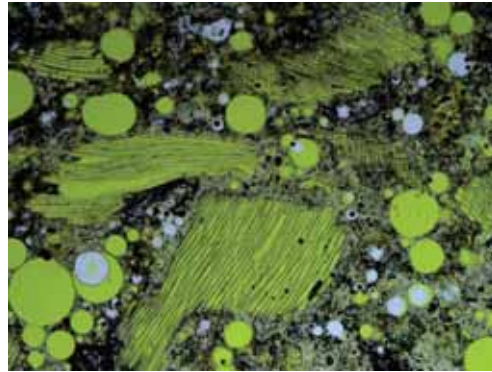
Figure 8: Micro analysis of a thin section of a specimen at 50 times magnification.

The hydrated product is hard and strong but the product decomposes over time by contact with water or air at high relative humidity (RH). The durability problems with this material are reason that the material has so to speak been forgotten in the following years. However, within the last 10 years a relatively high number of so-called MgO products (MgO-boards) have been put on the market within the building industry. MgO-boards have a composition, which is very similar to hydrated Sorel cement but has both organic additions, such as sawdust (wood flour), and inorganic filler additions such as sand, lime or volcanic ash – even though it may not be stated in the data sheets for MgO-boards. Figure 7 shows a cut of an MgO-board analysed in a stereo microscope at 10 times magnification. The analysis shows that the investigated MgO-board contains a high amount of organic material such as wood fibres or sawdust, and a high number of fine spherical air pores. Figure 8 is a micro analysis of a thin section of a specimen at 50 times magnification that verified both the considerable

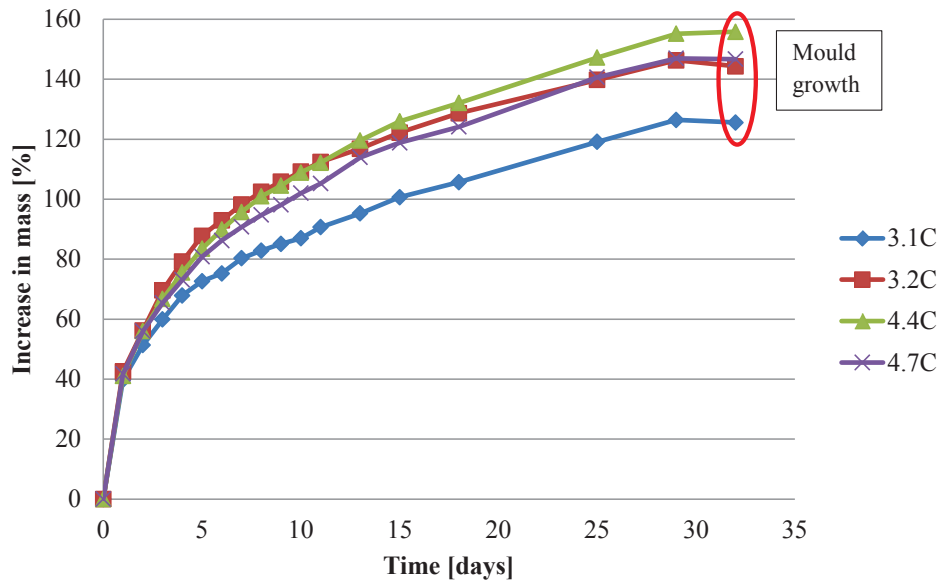
Figure 13: Course of the moisture retention at 95% RH.
